#### **Comstock Cemetery Foundation** -**An outdoor museum**

# Bathroom Documentation Field Observations, Stabilization and Treatment

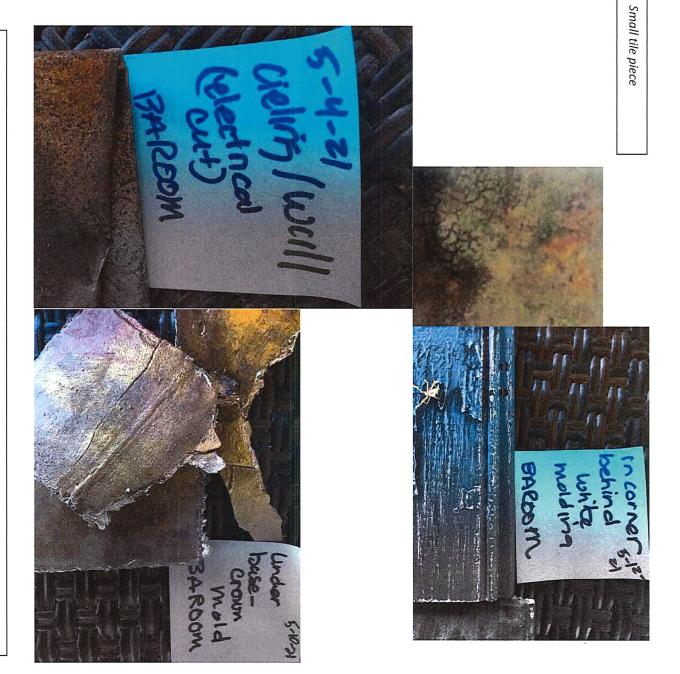
Material Fragments from Bathroom

Pressed Tin Fragment

and colors. We have a standing request for a CCCHP Board review of our treatment plan for the south wall which includes the installation of modern pressed tiles. We have revised this treatment in hopes of making it more acceptable. The tiles will be installed on a temporary basis using only upholstery tacks, no glue or adhesive will be applied, the treatment will be 100% reversible, and interpretation will be added to explain the historic use of pressed tin in commercial and residential structures. The found fragment of old pressed tin will be on display in this non-public use room.

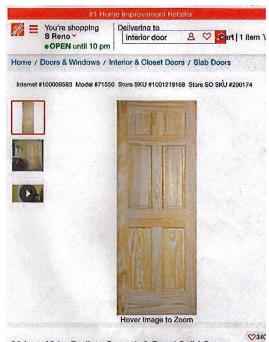
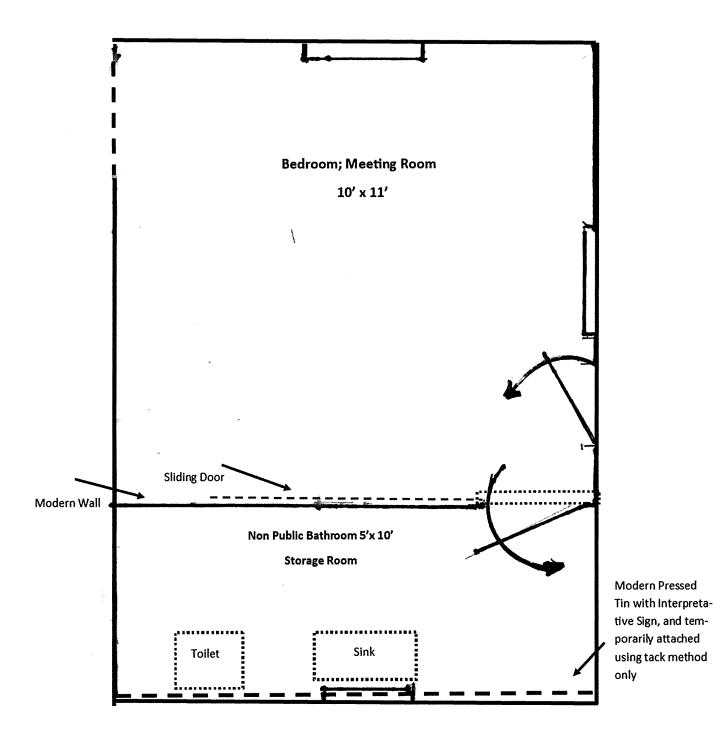
Door to be Used

Waiting on Approval for Barn Door

30 in. x 80 in. Radiata Smooth 6-Panel Solid Core

<u>Treatment-</u>We will go to the matt to get this treatment plan approved. We have a standing request for a CCCHP Board review of our treatment plan for installation of a sliding door. We would like to utilize a sliding door-not a pocket door as the wall construction is not suitable. There were many sliding and/or barn doors used on the Comstock especially in the more industrial buildings. This adaptation is tied to the new usage of the space. And, given its mining history, the more industrial feel is compatible with its character of the evolutionary salvage and reuse.

Today, you can see the marks of the sliding hardware around town, but most hardware has been taken for resale or reuse. The sliding mechanism is simple and can be removed at any point. The installation is reversible, and the door that is planned could be hinged at any point. The door will fit the character of the building and be constructed of pine, newly purchased. We are searching for the correct size however the contractor can adjust to fit if needed (see picture).
