City of Ely, Nevada Historic City Hall and Fire Station Rehabilitation

An Historic Structures Report

RAFI Architecture and Design

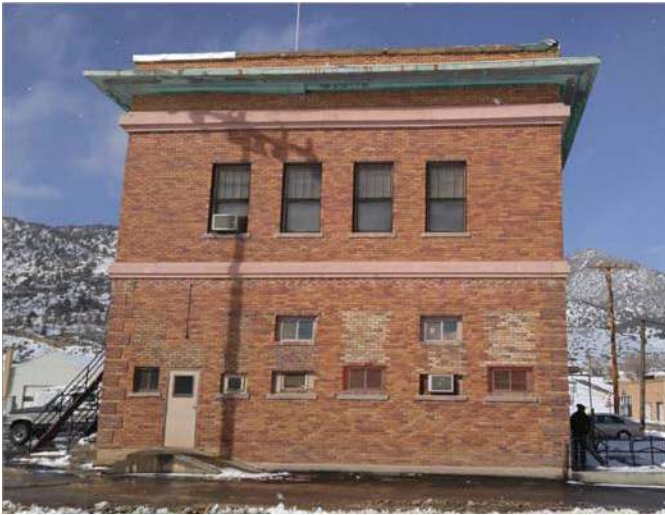
South Elevation (Notice Changes in Brick Color at Alterations)

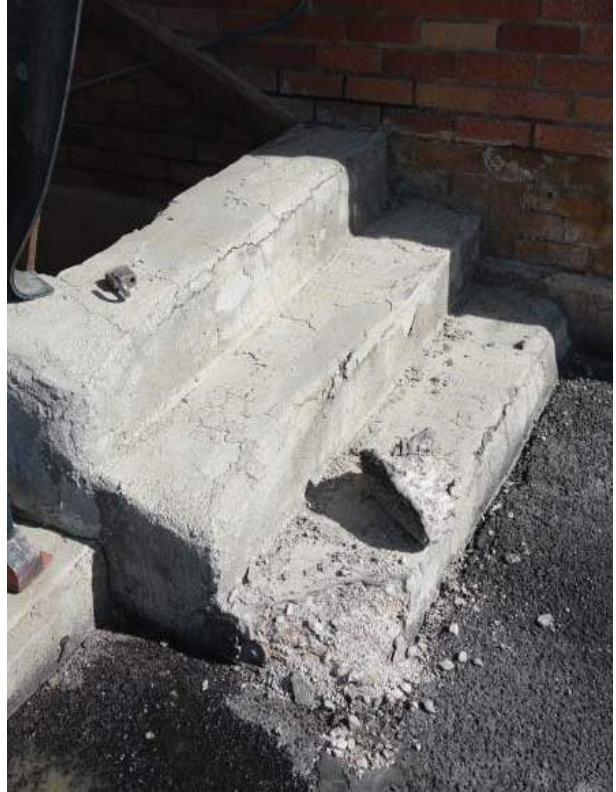
Damaged stairs to the basement.

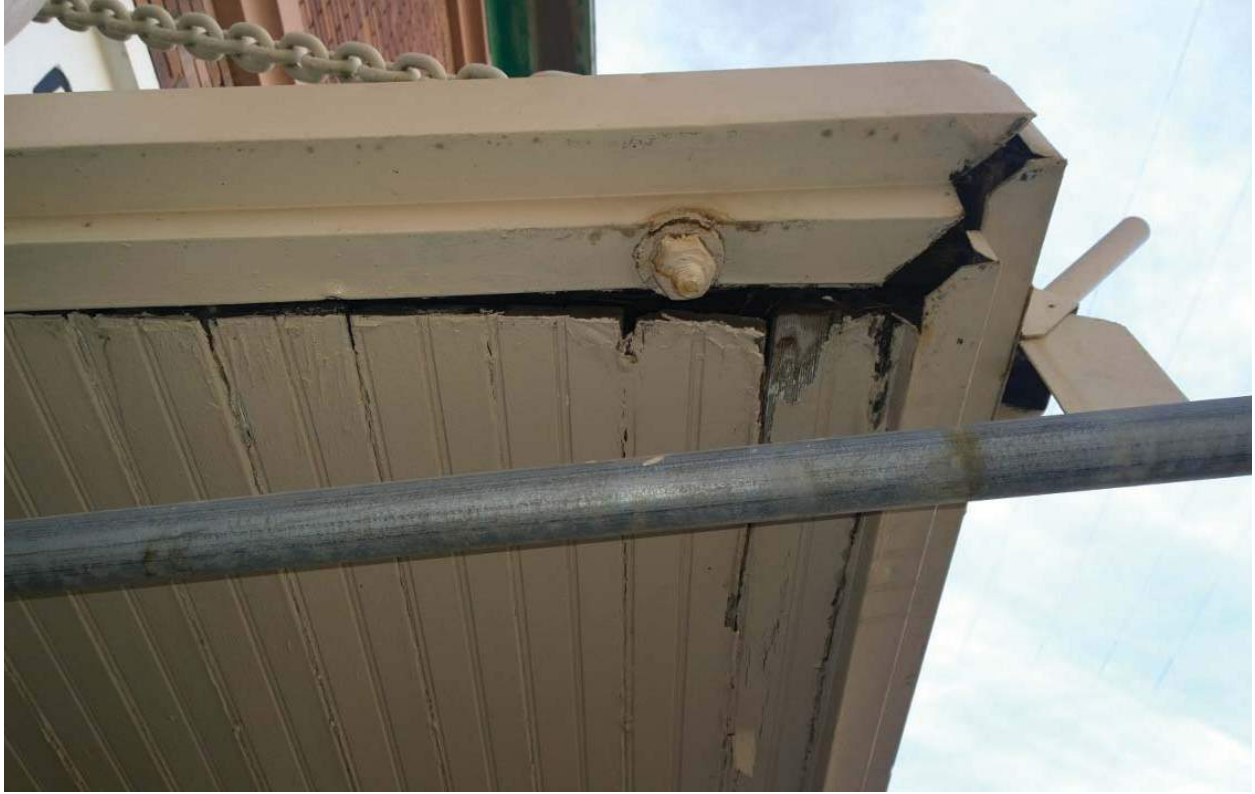
Damage to the entrance of the building.

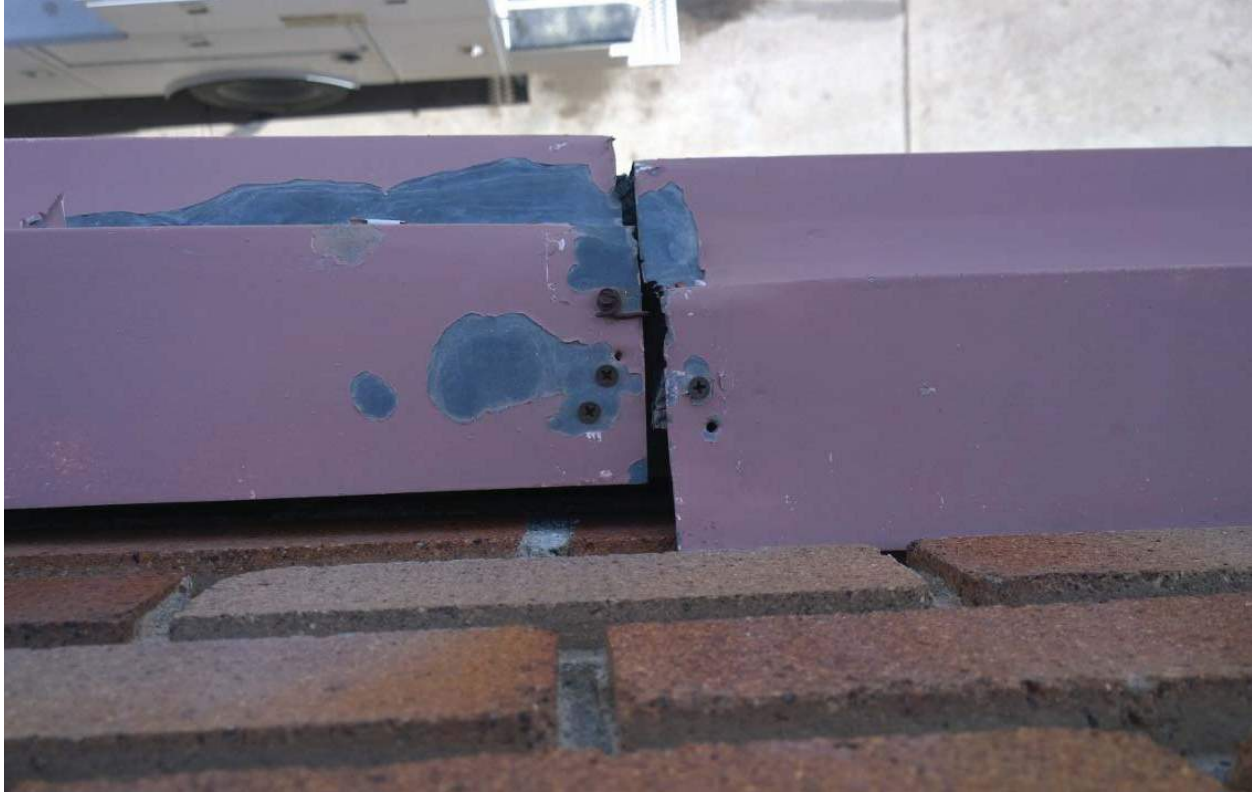
Damage to the cornice.

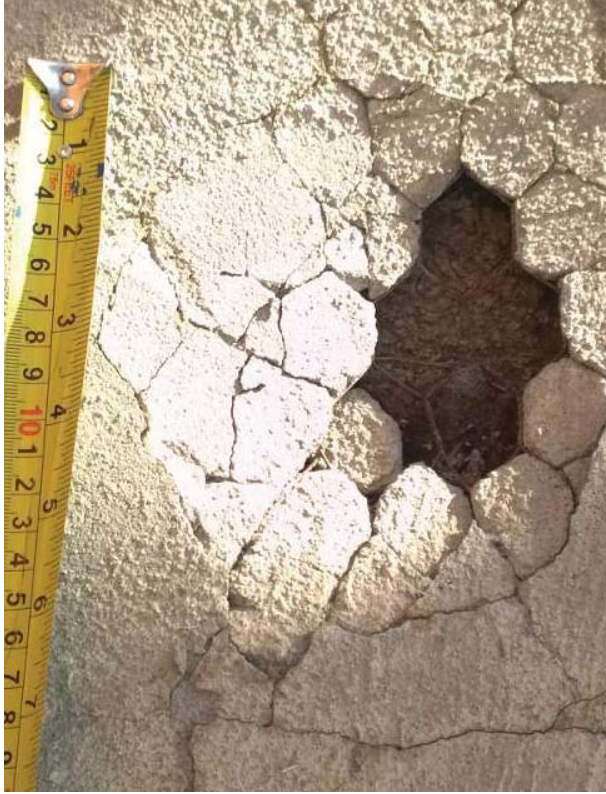
Damage to basement entry.

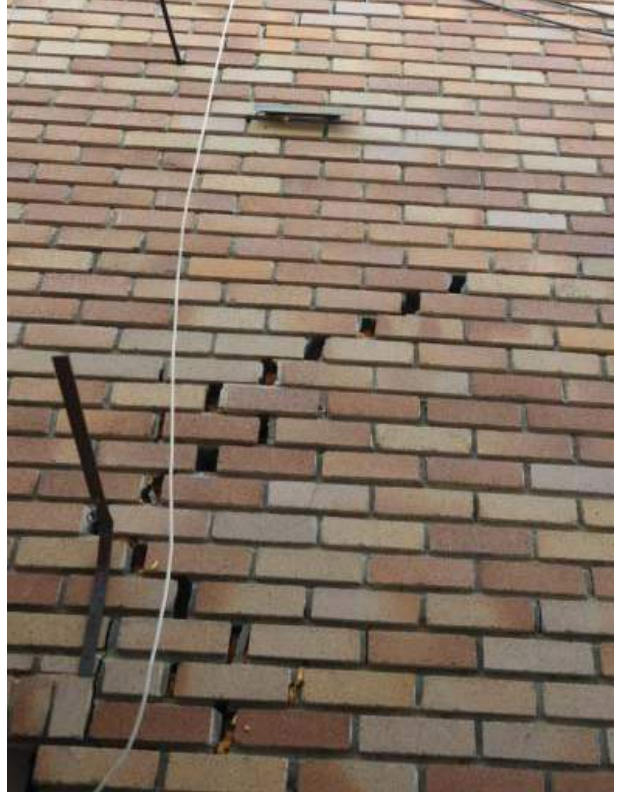
Large crack in the North facade.

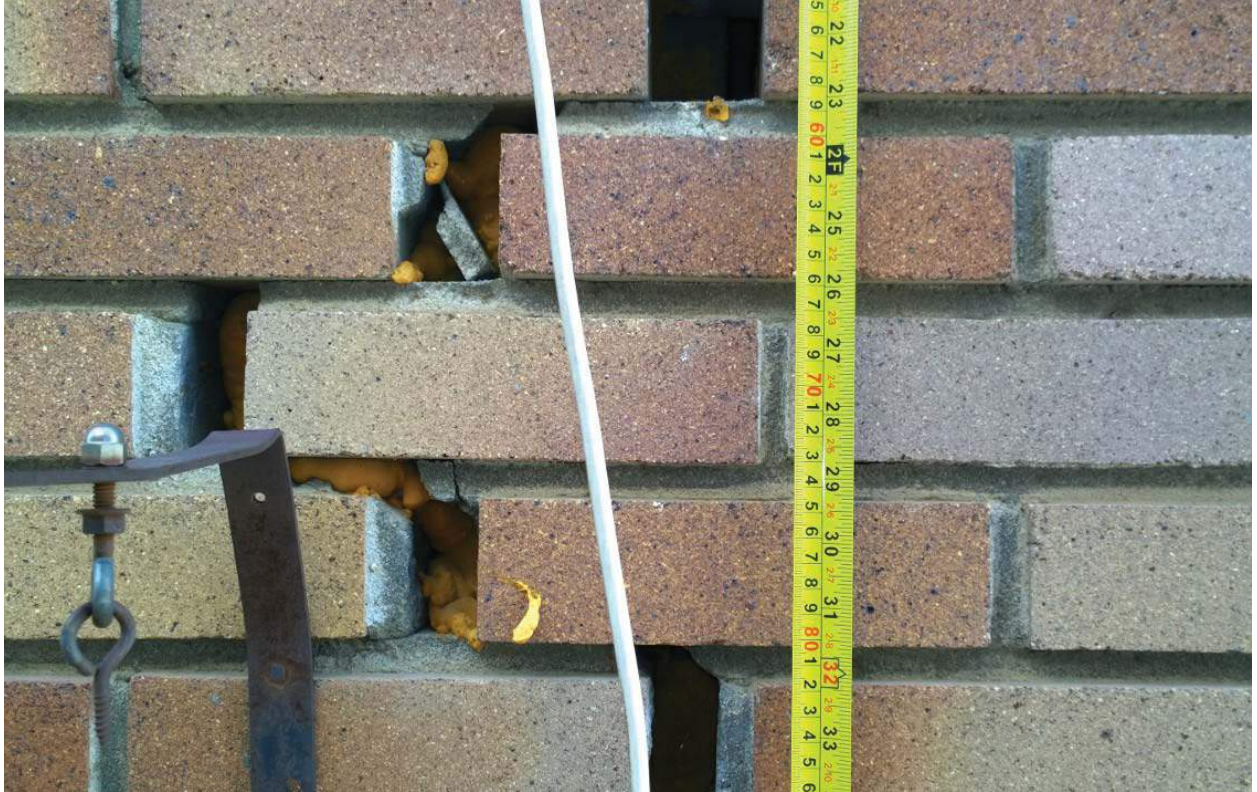
Large crack in North facade.

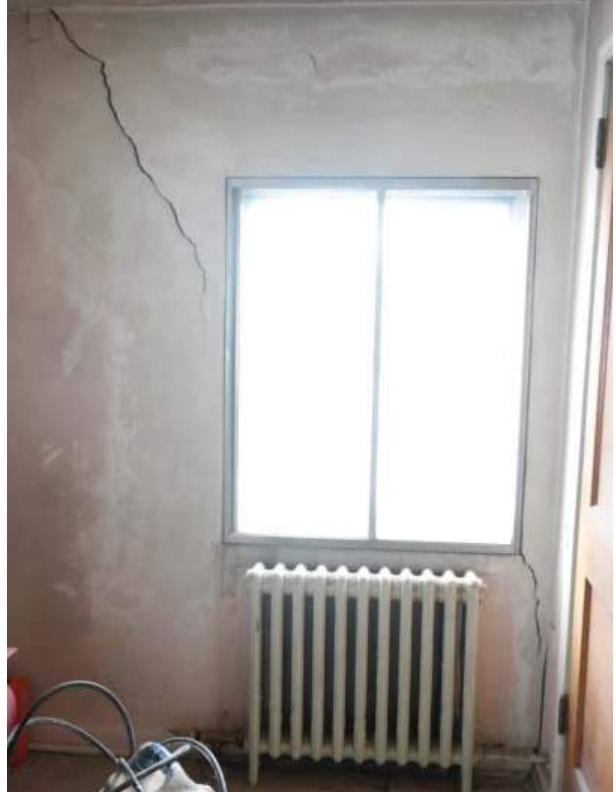
Large crack on North facade.

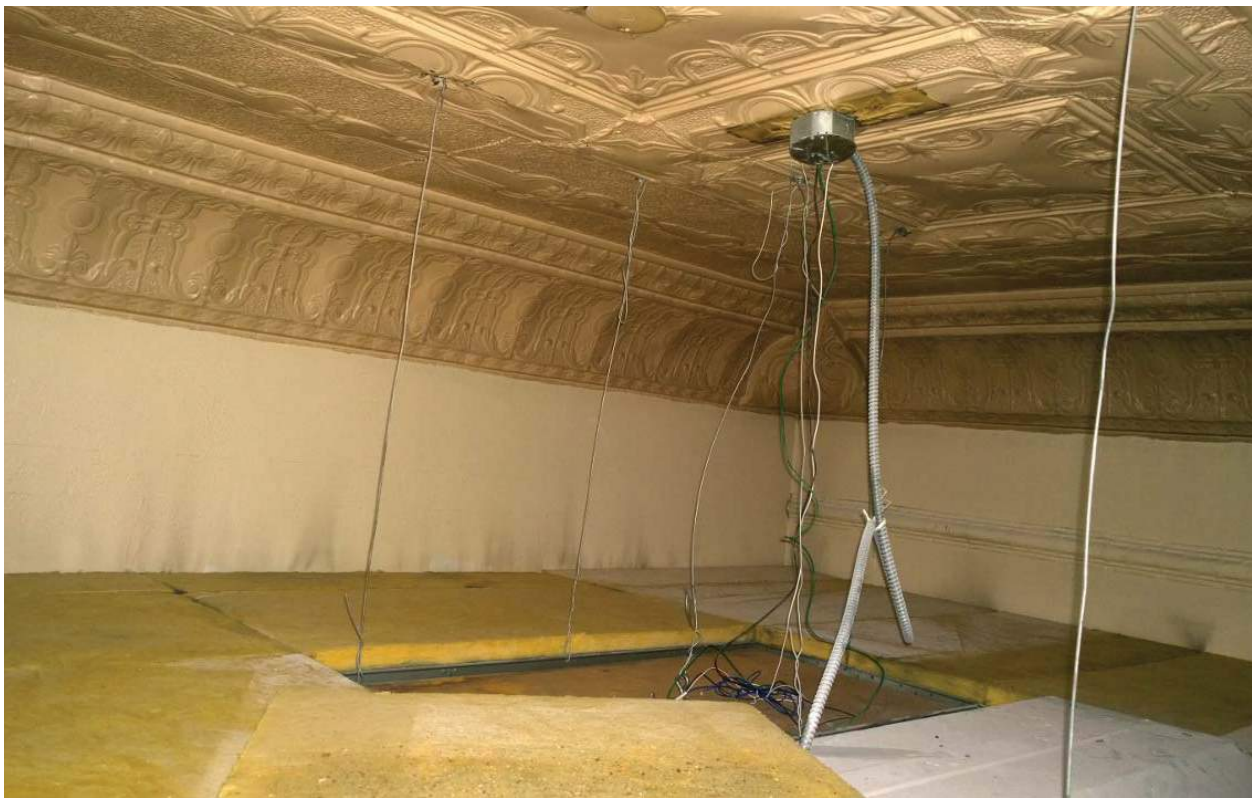
Electrical wires haging through the ceiling.

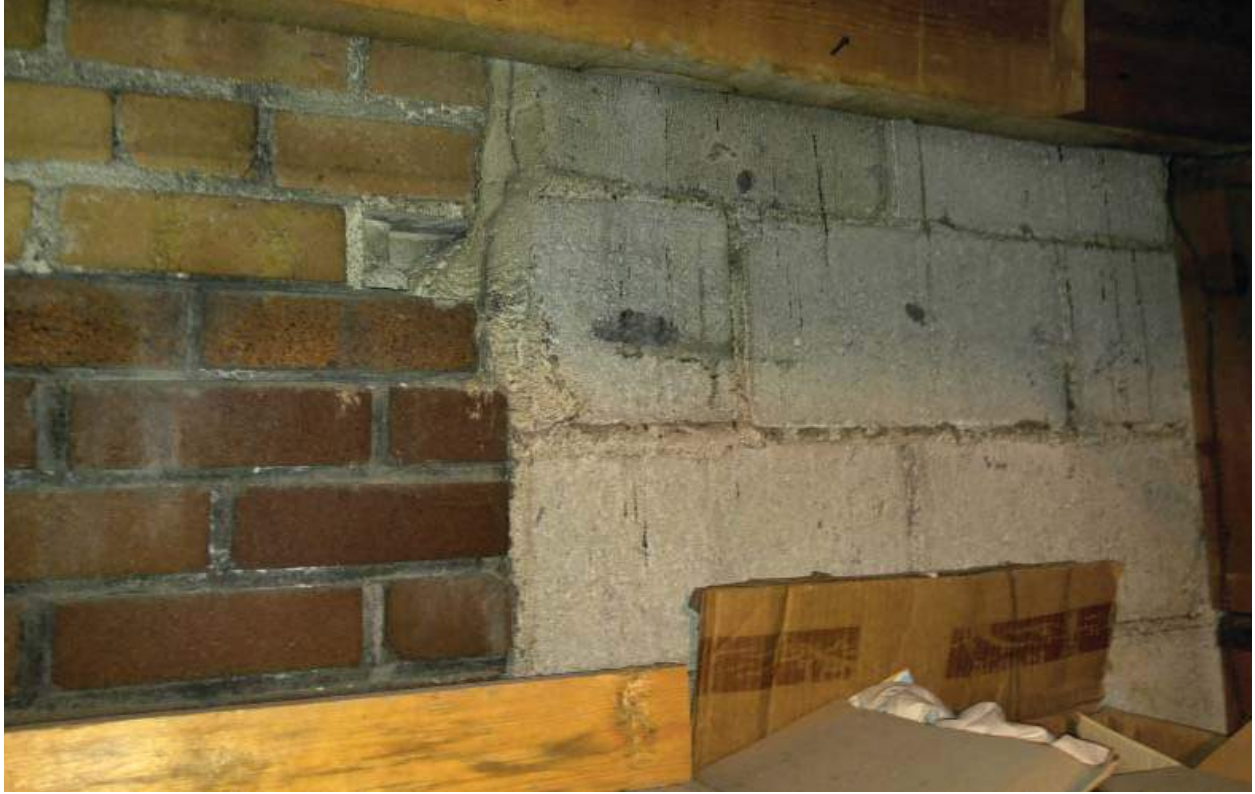
Masonry infill from previous renovation above the current firestation garage.
