# **Huntridge Theater**

**Las Vegas, Nevada**

Site Visit conducted by

*October 11, 2016*

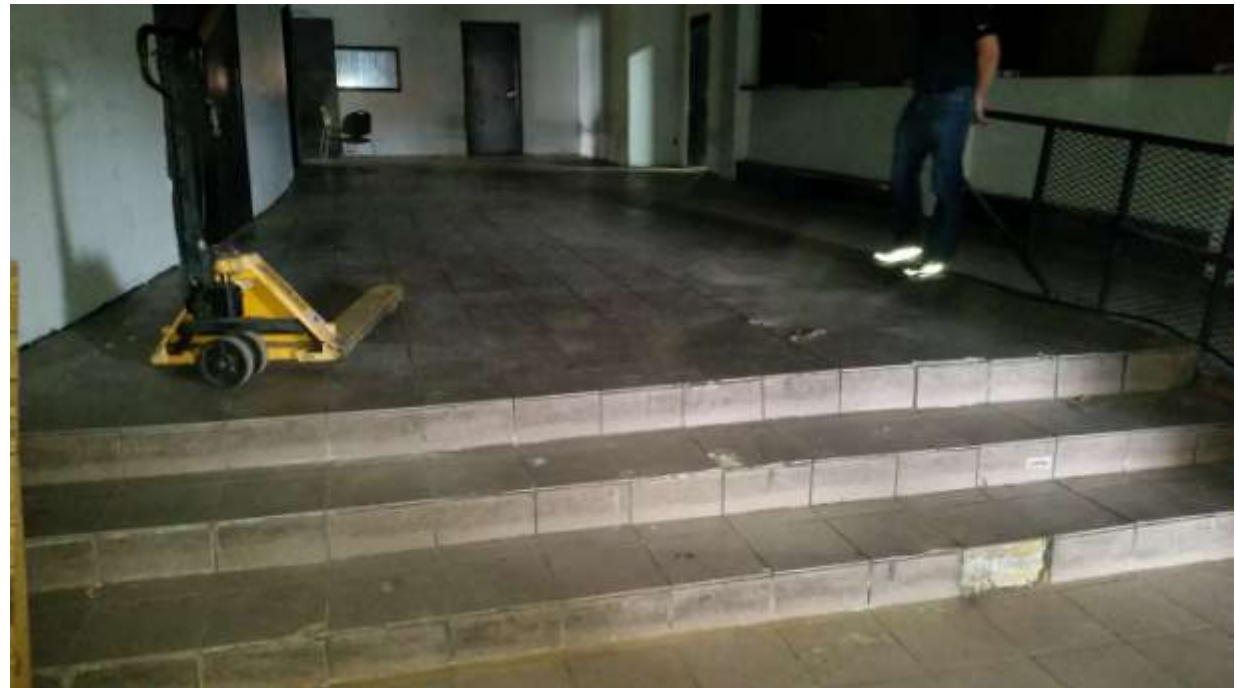
Lobby from Front Entrance

Visible in photo are broken tiles on lobby floor and stairs

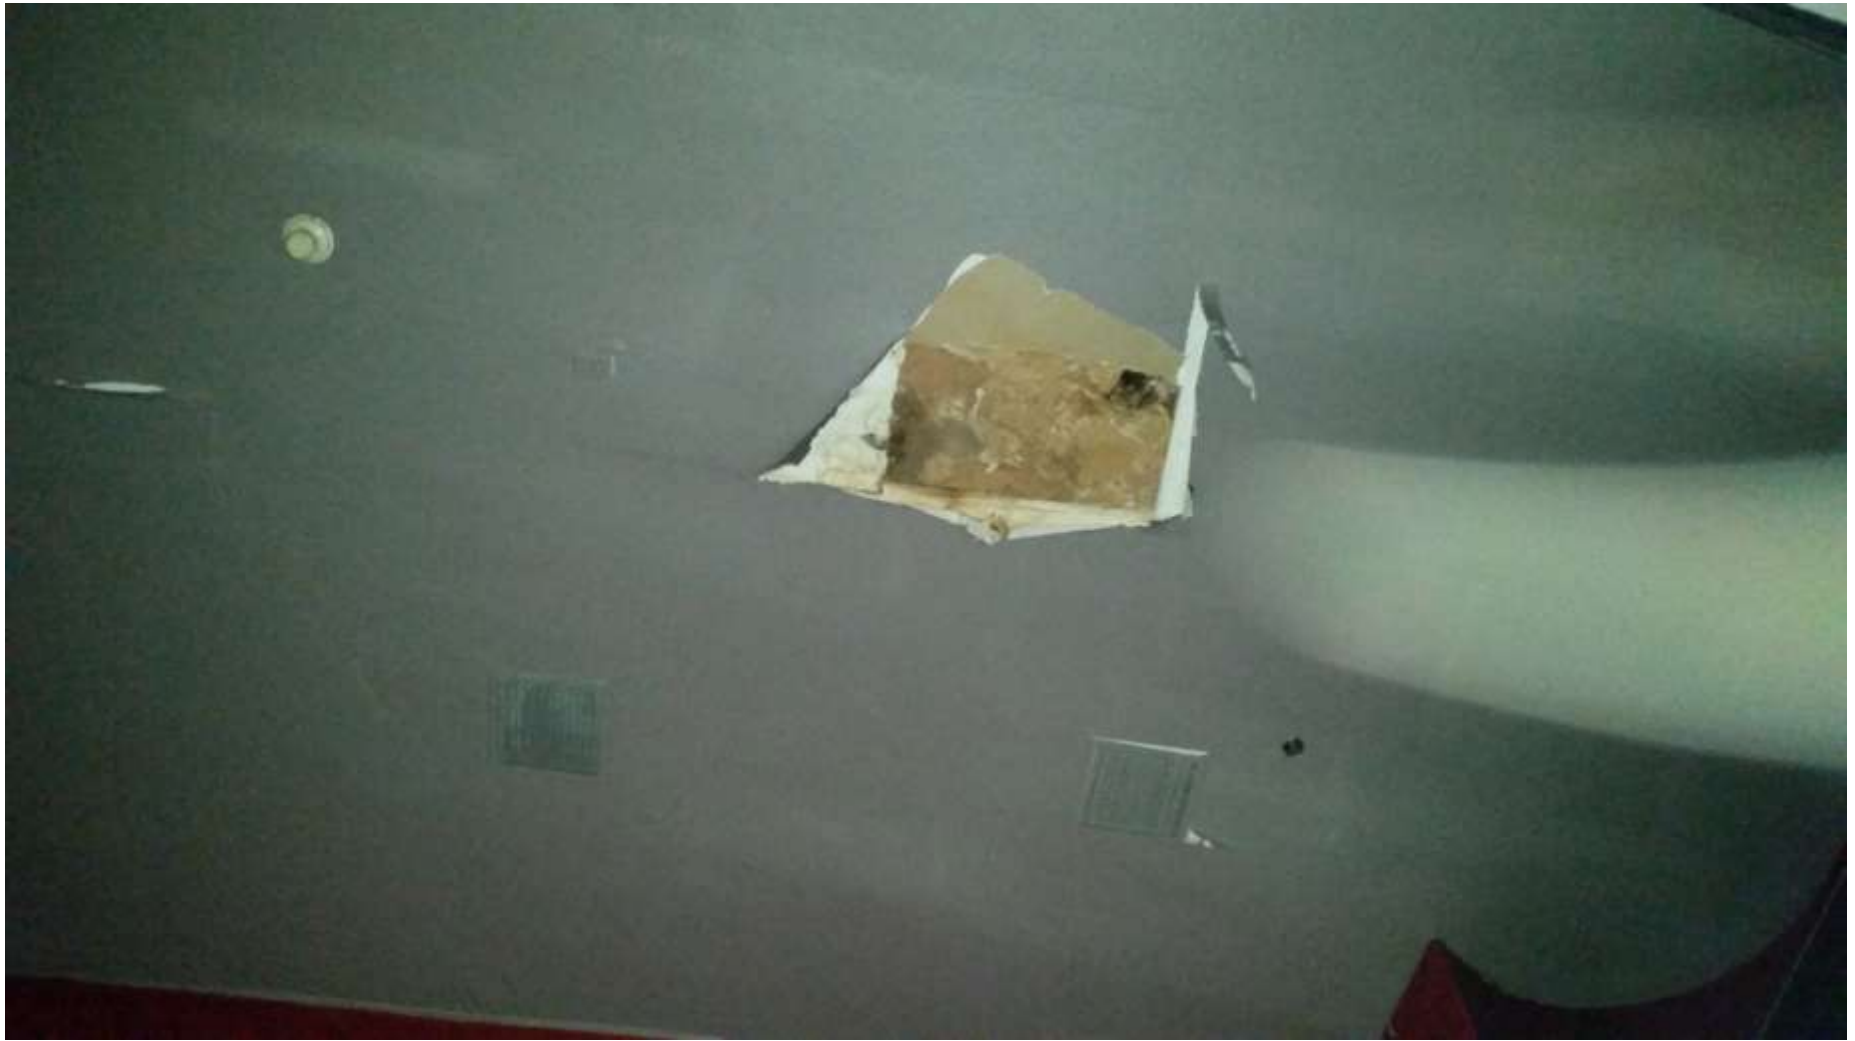
Ceiling Of Lobby With Evidence Of Water Intrusion

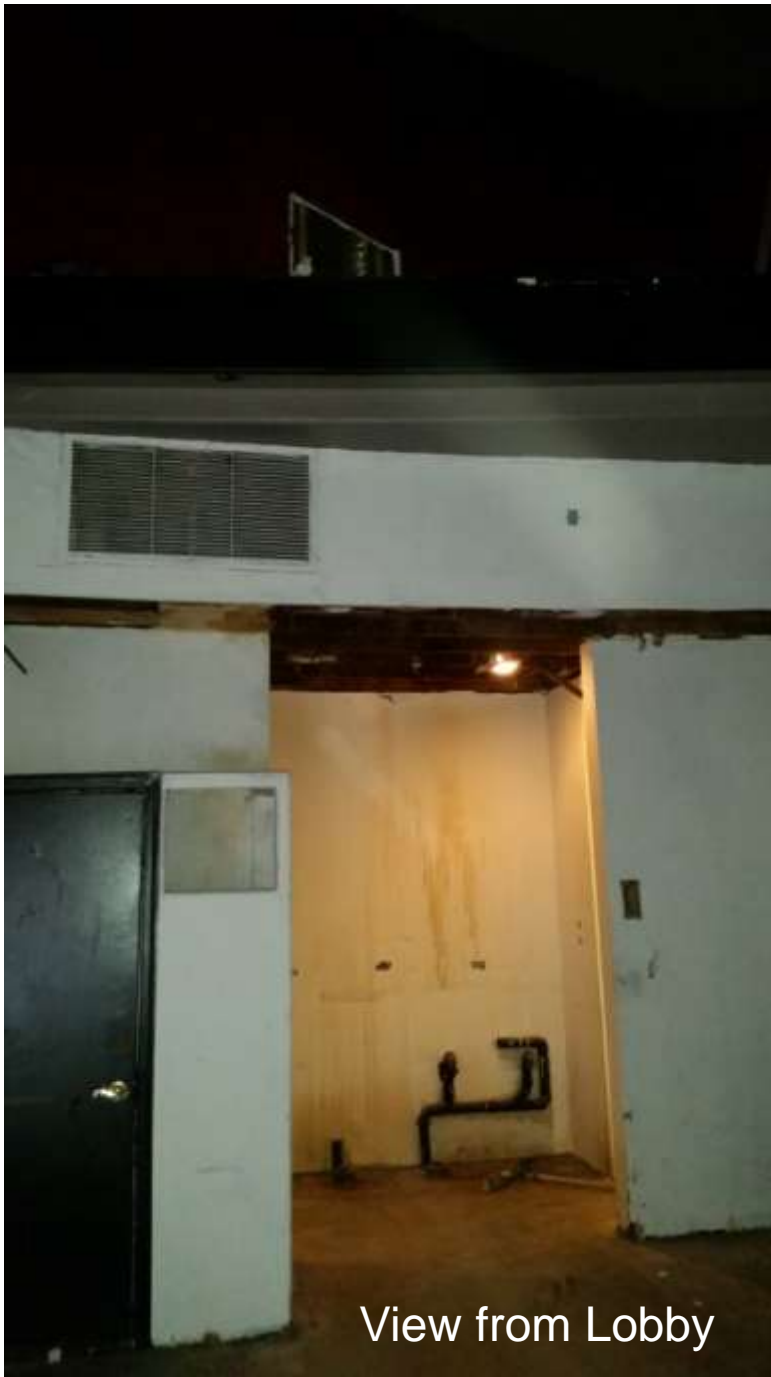
# Restroom

Visible in photo is evidence of water intrusion

Ceiling in restroom has been removed

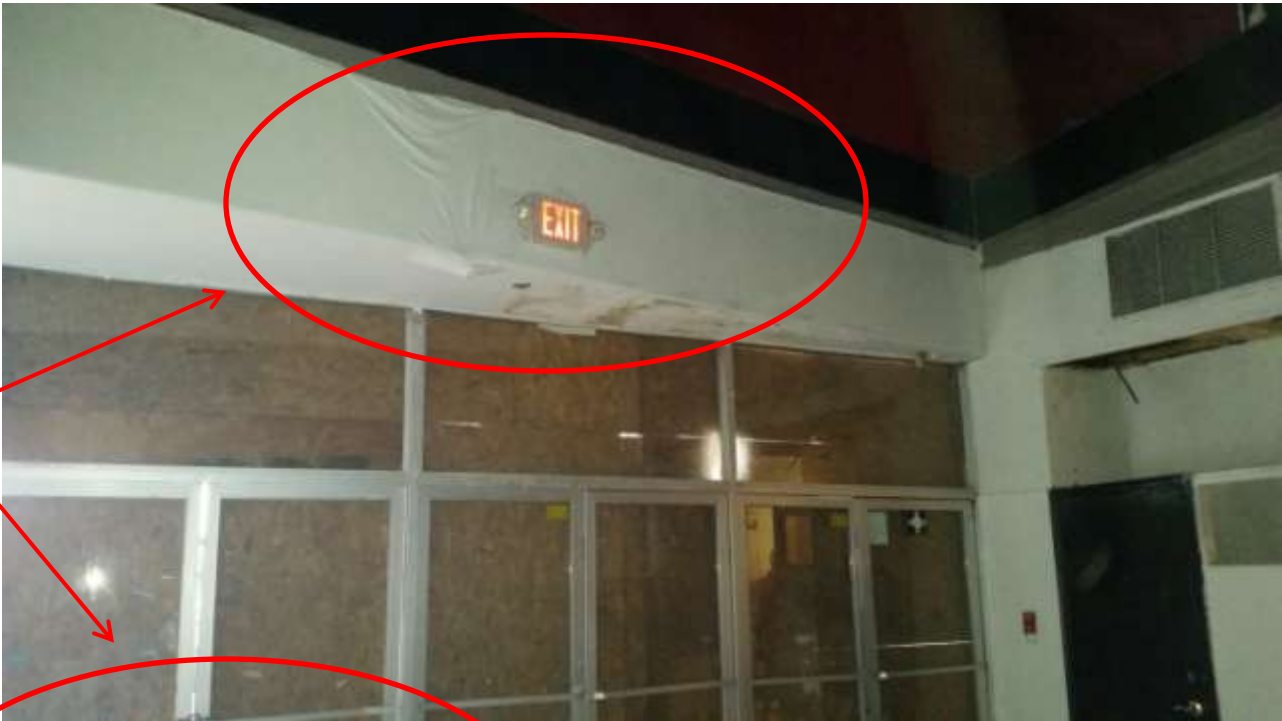
Front Lobby Doors

Note evidence of water intrusion

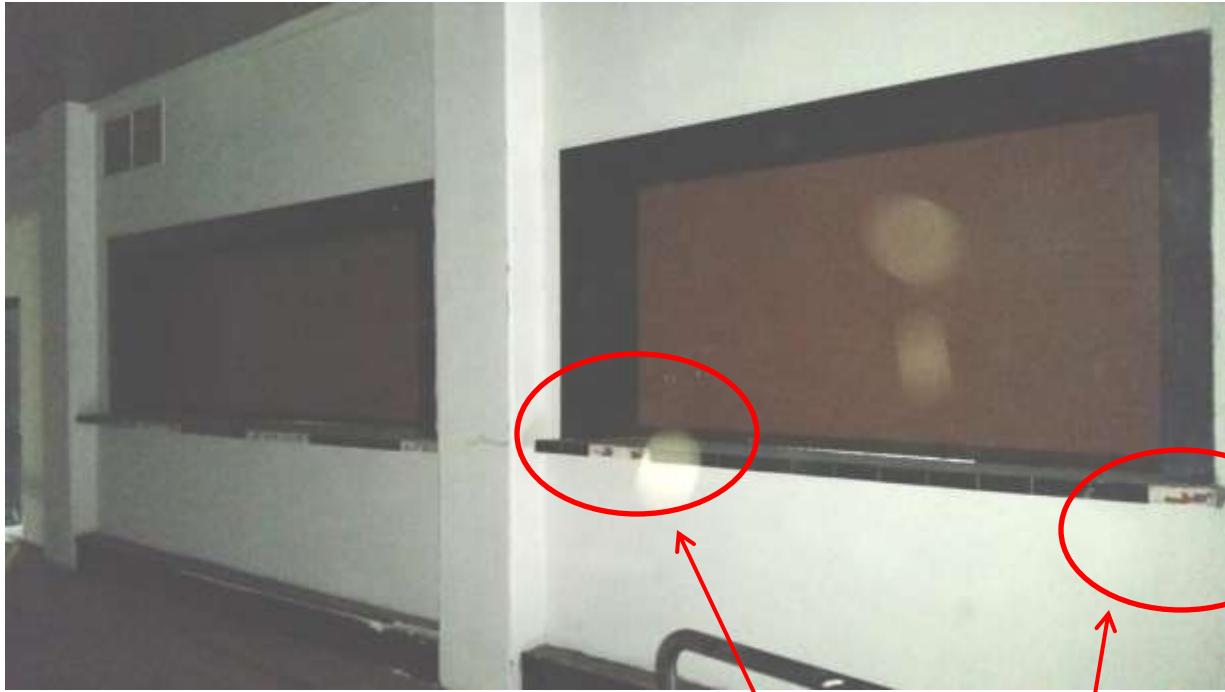
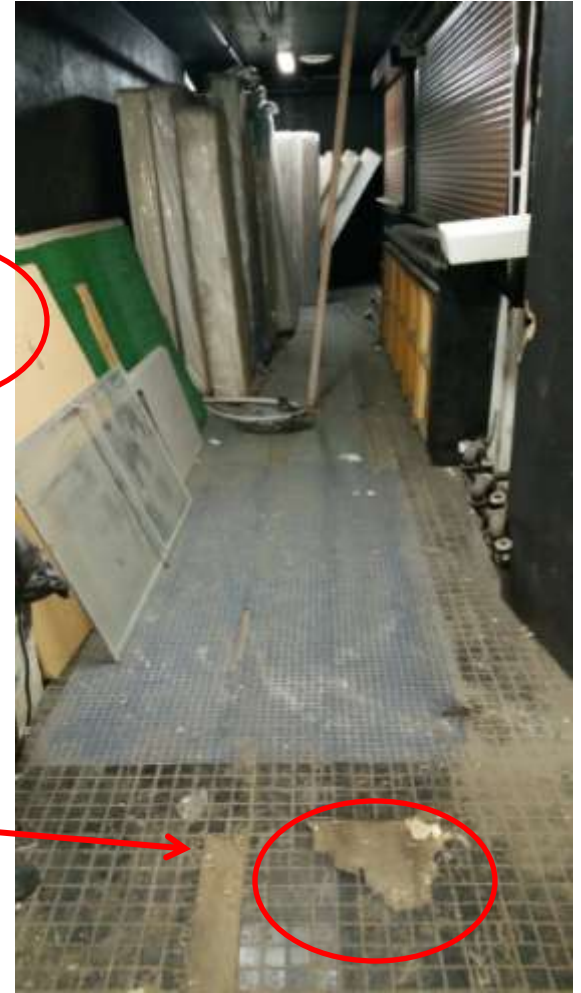
## Concession Area, Interior and Exterior

Note: Damaged and missing tiles on floor and counters

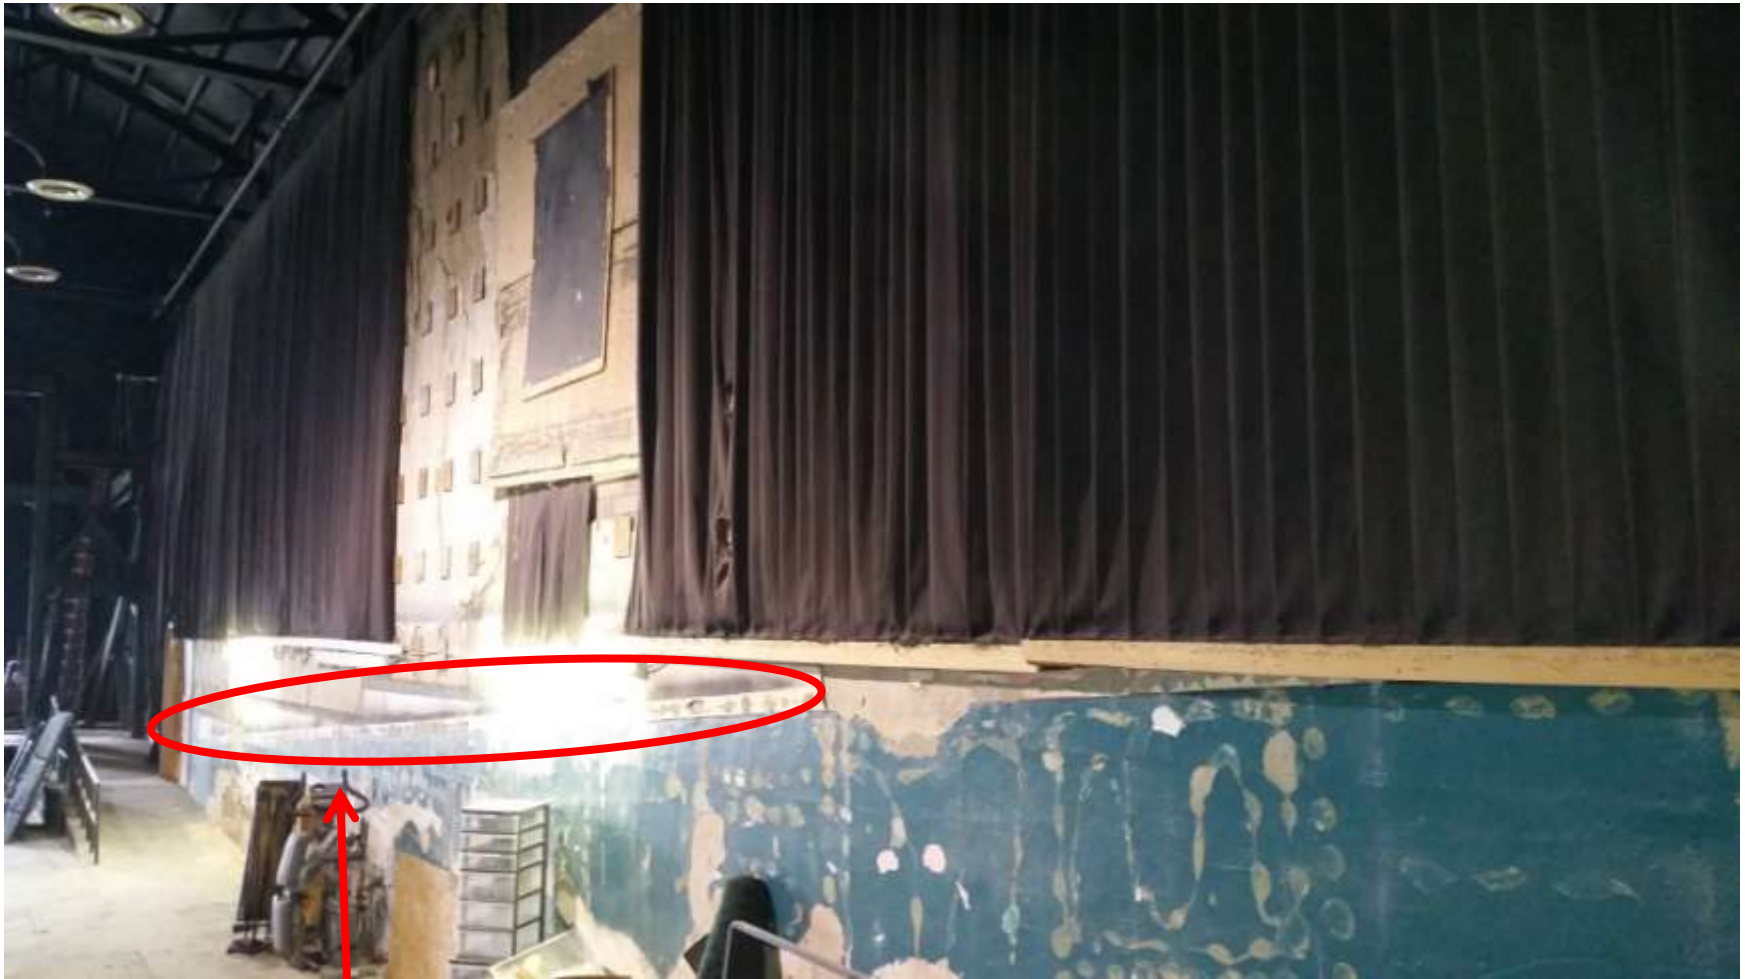
## View of South Side of the Auditorium

Note: Raked floor removed, walls obscured by drapes

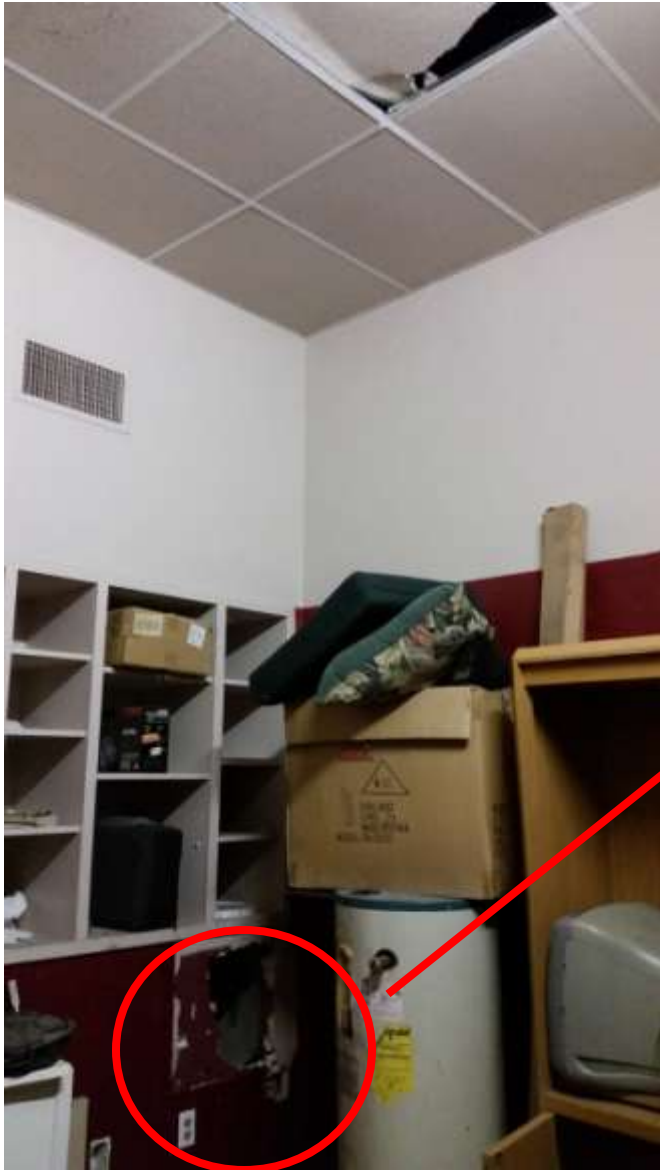
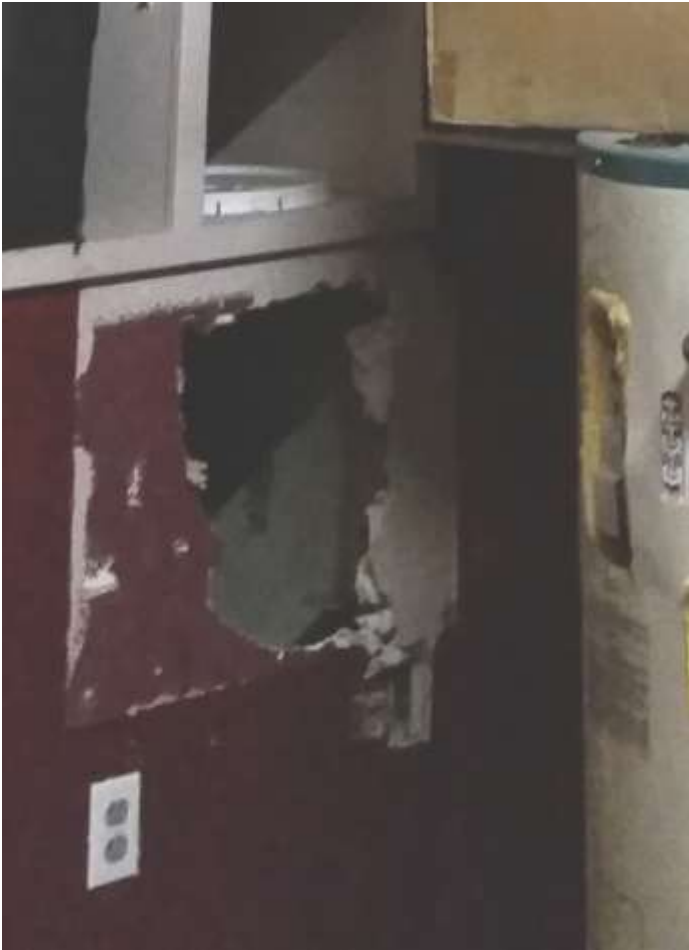
Backstage Area

Note, damage to wall (see enlarged image)

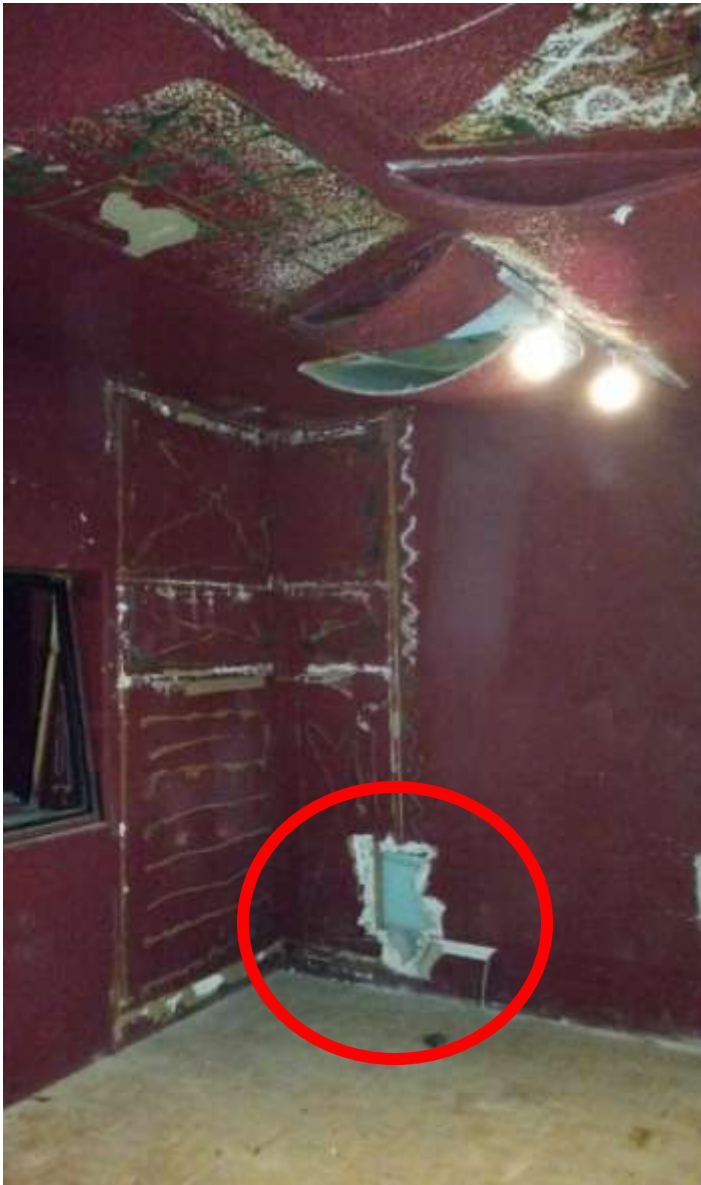
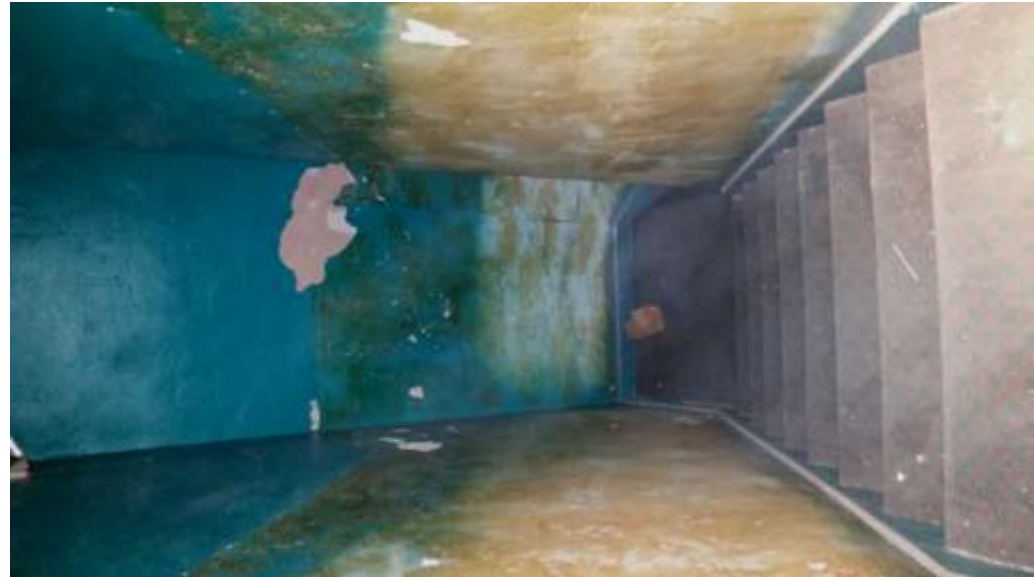
## Second Floor Sound Studio Area

Note: damage to walls

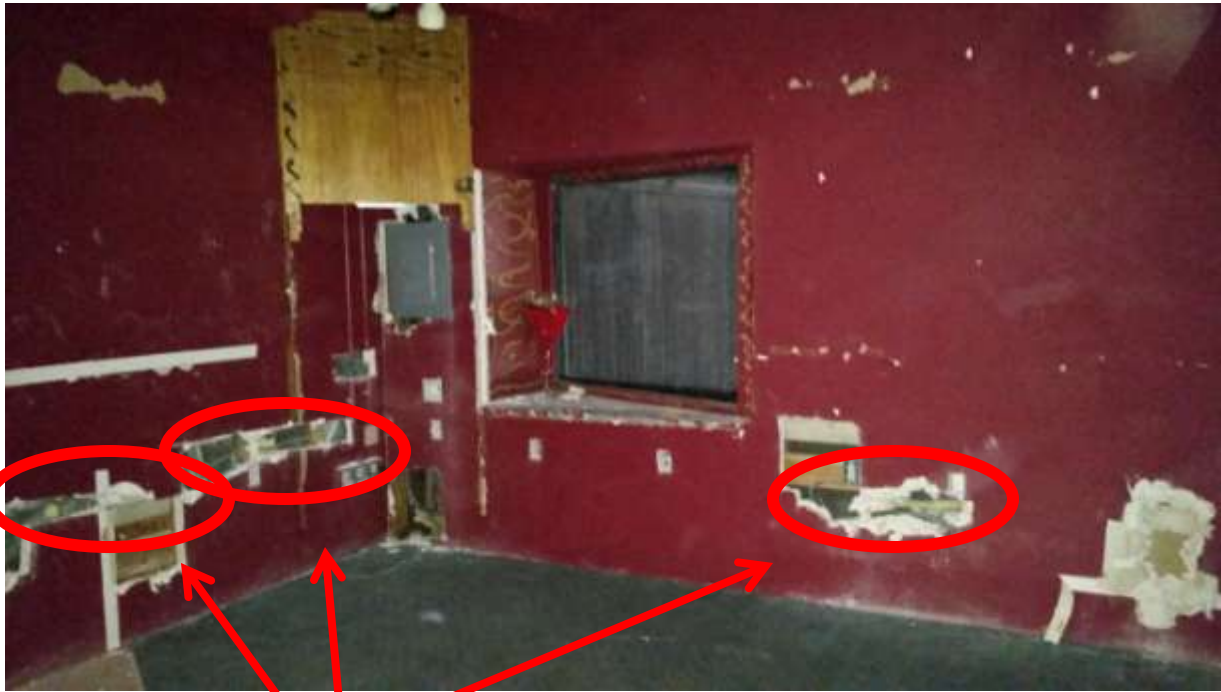
## Second Floor Sound Studio Area

Note: cuts in wall, possibly to  
access interior sound equipment
