NEVADA COMMISSION FOR
CULTURAL CENTERS AND HISTORIC PRESERVATION (CCCHP)
GRANT APPLICATION FOR FY2021-2022

Historic Property Name: Boulder City Water Filtration Plant Date Built: 1932

LGA Architecture (LGA) is pleased to submit our final Historic Structure and Preservation Assessment Report re: architectural, historical significance, structural engineering, (MEP) mechanical, electrical, & plumbing engineering assessments, life-safety assessments, and hazardous materials assessment for the Boulder City Water Filtration Plant project. This Final Assessment Report also now contains a Section 6; Cost Consultant Report. This cost estimate is for the strategy we are recommending moving forward to protect and preserve this building for a future Community Vision.

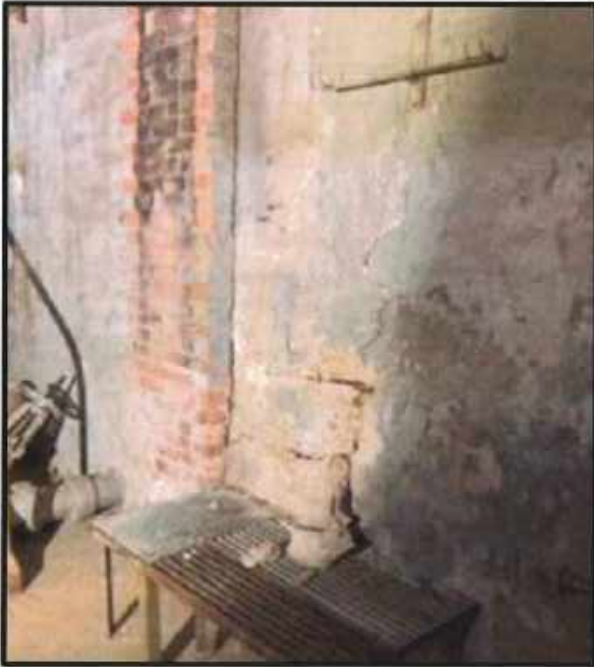
Figure 12 – Concrete Spalling and Deterioration at Pipe Gallery Foundation Wall

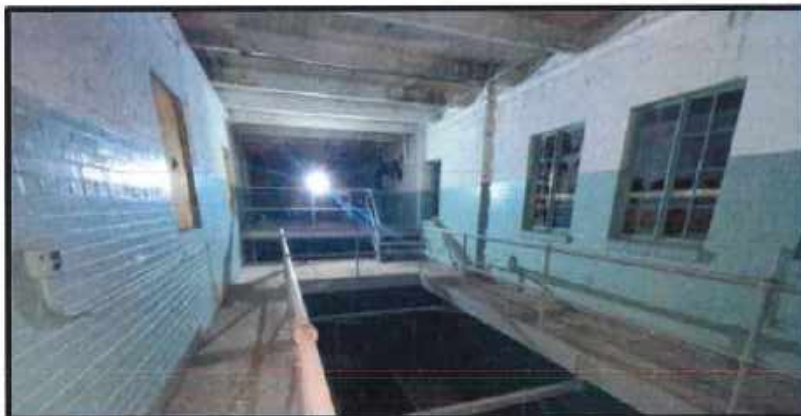
Figure 22 – Good Condition of Floors at Northeast Addition

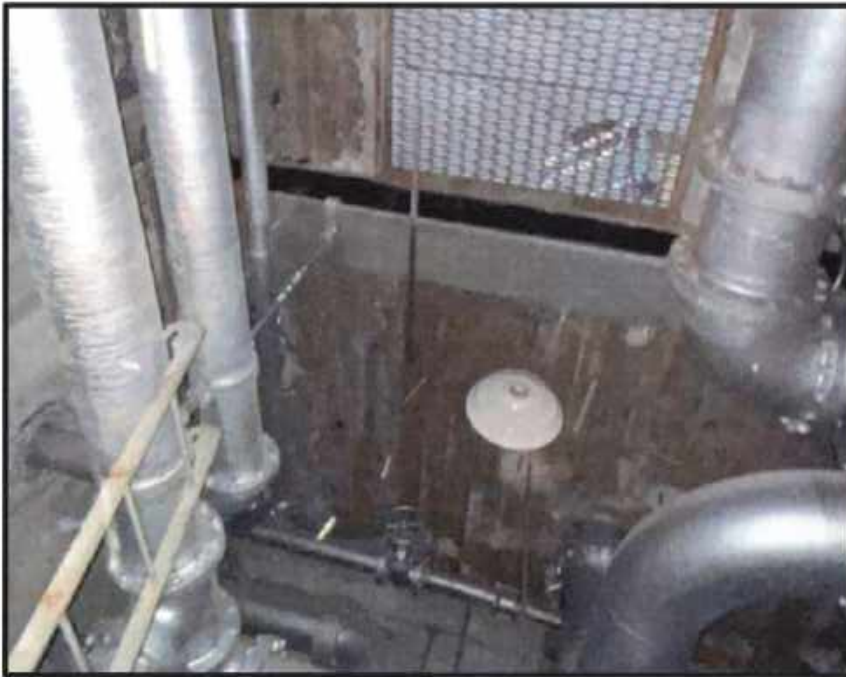
Figure 23 – View of Spalling at Underside of Operating Floor Concrete Slab

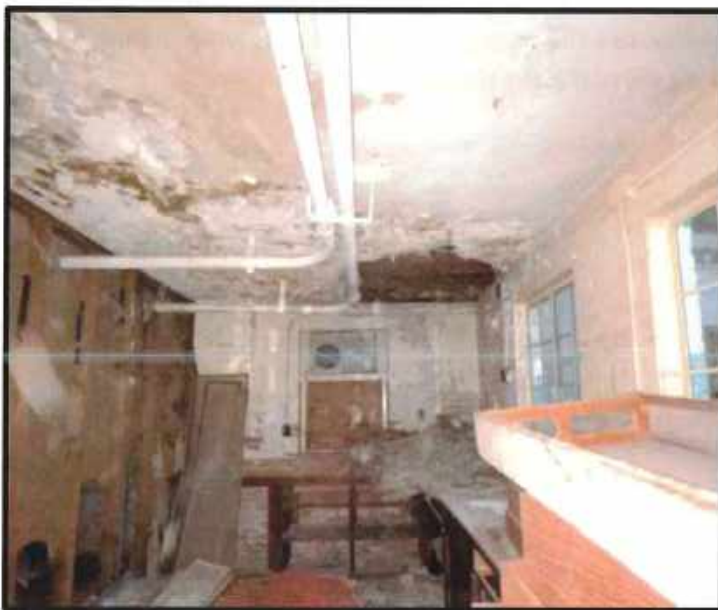
Figure 27 – Plaster Ceiling Failure at NW Addition

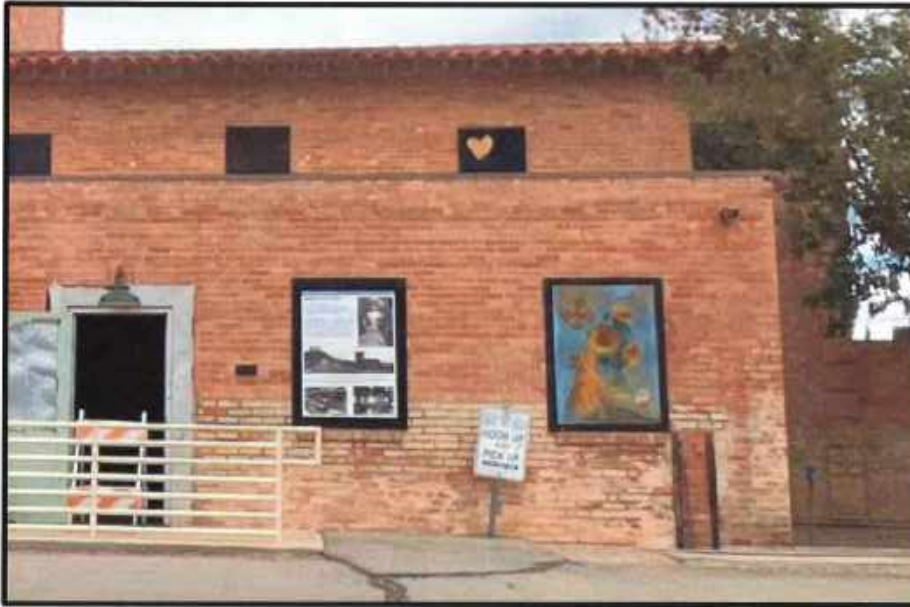
Figure 29 – Mortar Loss Due to Rising Damp

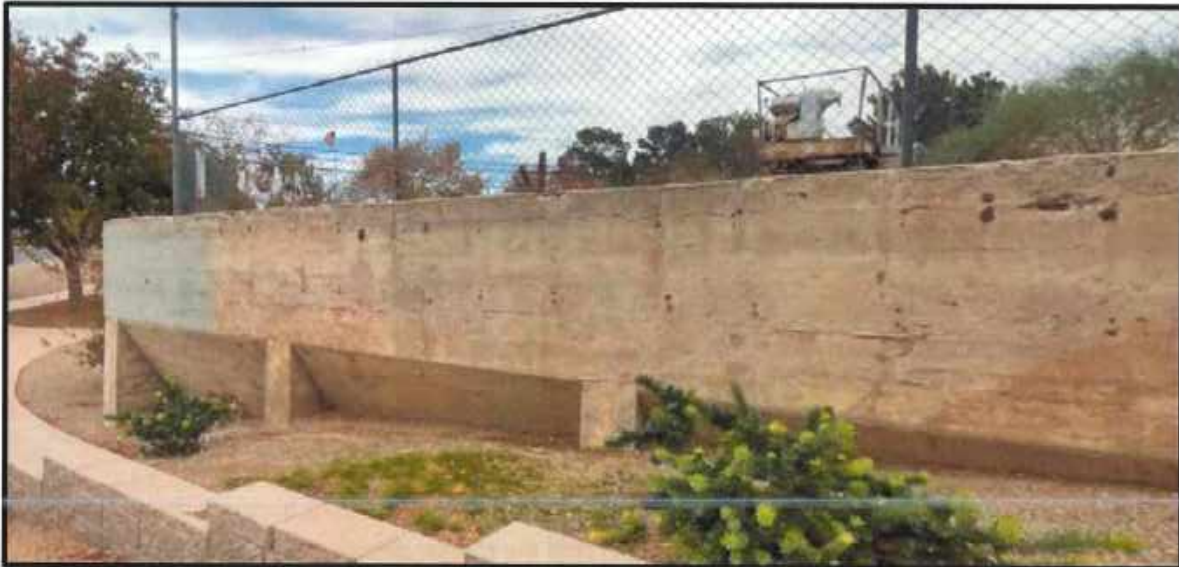
Figure 30 – Concrete Damage at Top of Walls

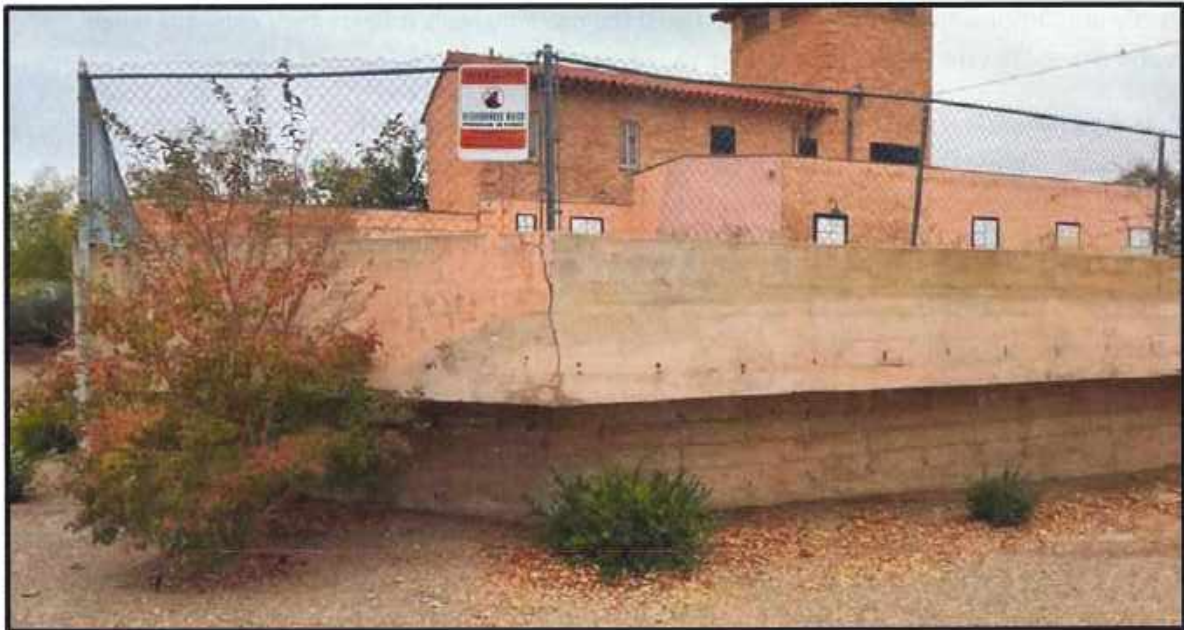
Figure 31 – Crack at Clarifier Tank Retaining Wall

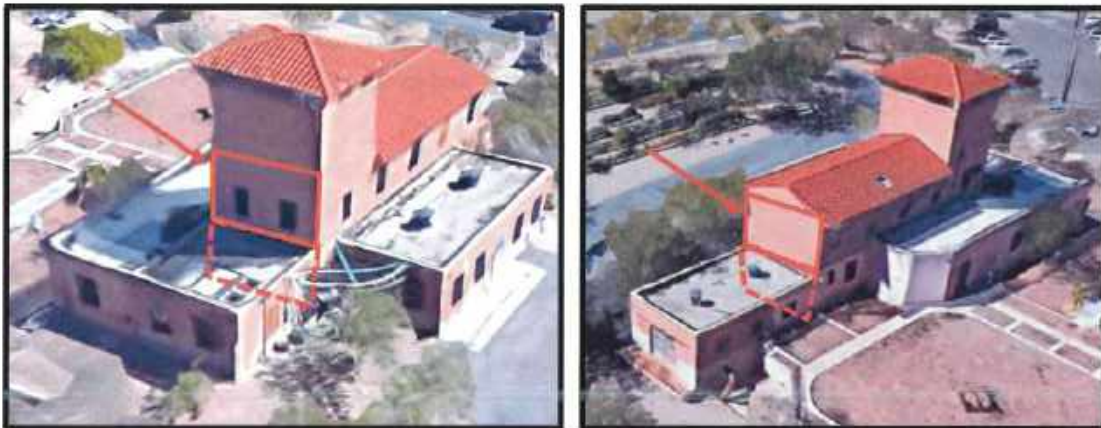
Figure 35 –Vulnerable wall piers in the Northwest Elevation (left) and Southwest Elevation (right)

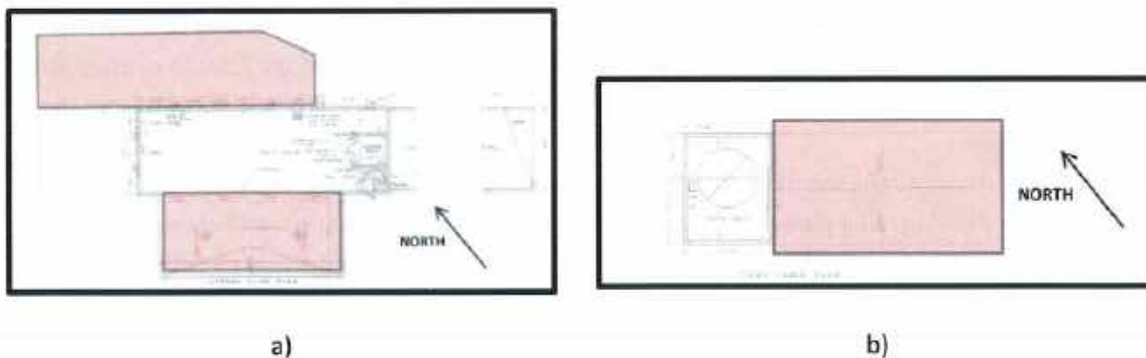
Figure 38 - Schematic plan showing diaphragms with a vulnerable aspect ratio a) storage floor, and b) tank floor levels
