Existing Conditions Photographs

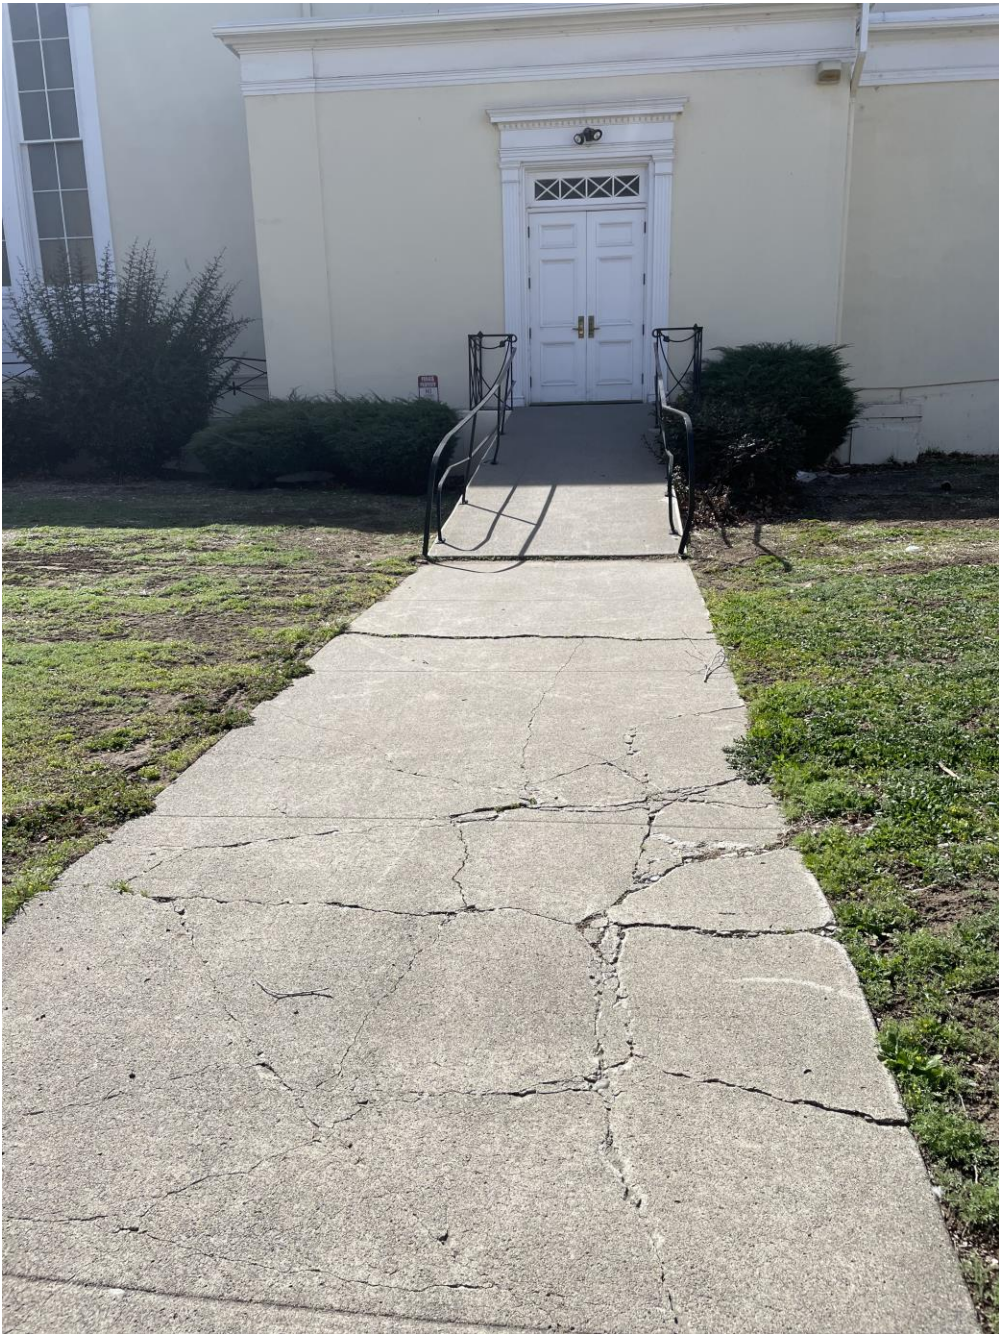
East facade with existing ramp and entrance.

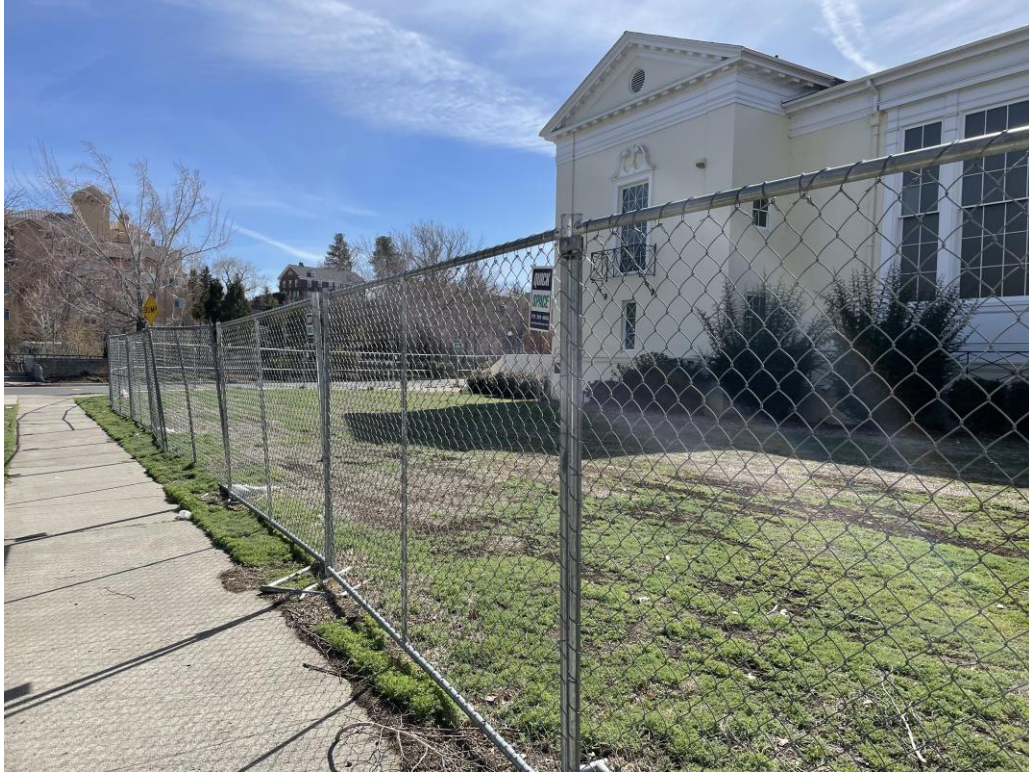
East facade, looking southwest.

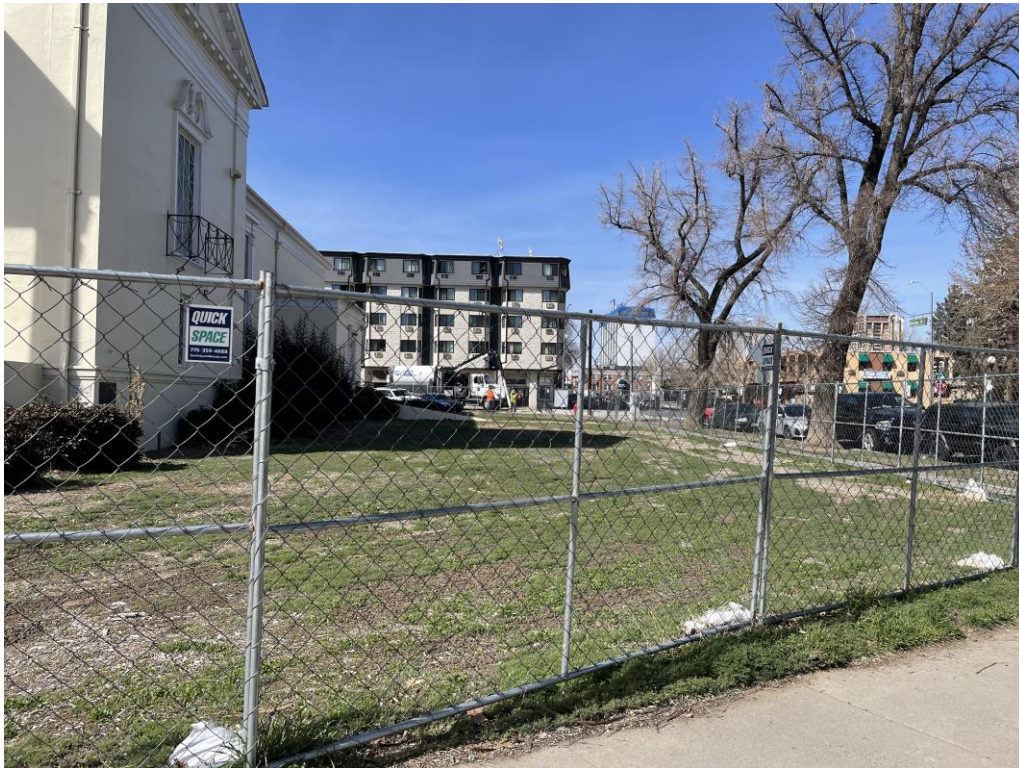
East facade, looking north.

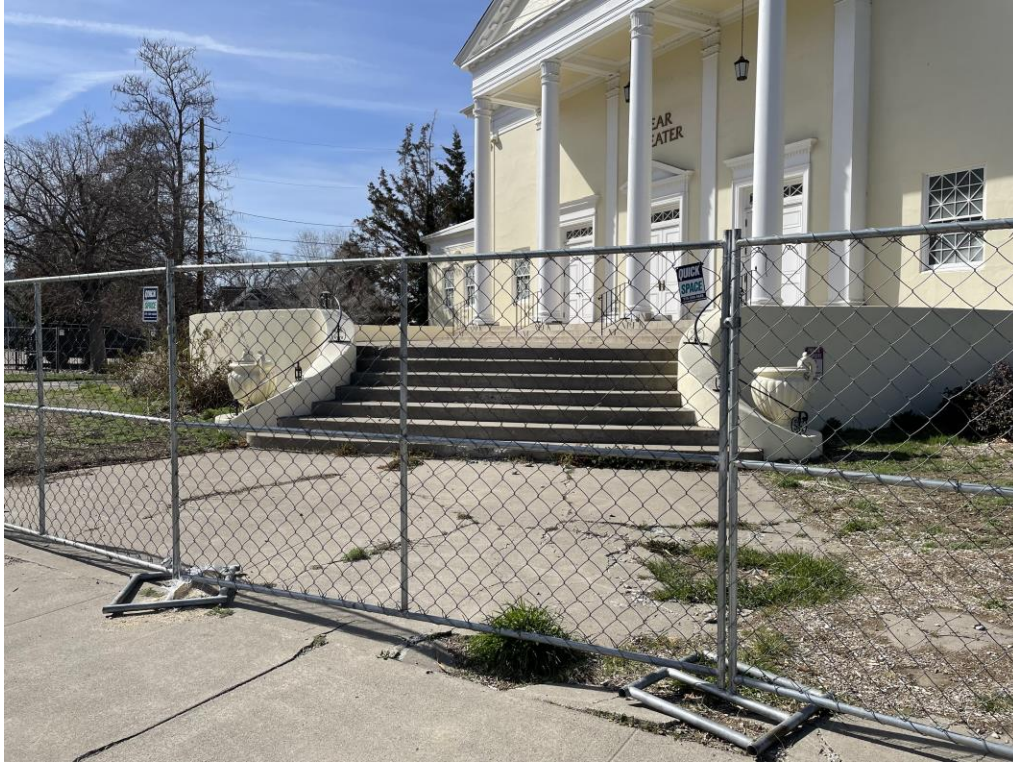
Front (south) facade, right sidewalk and stairs up to main entrance. Shows damaged concrete.

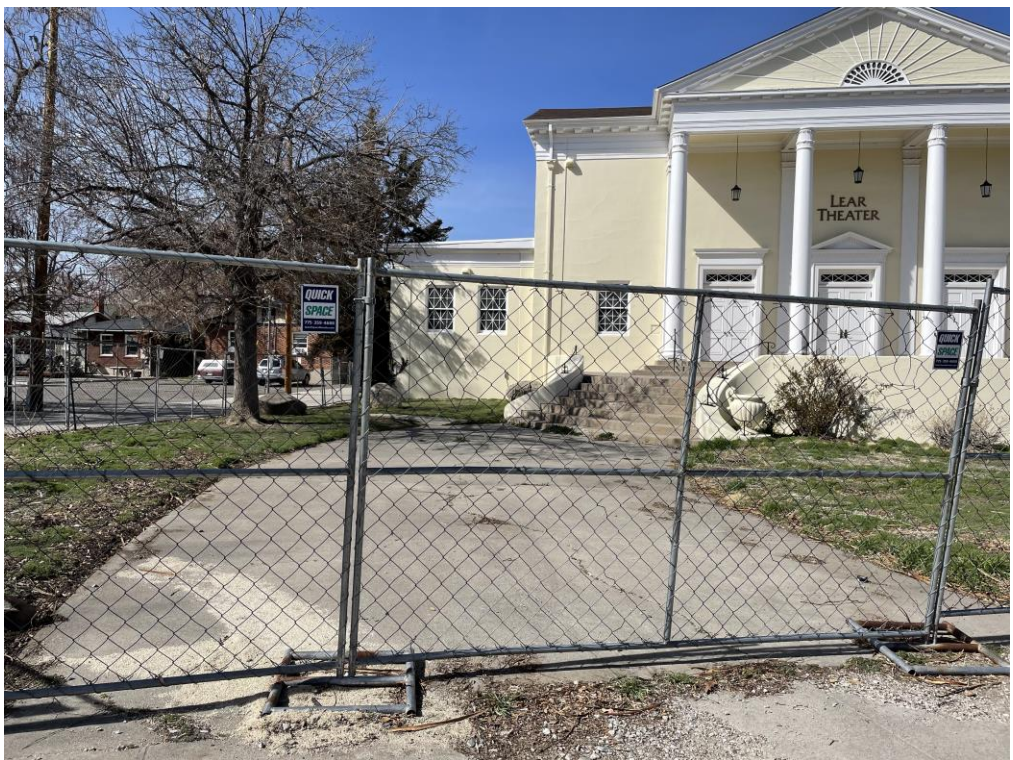
Front (south) facade, left sidewalk and stairs up to main entrance.

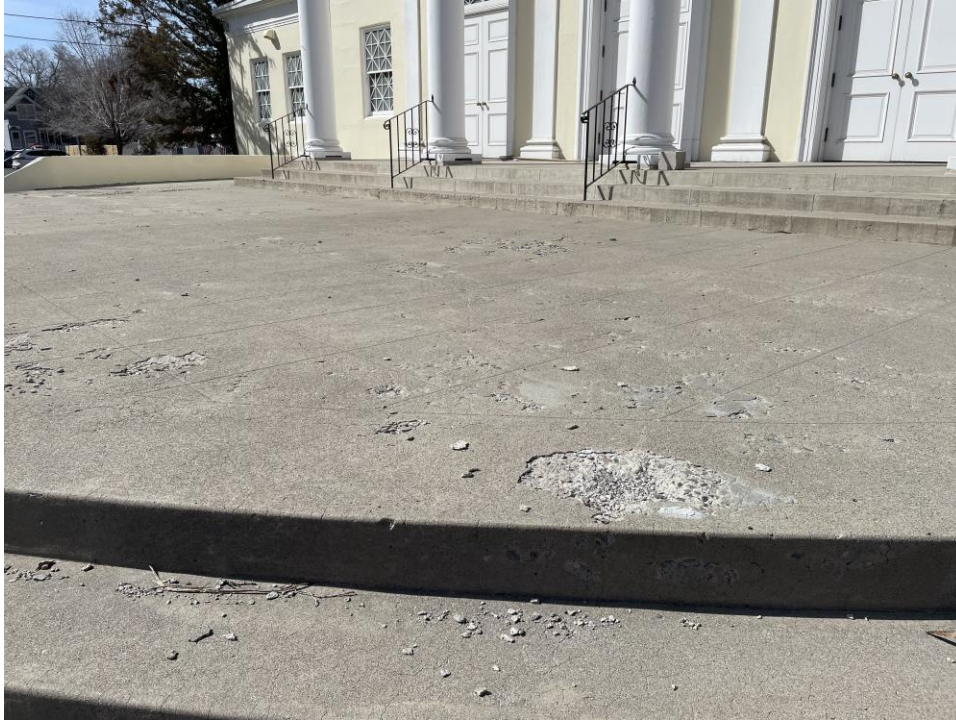
South facade main landing, showing concrete damage.

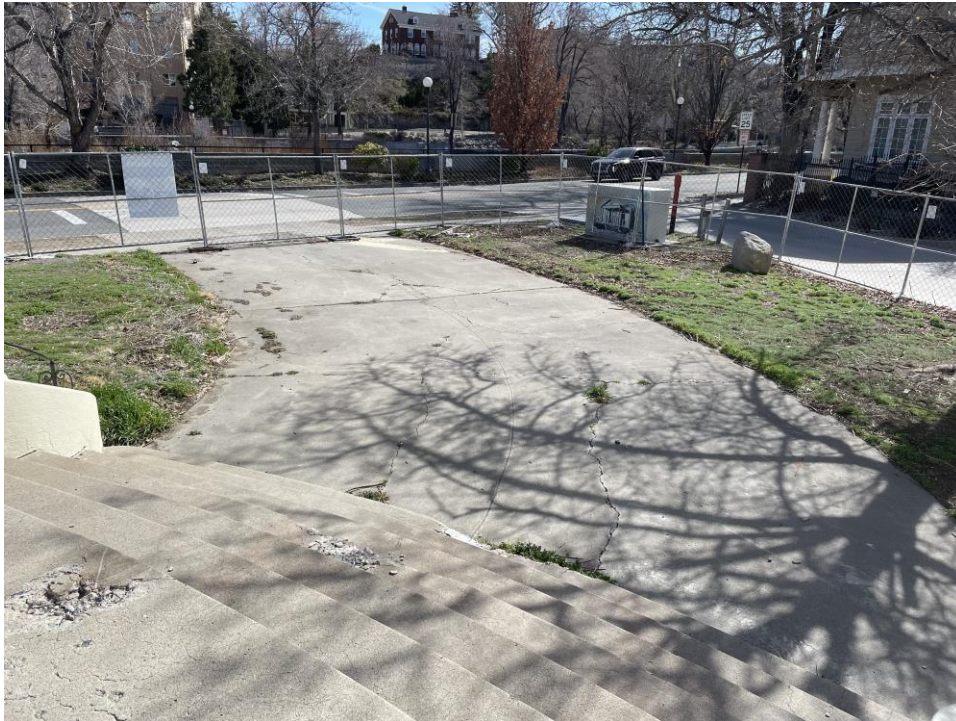
Looking south from main landing on south facade, western stairs and sidewalk.

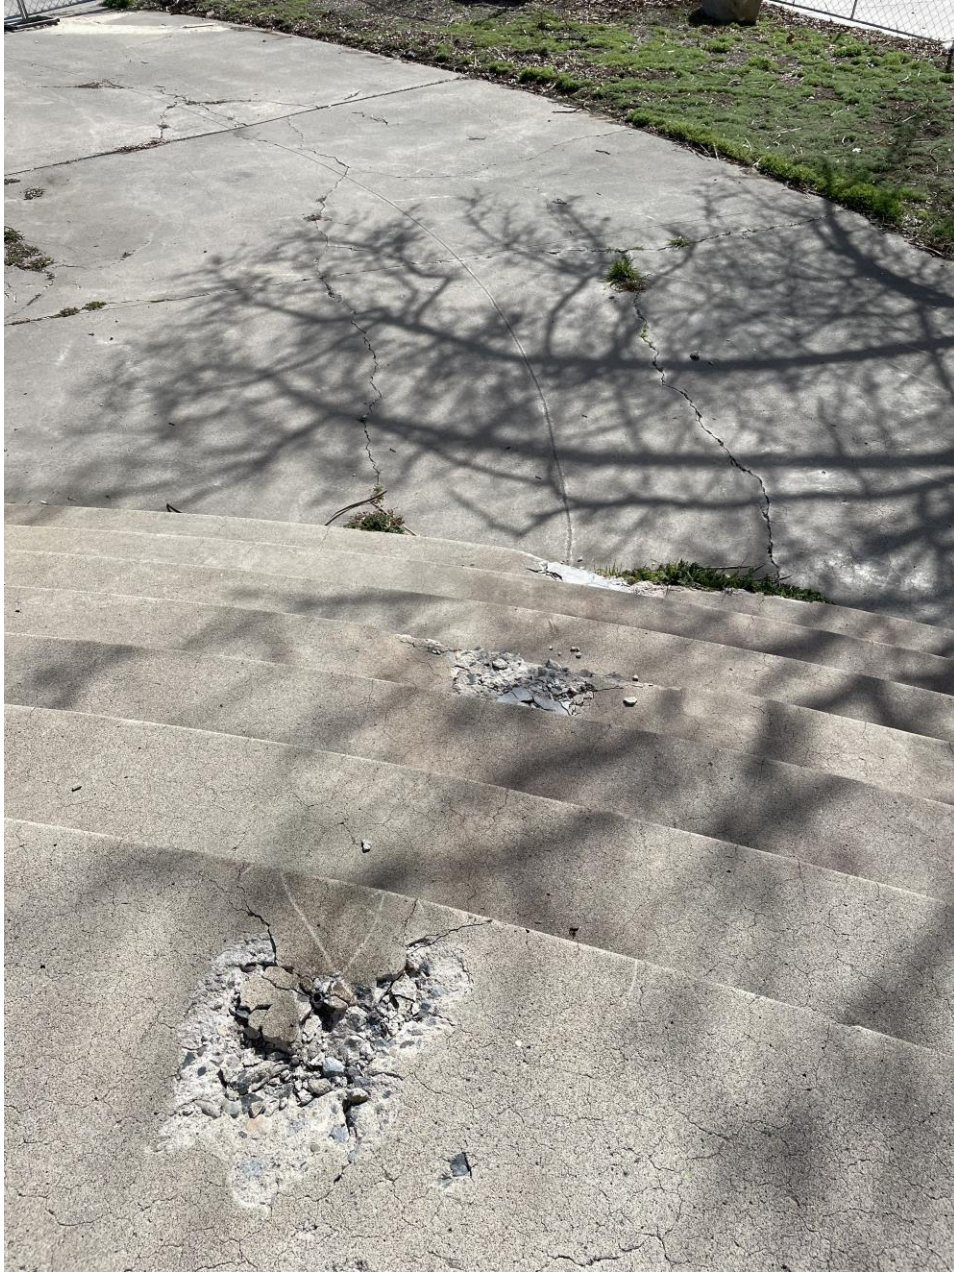
Detail of western stairs and sidewalk off of main landing on south facade.

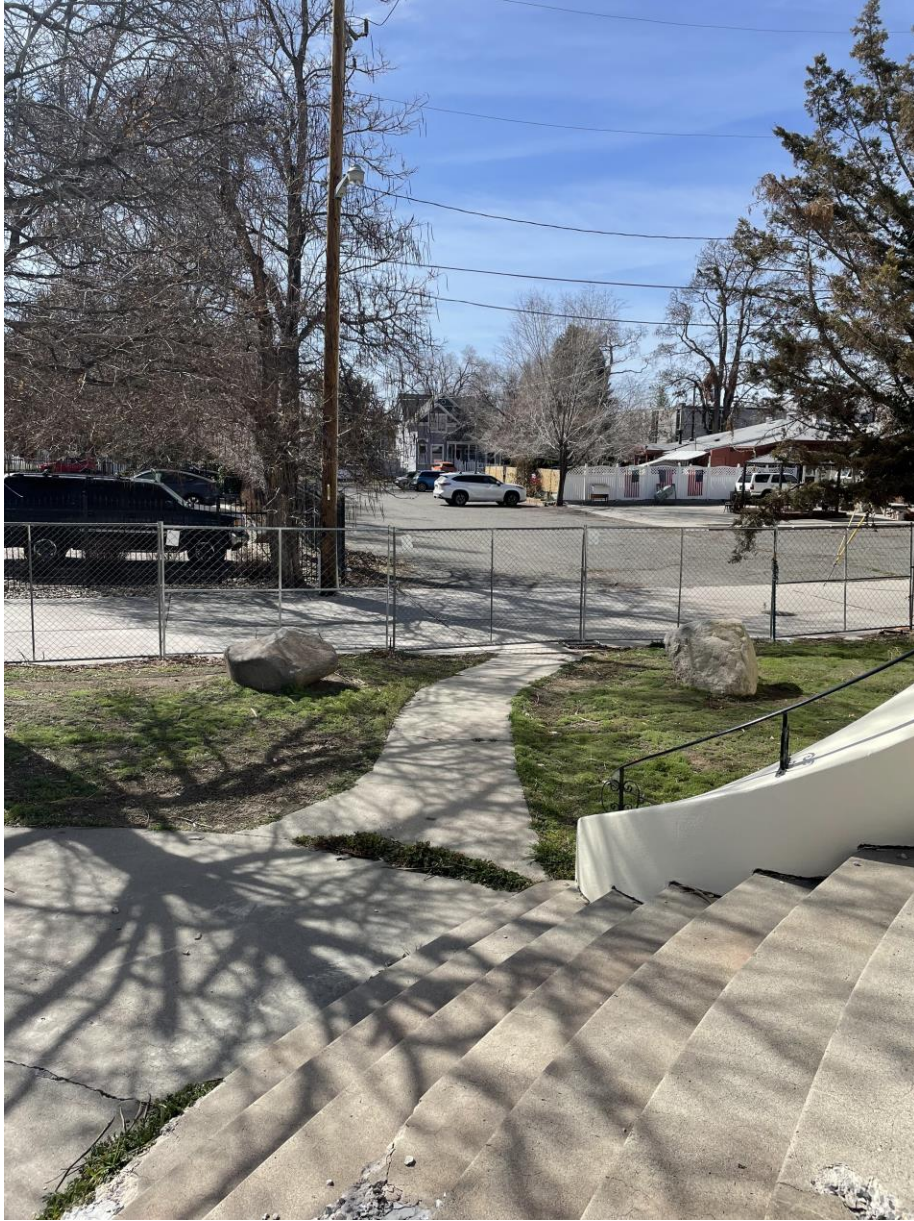
View west from western staircase off main landing on south facade.

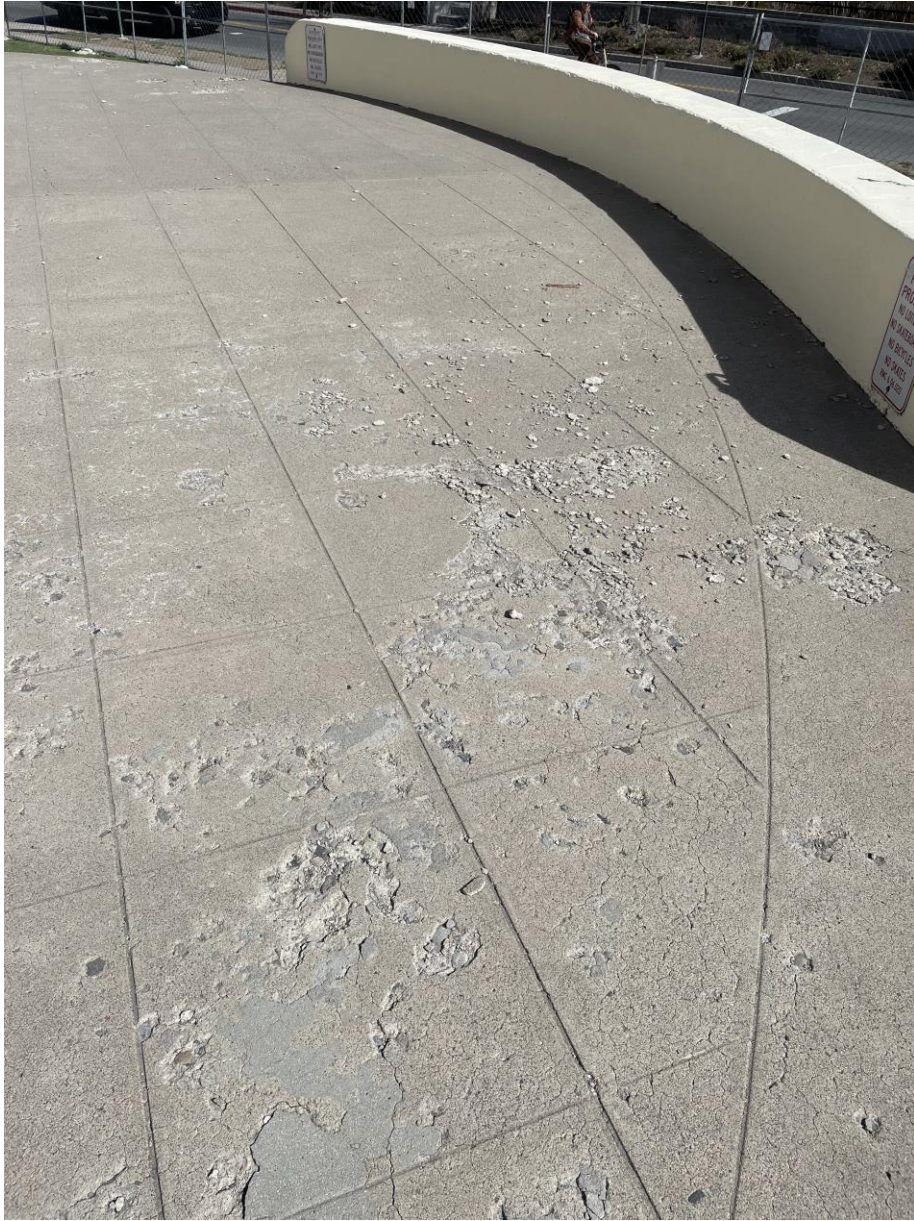
Main landing at south facade entrance, showing concrete damage and previous repair.

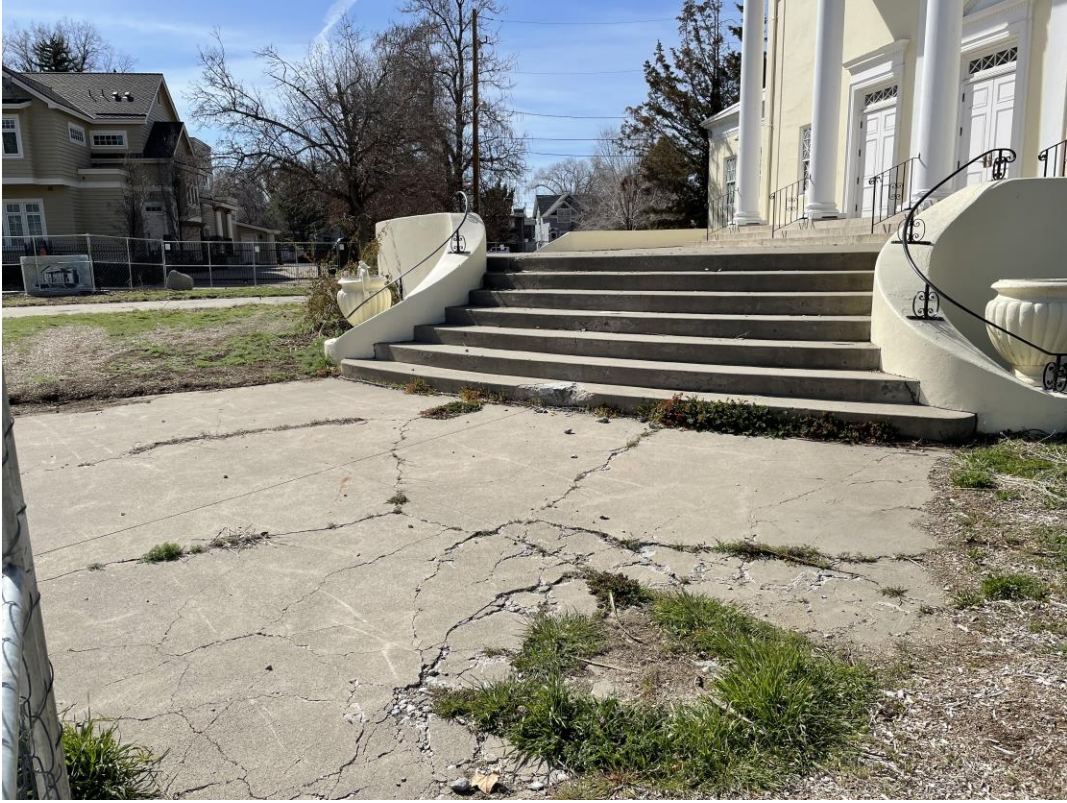
Detailed view of eastern staircase and sidewalk on south facade.

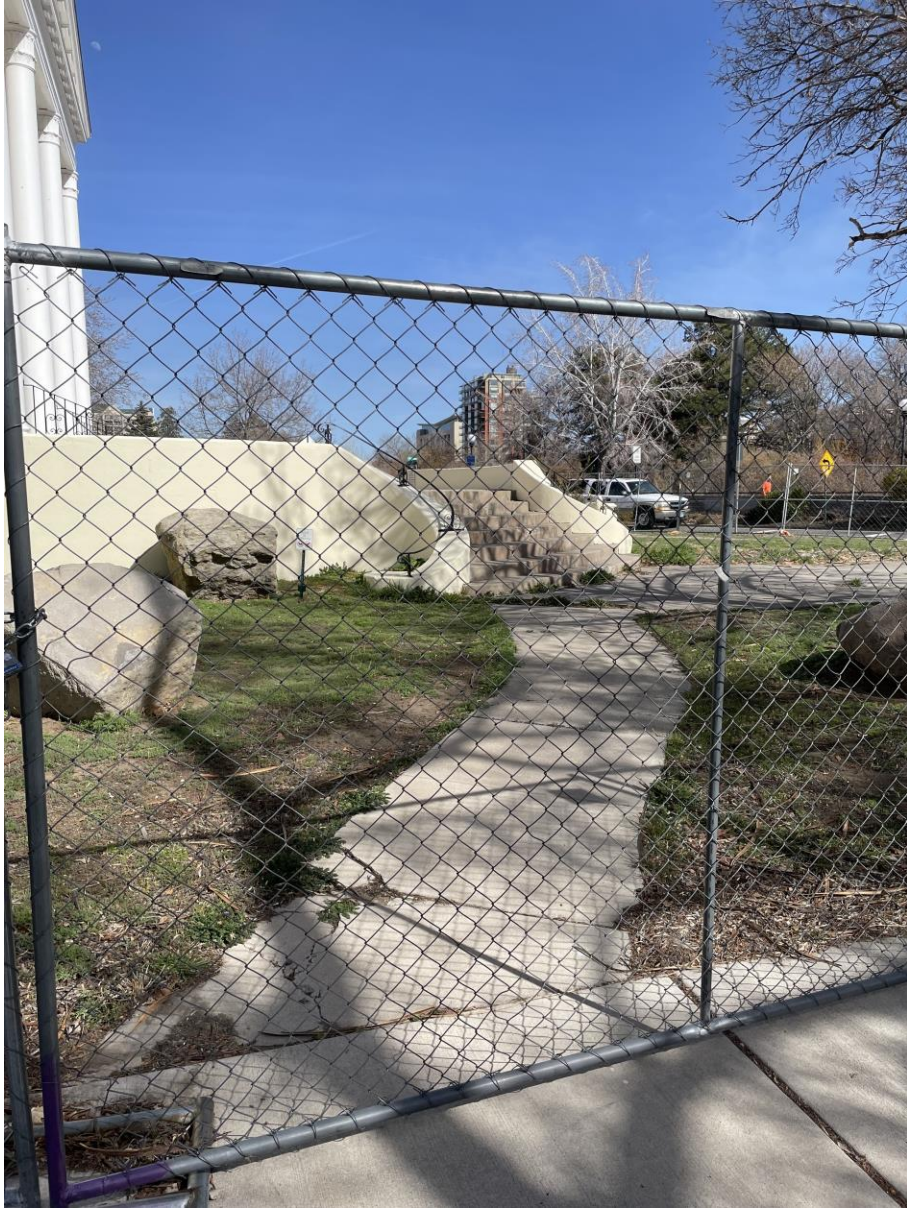
View of south facade from west.

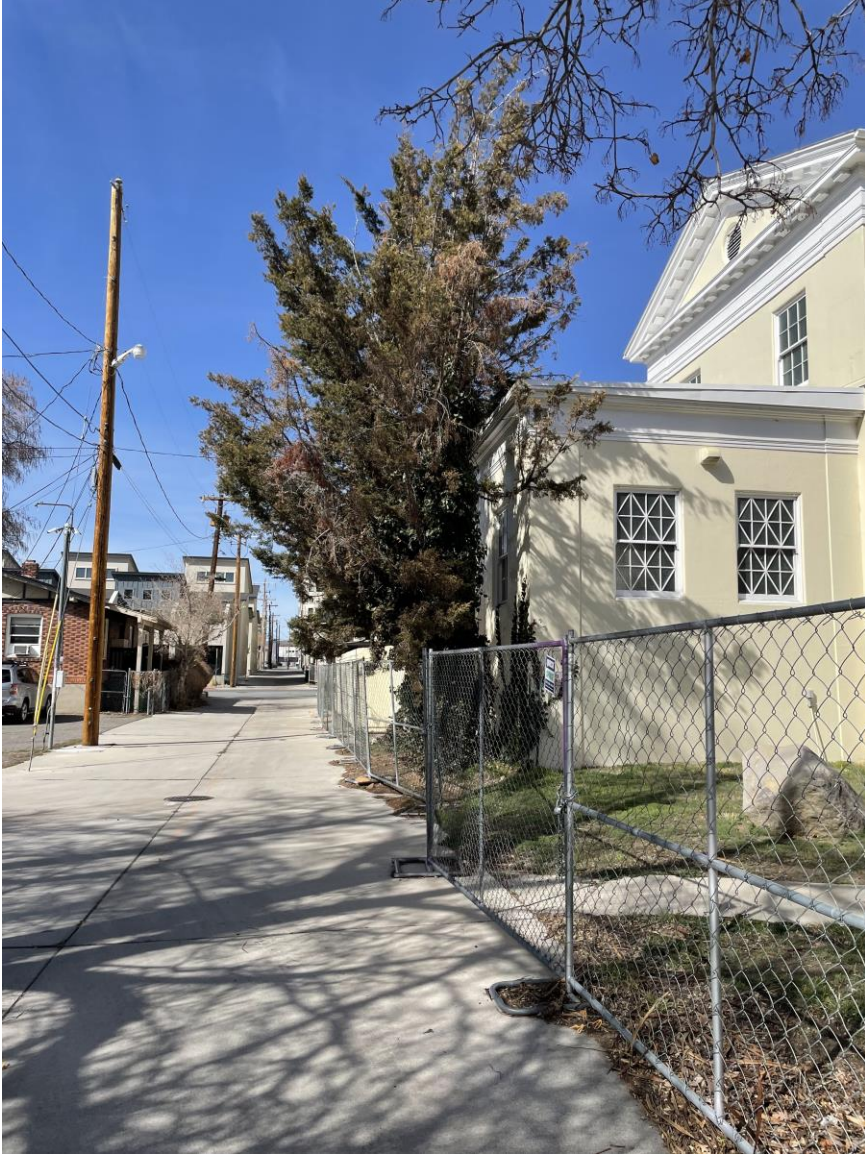
View of west facade, facing north.

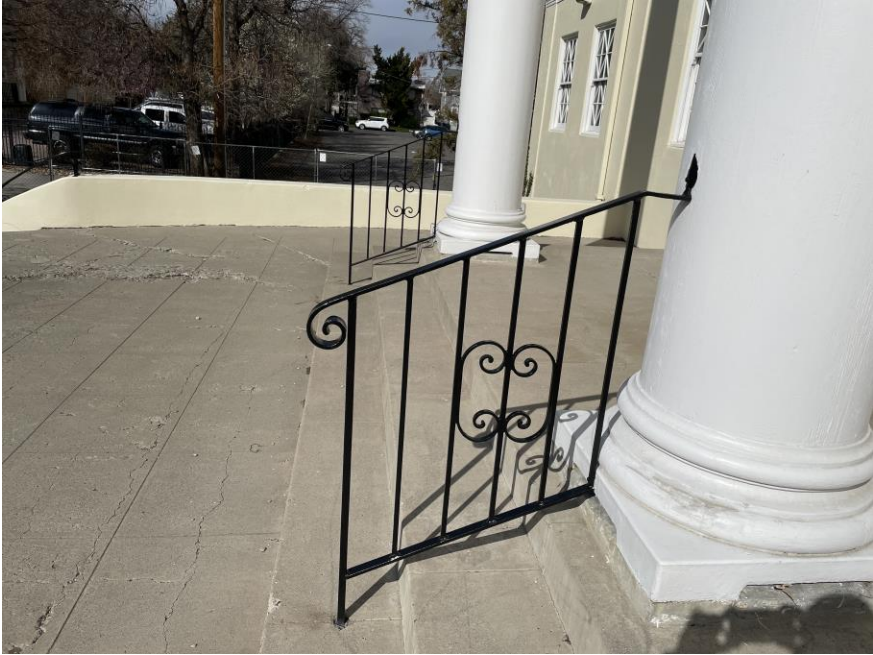
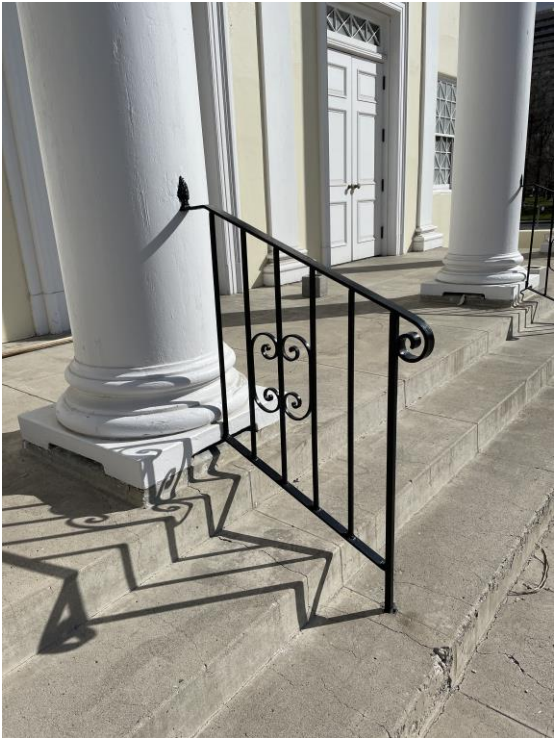
View of existing railings on south facade, main entrance.
