Stewart Indian School Complex
 Request for Permission to Undertake Structural or Visual Alterations

NEVADA STATE PUBLIC WORKS DIVISION CARSON CITY, NEVADA	Checked: NIS Drawn: MAM Scale: AS NOTED Date: 8/15/17
		ENVIRONMENTAL HAZARD CLEAN UP - OLD GYM STEWART Project Number 17-C09 SHEET 09B - FLOORING & ASBESTOS DEBRIS ABATEMENT PLAN

Work Completed as a part of Initial Clean-up effort on October 12, 2017

Proposed Work

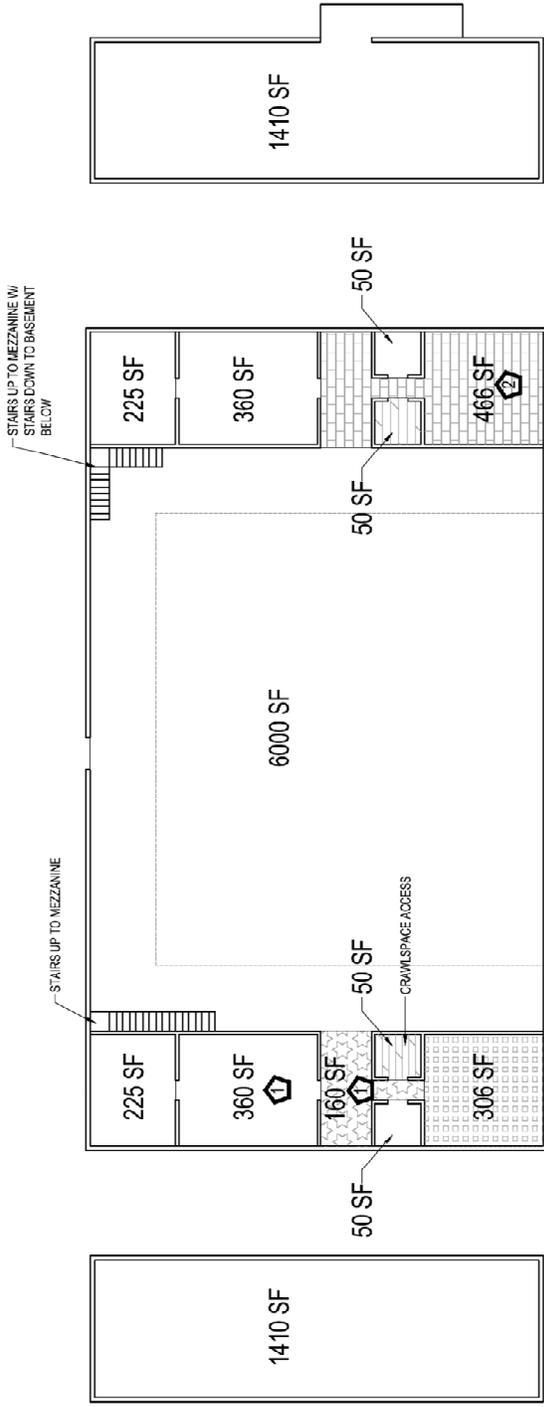
1. AREAS CONTAINING EXCESSIVE DEBRIS PILES OF 30TH ASBESTOS VCT & NON-ASBESTOS CONTAINING MATERIAL TO BE ABATED.

2. AREAS CONTAINING EXCESSIVE DEBRIS PILES OF 30TH ASBESTOS VCT & NON-ASBESTOS CONTAINING MATERIAL TO BE ABATED. SHELVING UNITS IN THIS AREA SHALL BE WIPED DOWN & DISPOSED OF.

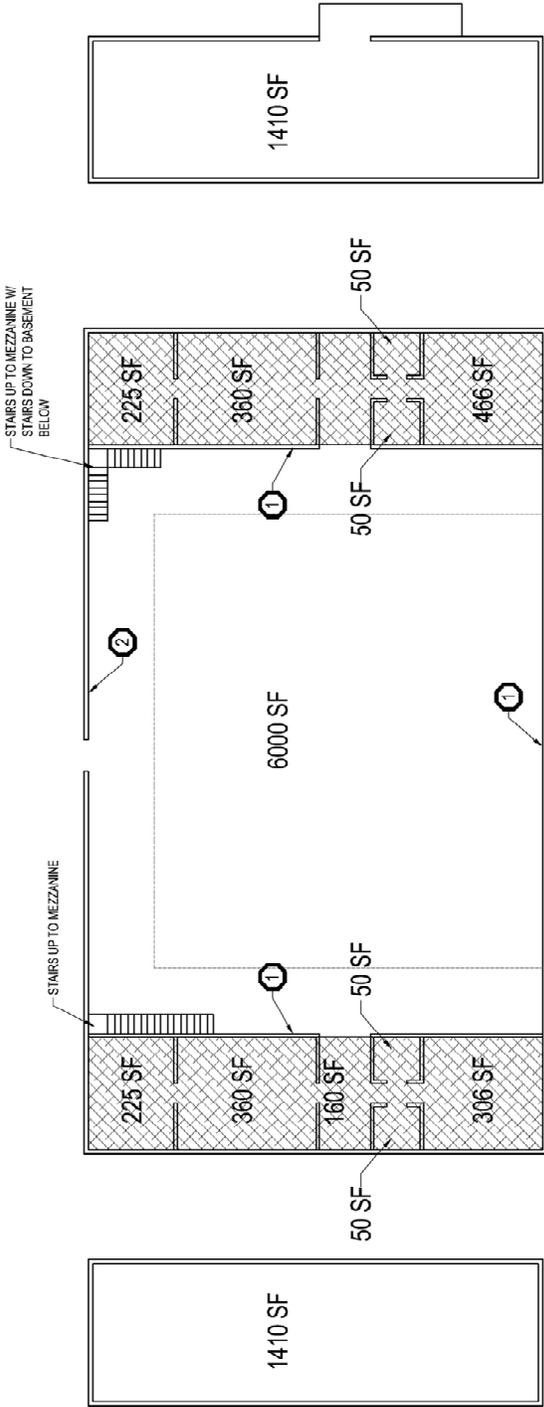
KEY NOTES
① PEELING LEAD PAINT TO BE ABATED ON THIS WALL FROM CORNER TO CORNER, AND FROM FLOOR TO UNDERSIDE OF MEZZANINE.
② PEELING LEAD PAINT TO BE ABATED ON THIS WALL FROM CORNER TO CORNER, AND FROM FLOOR TO TRUSSES @ ROOF STRUCTURE.

CEILING ABATEMENT LEGEND
 PLASTER CEILINGS TO BE REMOVED IN THEIR ENTIRETY. PLASTER CONTAINS NO HAZARDOUS MATERIALS, BUT HAS A LEAD PAINT FINISH.

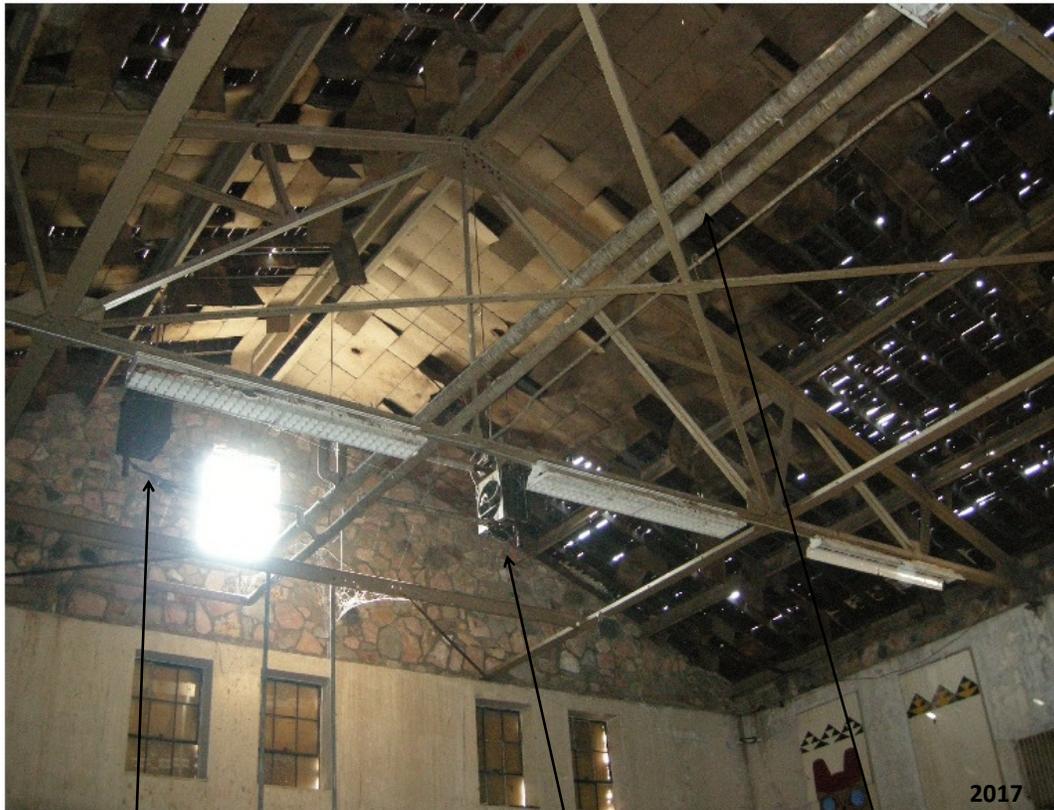
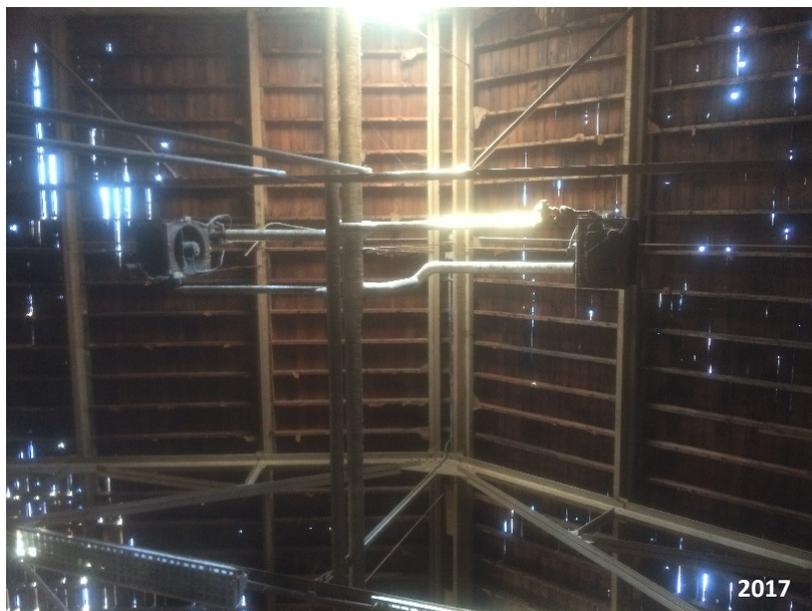
Abate the piping that has asbestos TSI in the gym area/ceiling. The piping is rusted and we will remove the TSI and metal Pipe. We will leave the Heater unit itself. These are old but not original.

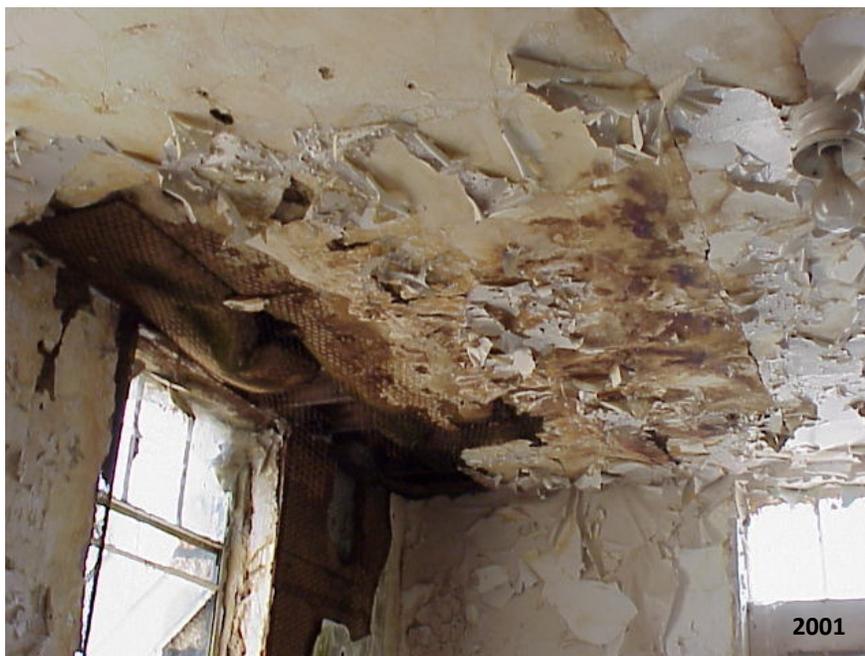
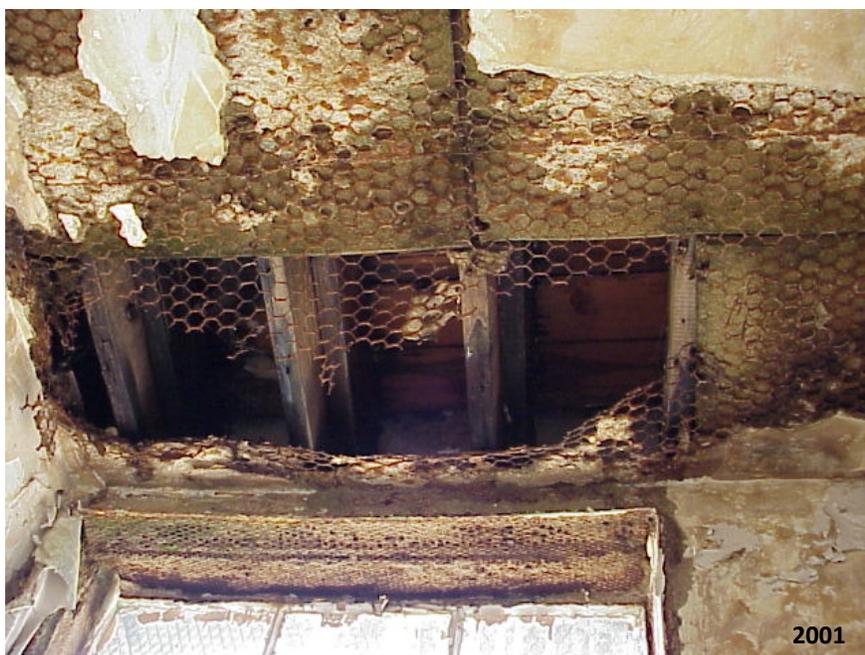
We will remove the plaster ceilings in the east and west end of the single story sections. This has to be conducted to structurally re-support roof of the structure due to water damage of the roof joists.

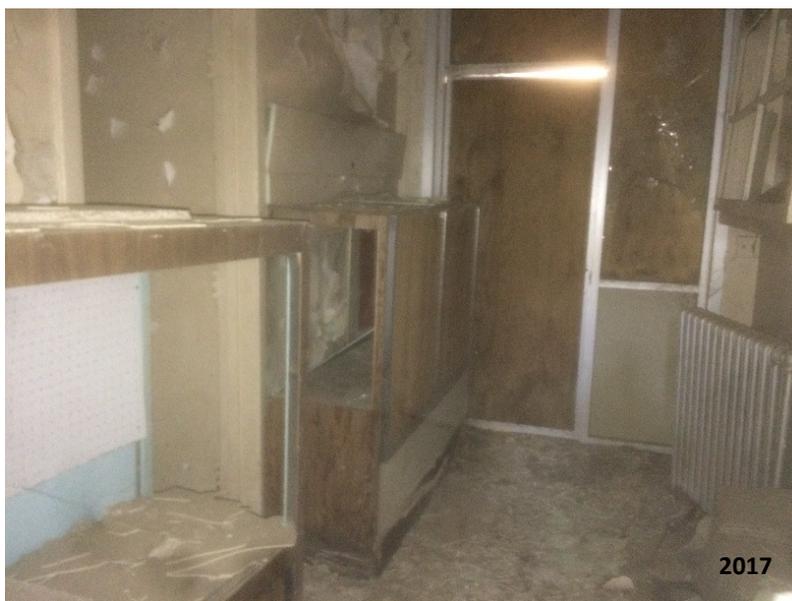
Cabinets in the main hallway entrance on the west side. VCT Floor tile on the floor and radiator. Cabinets will be stored in gym area and radiator will remain in building.

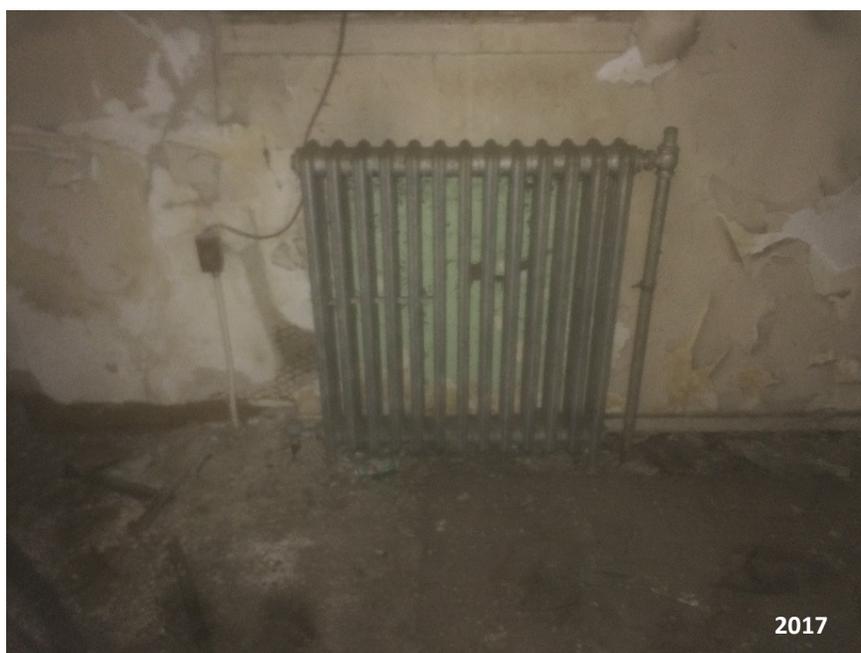
Ceiling radiators/heater. Heaters will remain in place and piping (asbestos) will be removed.
