## Conceptual Proposal

# Floyd Lamb Park Haybarn

Prepared by  
**Department of Public Works**  
David Bowers, P.E., P.T.O.E., Director

# Summary

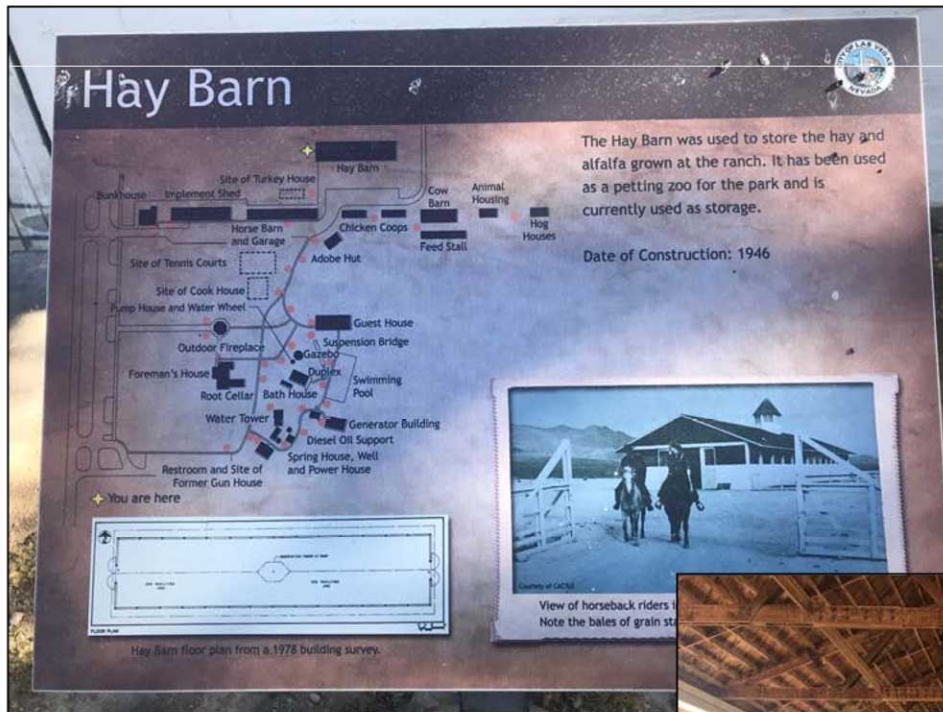
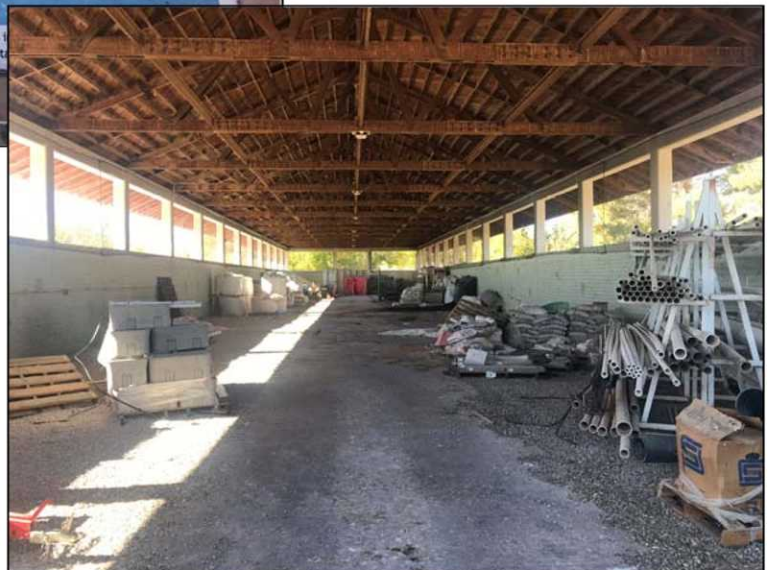
Existing space  
used for storage

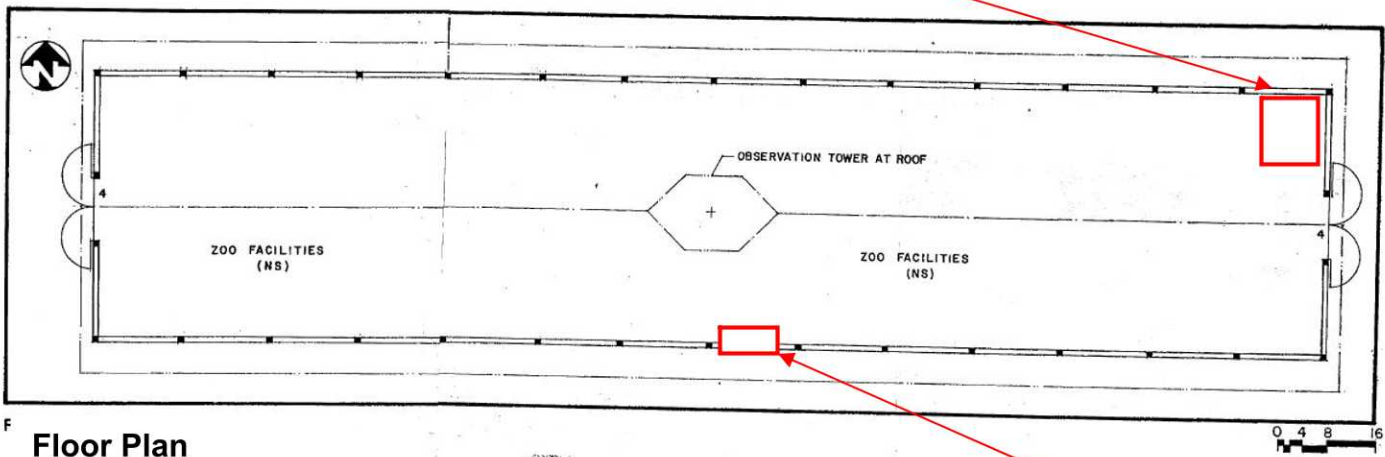
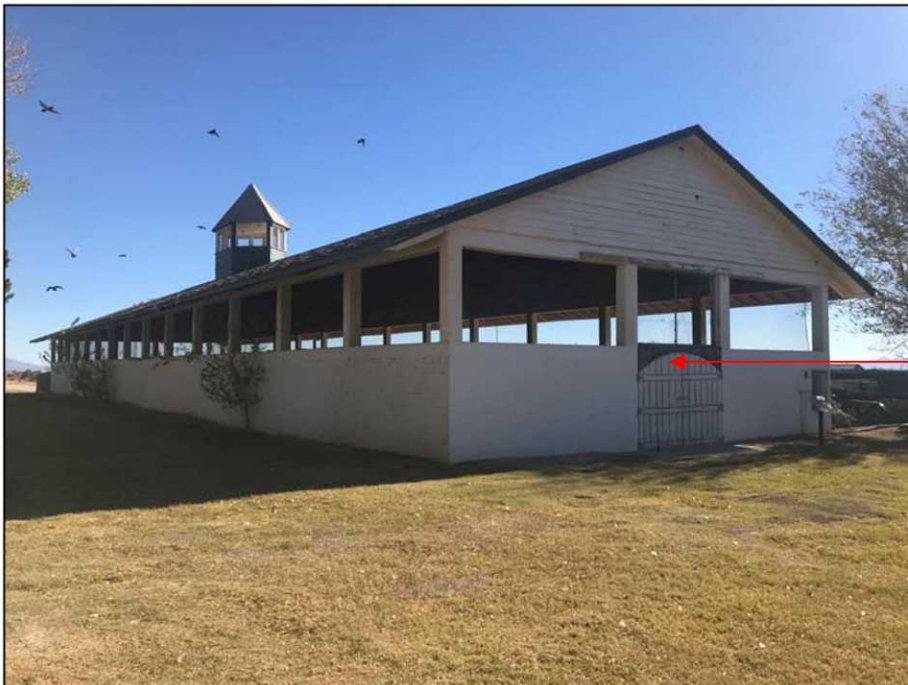
Fire Pump/Riser Room with outside door required. Area to include small service sink with water connection.

Third exit required if occupancy is over 500

Replace gates with new fire exit doors with panic bars.

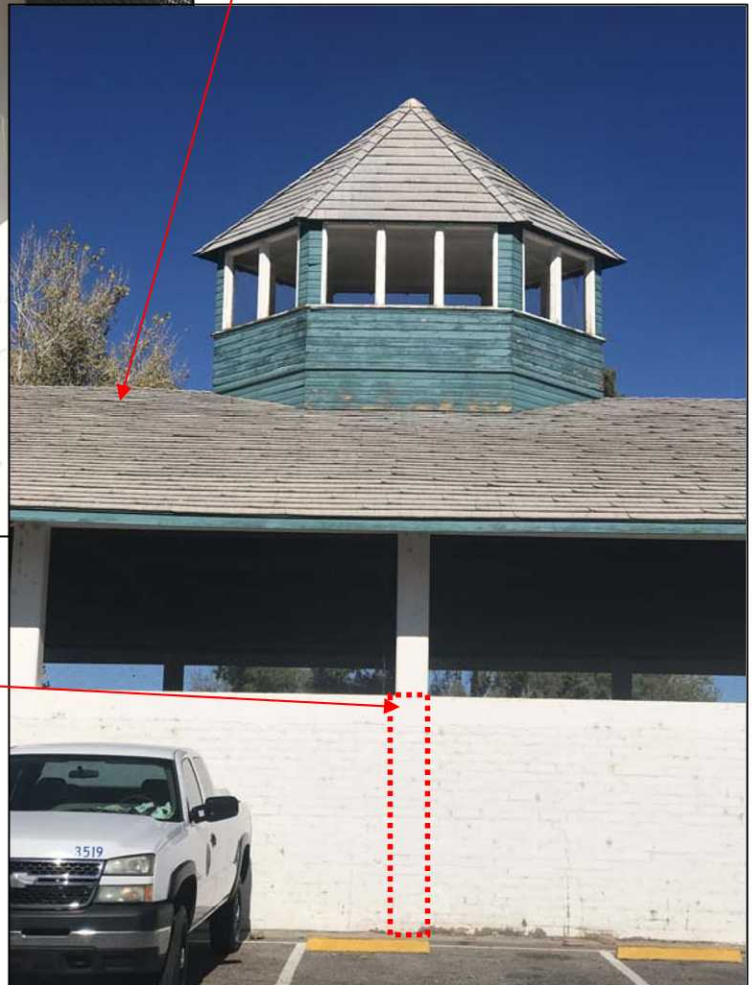
Seismic retrofit connections are required at existing columns to tie the roof structure and transfer lateral loads to the foundation. Masonry walls are currently unreinforced.

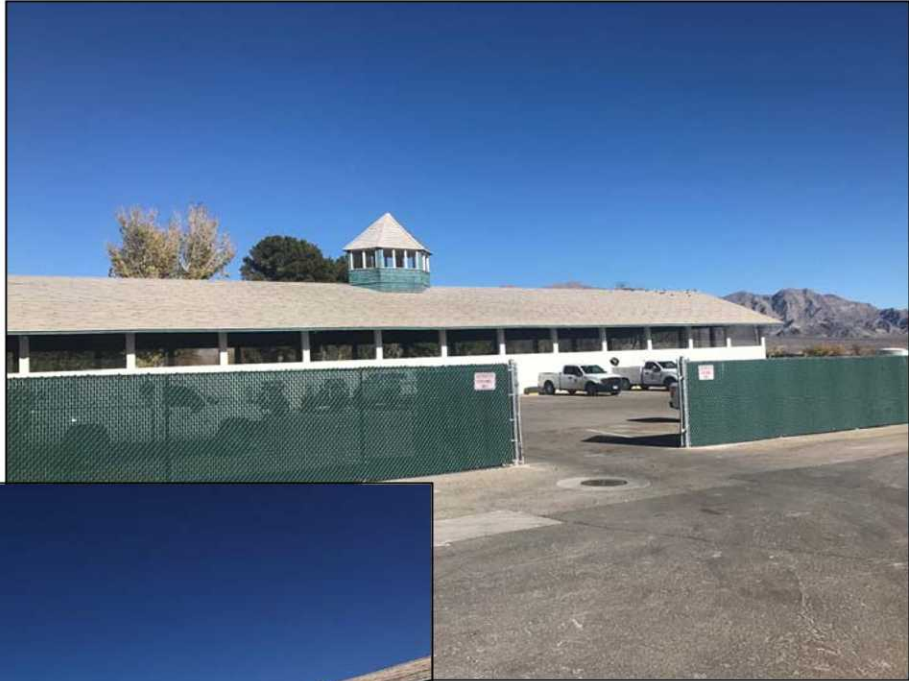
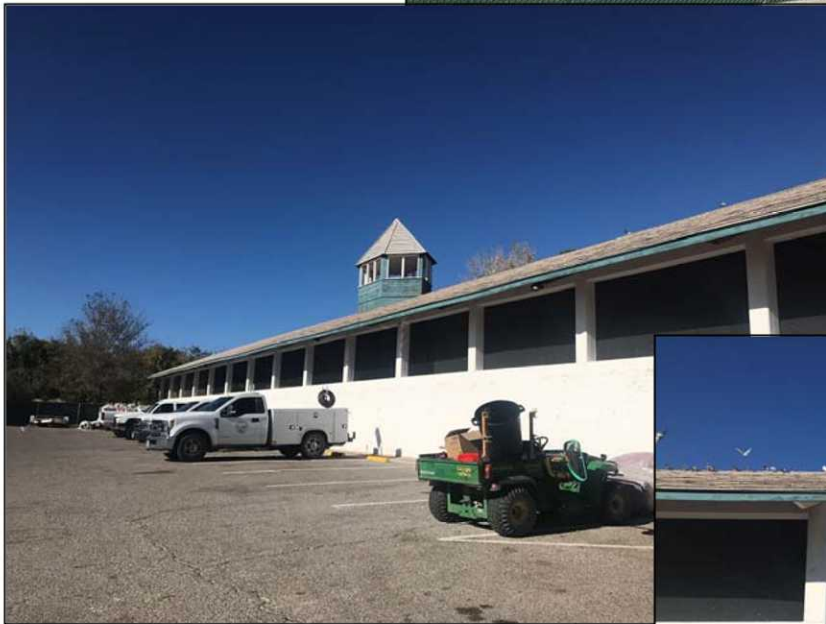
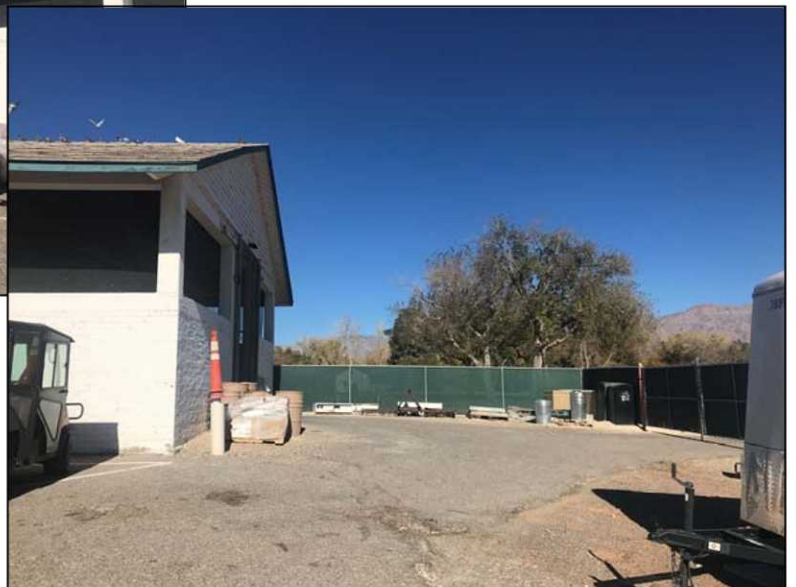
Existing parking area currently used by City Park Maintenance Vehicles to be repaved and restriped for Hay Barn Patrons. Handicapped stalls and way finding signage will be required with access from Tule Springs Road. Minor grading needed for drainage. Parks Department has requested an alternative area for storage if the Hay Barn is used for community events.

New asphalt paving/stripping and ADA stalls, signage, required for patrons. Building exterior LED lights may be the most cost effective way to illuminate the parking area that can accommodate at least 50 stalls.

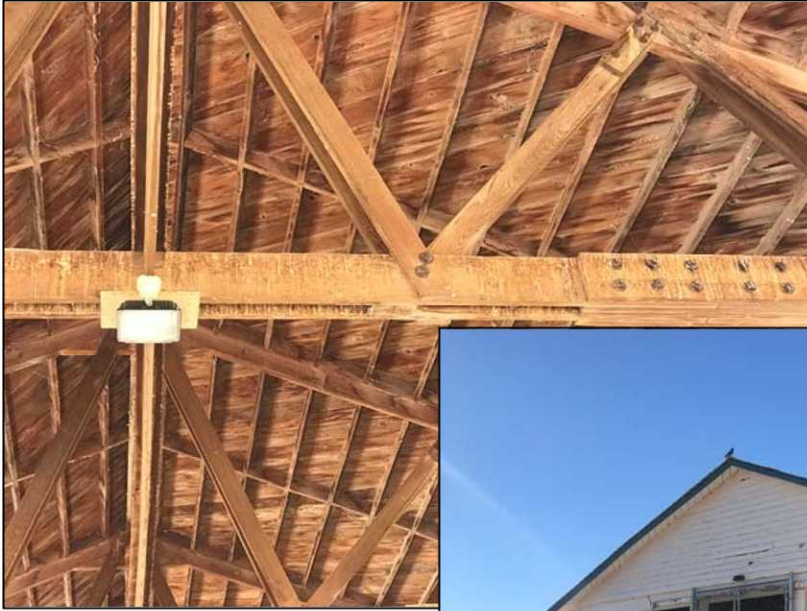
Due to neglect, interior and exterior repairs are needed. Existing wood siding should be pulled, repaired, patched, and receive new exterior stain. Masonry walls after seismic demo and replacement will receive block filler and elastomeric paint. Cloth netting currently on the upper openings should be replaced with a more durable factory coated enamel metal screen mesh.

New metal screen mesh recommended at openings
