National Register of Historic Places Registration Form

Historic name: Lampe, Wilhelm & William, Ranch

Other names/site number: Jacobs Family Berry Farm

Agriculture on the Carson River in Nevada's Douglas and Ormsby Counties

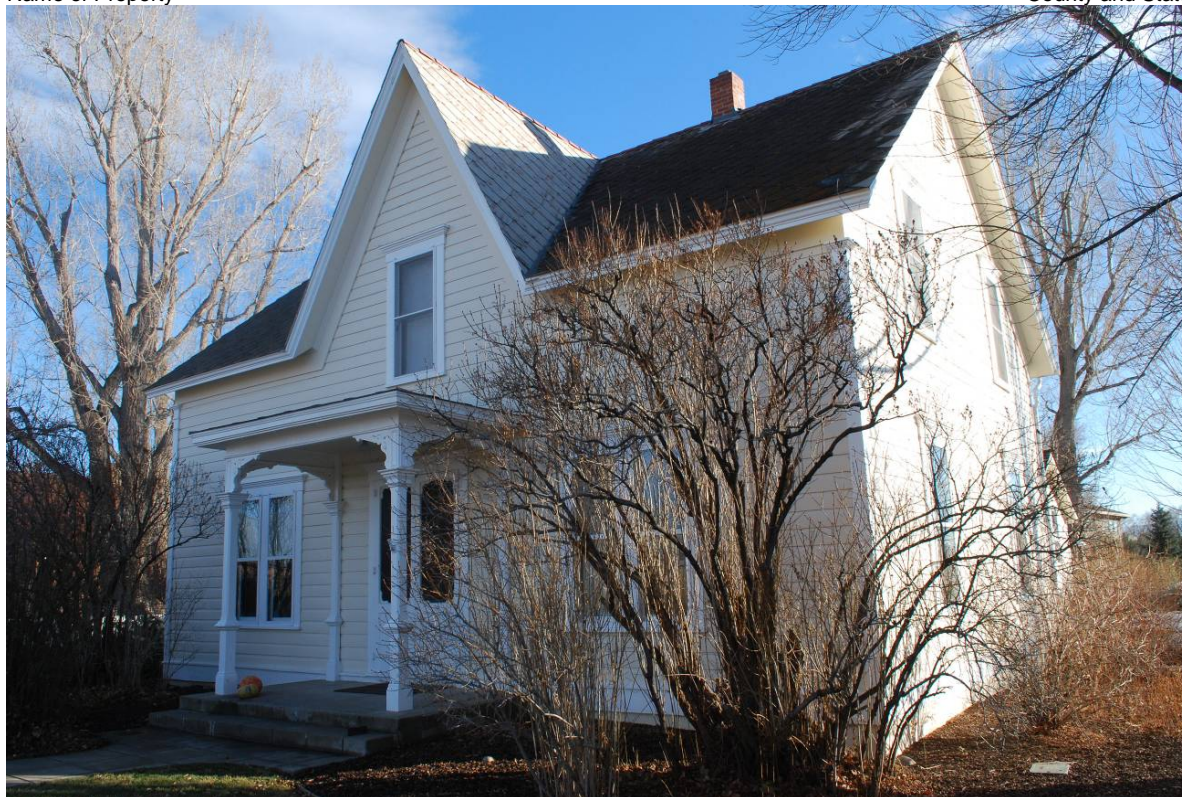
Photograph 3 – Lampe Ranch House, looking southeast.

The Lampe Ranch House, constructed in 1898 by Wilhelm and Maria Lampe, is an extremely late example of the Gothic Revival-style . It is a two-story home following the Centered Gable variety of residences in this style. The main section of the house on the north end has a moderately-pitched, side-gabled roof with a steeply-pitched intersecting gable centered on its north façade and a second-story, centered, gabled dormer breaking the rear (south) roofline. The roof is asbestos tile, added in approximately 1915 after a fire burned away a portion of the historic wood shingle roof. Two red brick chimneys break the roof crest. Extending from the north section to the south was a single-story extension, with a red brick chimney near its southern terminus. All siding is wood, dropboard, and all foundations are concrete perimeter, in some cases reinforcing historic rock pilings with lime grout, or slab. This extension received an addition in 1965 that in-filled space between a storage building and the main house. The storage building, also present by 1918, is a single-story front-gabled frame building with dropboard siding and heavily insulated walls, having served as a cool storage room for produce prior to the electrification of the ranch. Records and observation suggest that the 1918 storage building was initially the first residence for the family, built in 1872, but the historical record is not clear. The practice of expanding relatively simple homesteads into larger, architecturally extravagant dwellings was not uncommon in western agricultural areas. However, the two-over-two wood sash windows and dropboard siding matching that on the main Gothic Revival house suggests that regardless of the date of construction, the building was heavily remodeled in or after 1898 along with the construction of the main portion of the house. In 2007, the owners made a gable-roof extension from the 1962 addition to the east, creating a new entry and glassed in sunroom on the elevation.¹

Windows on the main section are wood sash windows with simple surrounds and modest crown molding. On the façade, a single one-over-one sash window is placed in the second story gable. On the first floor, paired one-over-one sash windows flank the main entry. The side elevation windows are two-over-two wood sash windows. They are symmetrically placed with two on the upper story and two on the lower story. The main entry has paired, wood panel storm doors with long, narrow screen openings. The main doors are heavy wood panel doors with windows detailed with Gothic styling. The main entry is covered by a single-story porch with a flat roof, square fluted columns and pilasters, and decorative verge-boards below the eave. It rests on a concrete slab with two steps leading to a concrete pathway to the front gate. Windows on the remaining portions of the house are predominantly two-over-two, either wood or vinyl dual-pane replacement windows on the intervening sections. The exception is the 2007 sun porch addition which has fixed, vinyl dual-glaze windows on all of its elevations.

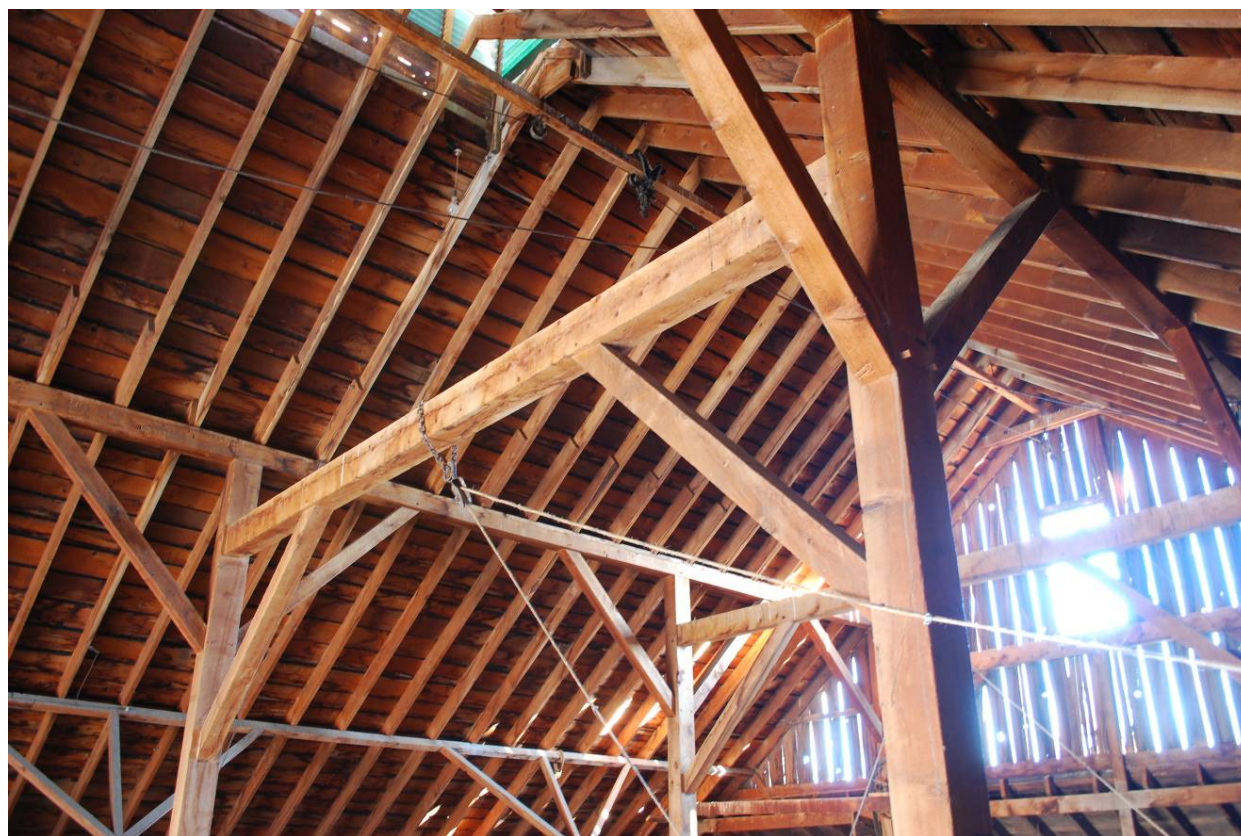
Photograph 6 – Barn interior, viewing primary framing and roofing structure, looking up and southeast.

The barn has heavy timber, mortise-and-tenon framing with selective reinforcement with steel bolts and straps, resting on embedded foundation stones. Oatman provides a detailed description of the barn's structure:

The barn has five bays (the distance between posts) and consists of a main aisle and two side aisles. The H bents (main aisle) have 10 by 10 purlin posts and 6 by 6 head braces connecting the 10 by 10 tie beams. The purlin plate...is connected with bladed scarf joints. The side aisles have secondary tie beams...with secondary canted purlin posts...with a secondary purlin plate...also connected with bladed scarf joints. All purlin posts and plates have 6 by 6 braces....This whole system supports 2 by 6 rafters on 24" centers. The longitude sills and cross sills are 10 by 10 and also employ bladed scarf joints as well as 6 by 6 foot braces. The paneling and loft are of a later date. One unusual feature of the barn is the numbering of the "H" bents. These numbers signify the order in which the barn was erected. The numbers are bold and concise. It could be that the timbers were cut and hauled to the jobsite or it was more efficient with [an] untrained crew.⁴

Along the center aisle are single-story walls with a mezzanine deck above the side-aisles. Paneling along the center aisle walls is comprised of flush 2"x10" boards. Most joints are fastened with 1" tenons. At the rear of the barn's center aisle, there is a raised wood floor for clean work space, leading up to the grain bins at the rear of the barn. The frame wall of the middle bin is movable to allow for adjustment based on the necessary storage space needed, and to allow the space to be used alternately for grain storage and for equipment storage. A belt driven grain elevator remains and is installed along the north wall of the grain bin area. The east side-aisle has a low ceiling and 6.5"x6.5" posts and beams framing the space, and was used historically as a feeding corral. The west side-aisle has matching posts and beams, but has a small shop crane, indicating the space had been used for loading and unloading smaller wagons. Interior framing posts and beams show circular saw marks, suggesting they were lumbered at local sawmills in the Carson Valley.

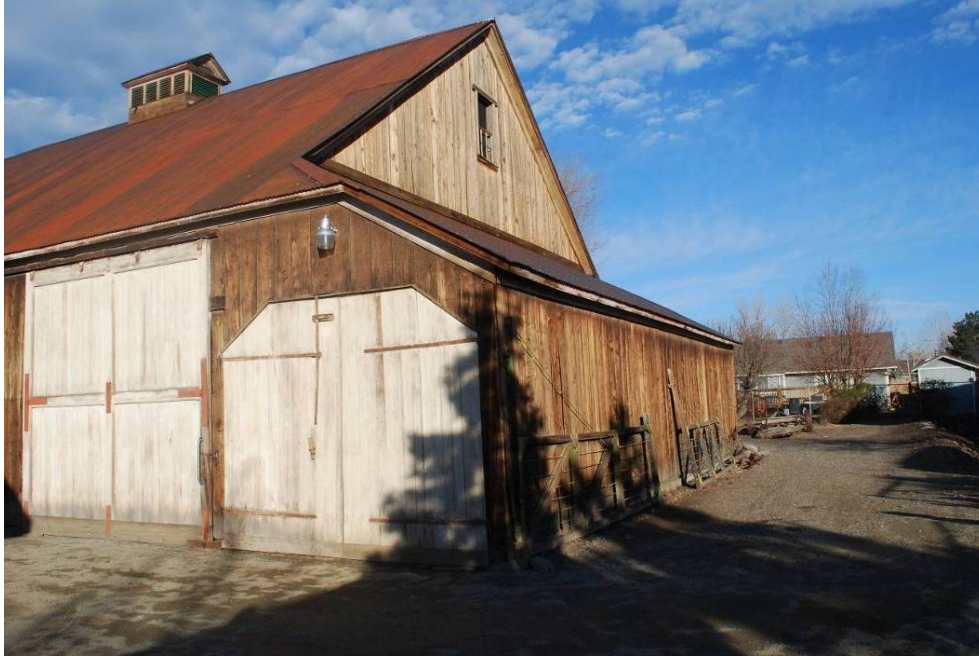
Photograph 7 – Barn, rear elevation and southwest corner, looking northeast, showing grain bin addition.

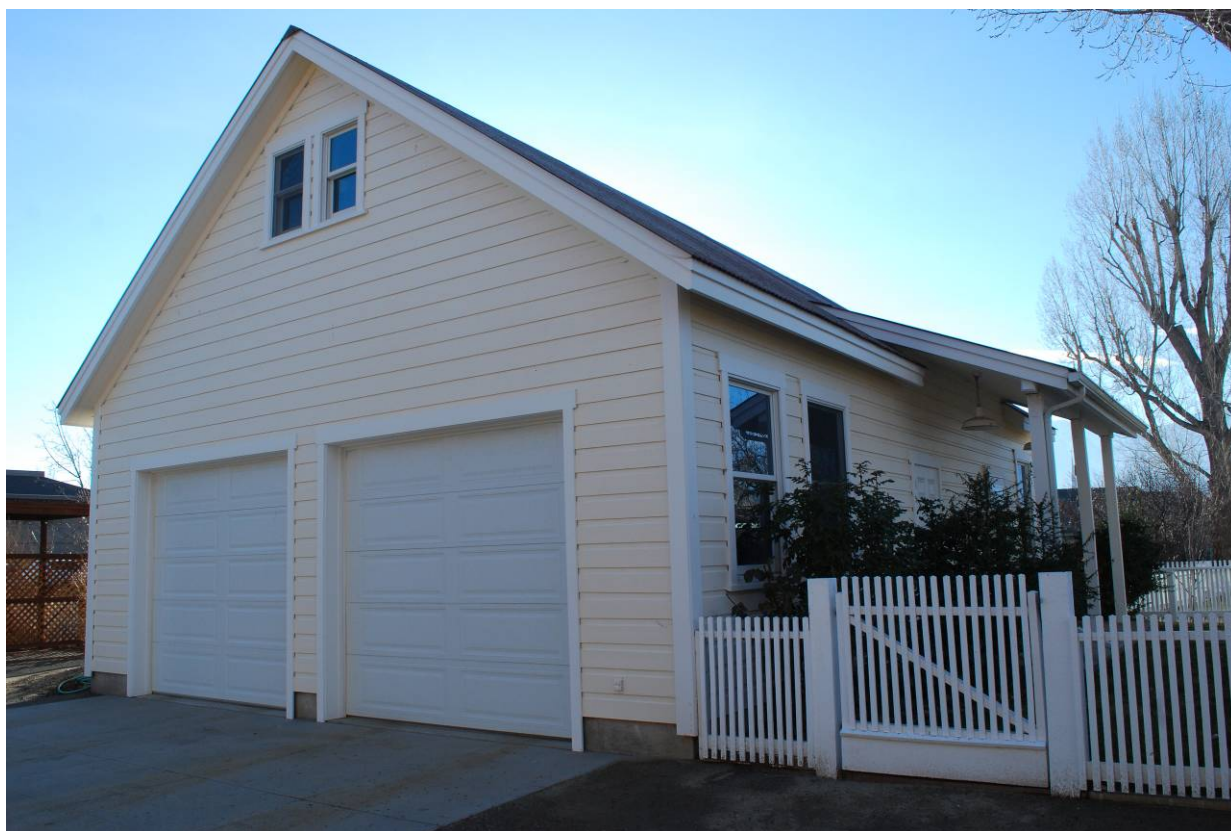
Photograph 12 – Guest House, east and north elevations, looking southwest.

The Guest House is a small, one-and-one-half story residence and garage near the southern end of the property. It has a moderately pitched, side-gabled roof of corrugated steel and wood drop-board siding, allowing it to be stylistically compatible with the historic Ranch House to its northwest. It sits on a concrete slab foundation, and has a pair of large garage doors with a driveway breaking its east elevation. There is a shed porch with squared posts on the north façade, with a simple panel door. Windows on the façade and in the gable ends are vinyl one-over-one windows, both single and paired, of varying sizes. A modern wood picket fence encloses a small yard space around the building's north façade, and is designed in the same style as the fence surrounding the Ranch House.

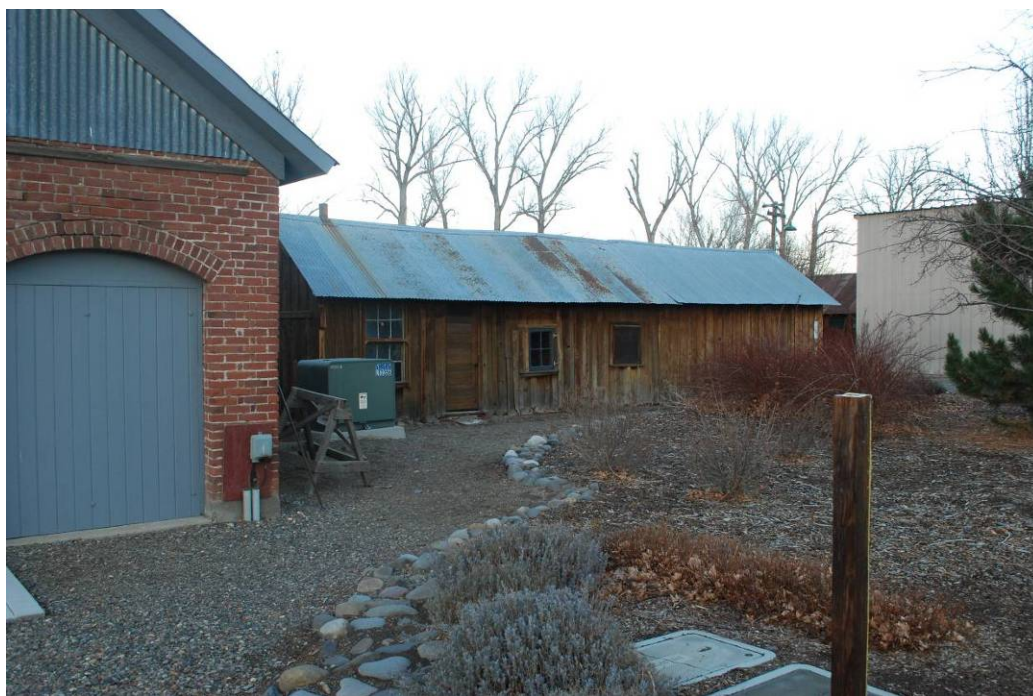
Photograph 14 – Poultry House, north elevation, looking northeast, with Creamery (left) and Warehouse (right).

The Poultry House appears to be a combination of buildings, including the first automobile garage built sometime in the late-1910s, then moved across the property around 1920 and connected with another shed building to create the Poultry House as it stands today. This appears to have been in response to a fire at the house, which likely occurred in 1915.⁷

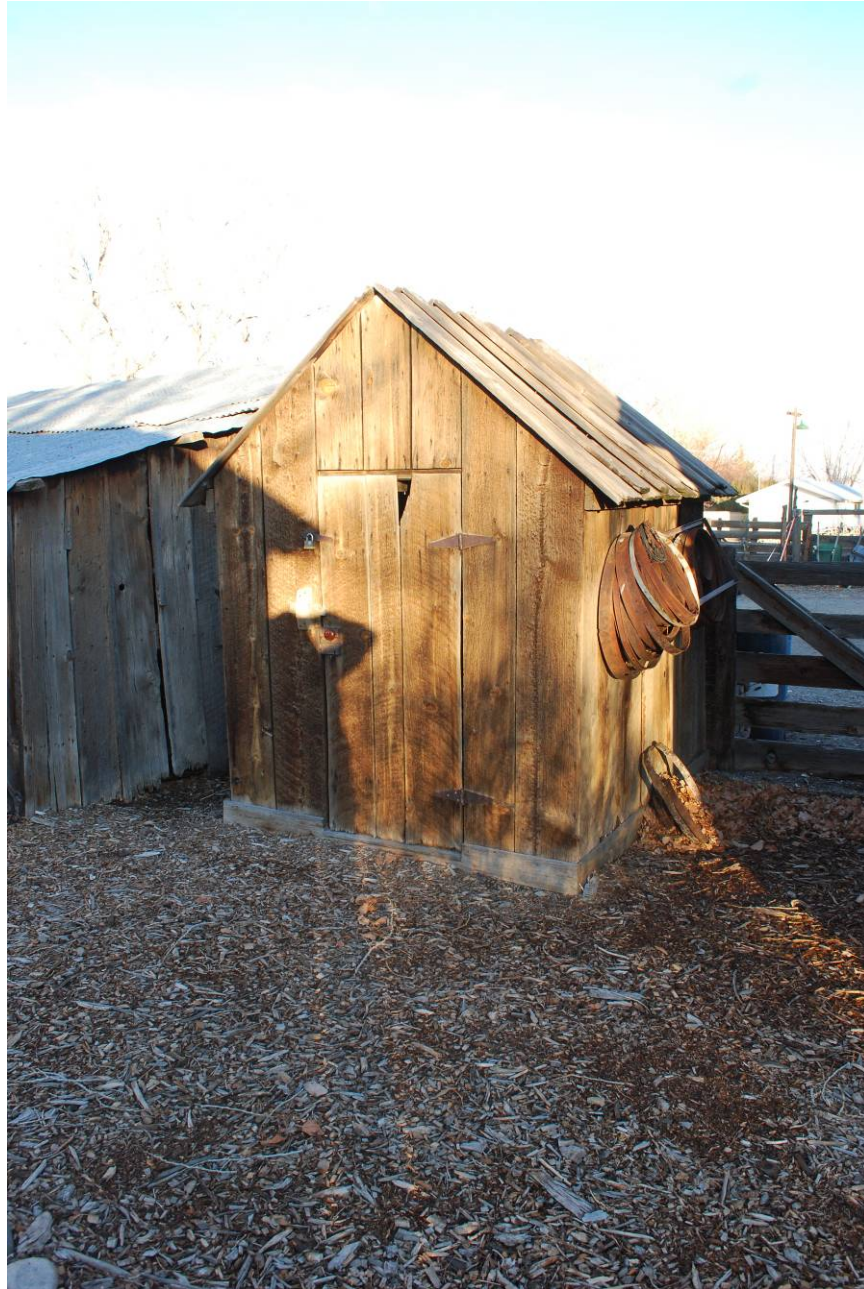
Photograph 16 – Smokehouse, west façade, looking northeast.

The Smokehouse is a simple, one-story front-gabled structure sitting on grade with no foundation and facing west. It has flush vertical board walls and roofing, with the roof secured with additional battens. A doorway of flush boards is on the west façade, and there do not appear to be any windows in the building. Hooks for equipment are on the north wall's exterior. It is possible the structure was built earlier than the 1920s, but it is first confirmed in records by the 1920s.

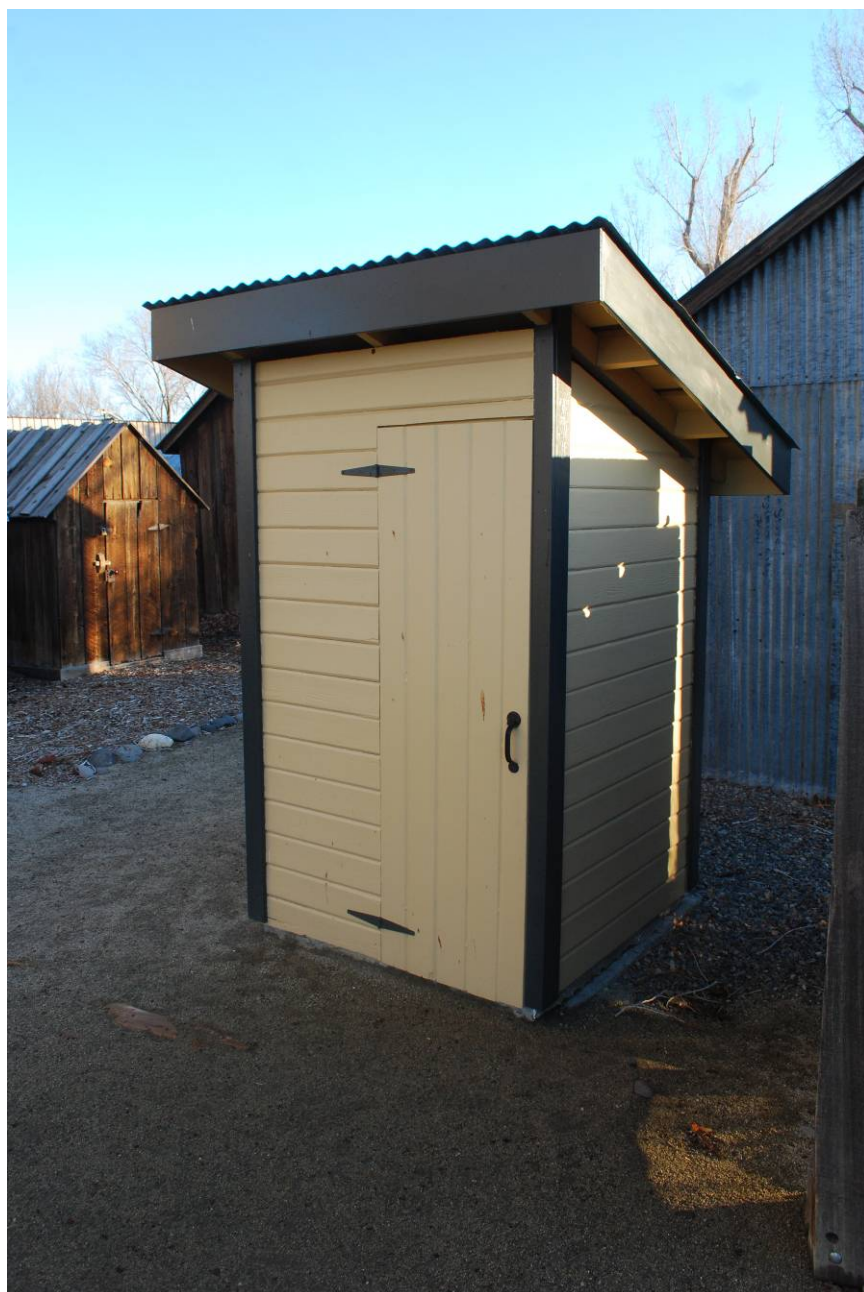
Photograph 17 – WPA Privy north façade, looking southeast.

The Privy appears to be a Works Progress Administration (WPA) privy constructed as part of rural sanitation efforts during the New Deal in the 1930s. It is a simple, single-story frame structure on a concrete slab foundation and a shed, corrugated steel roof slanted upward toward the structure's north façade. It has wood, dropboard siding, and a vertical board door that appears to be re-oriented salvage dropboard. The structure has modern vents along its east, west, and south walls.

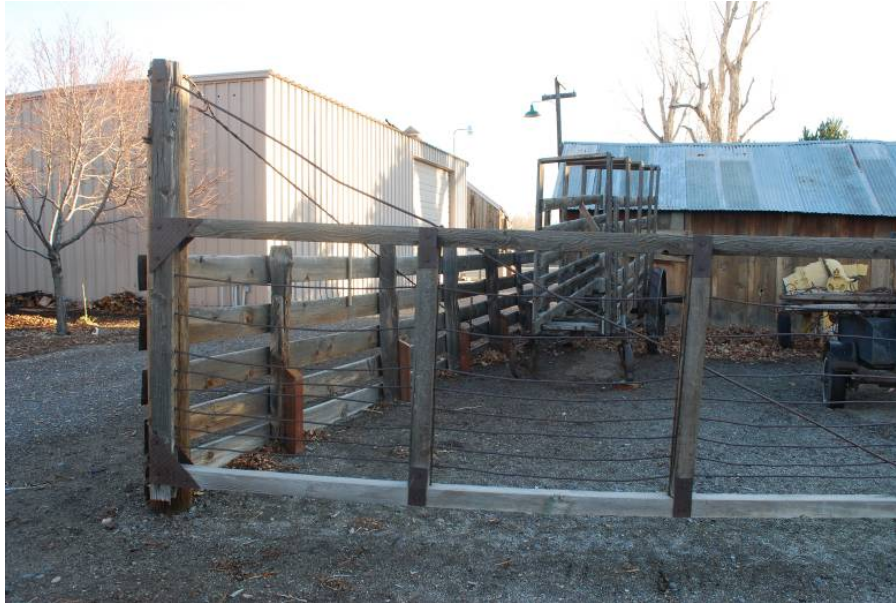
Photograph 19 – Corral and gate, looking south.

Historic Associated Feature – *Corral* – The corral is a small space attached to both the Large Loafing Shed and the north elevation of the Poultry House. It has a simple post-and-board fence approximately 5' high. A square-frame, wire gate provides primary access on the east side of the Corral, with a built-in livestock sorting chute along the outer fence just to the north of the gate.

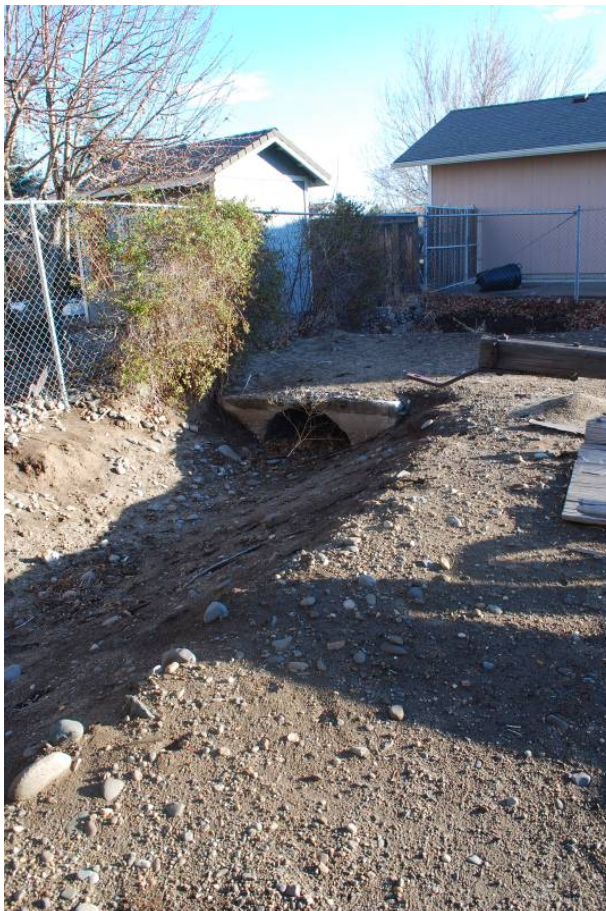
Photograph 21 (right) – Remnant of the Hussman Company Ditch and a concrete culvert and bridge at southeast edge of property. Formerly, the road leading from the main house and barn led across this bridge and into alfalfa fields to the east.

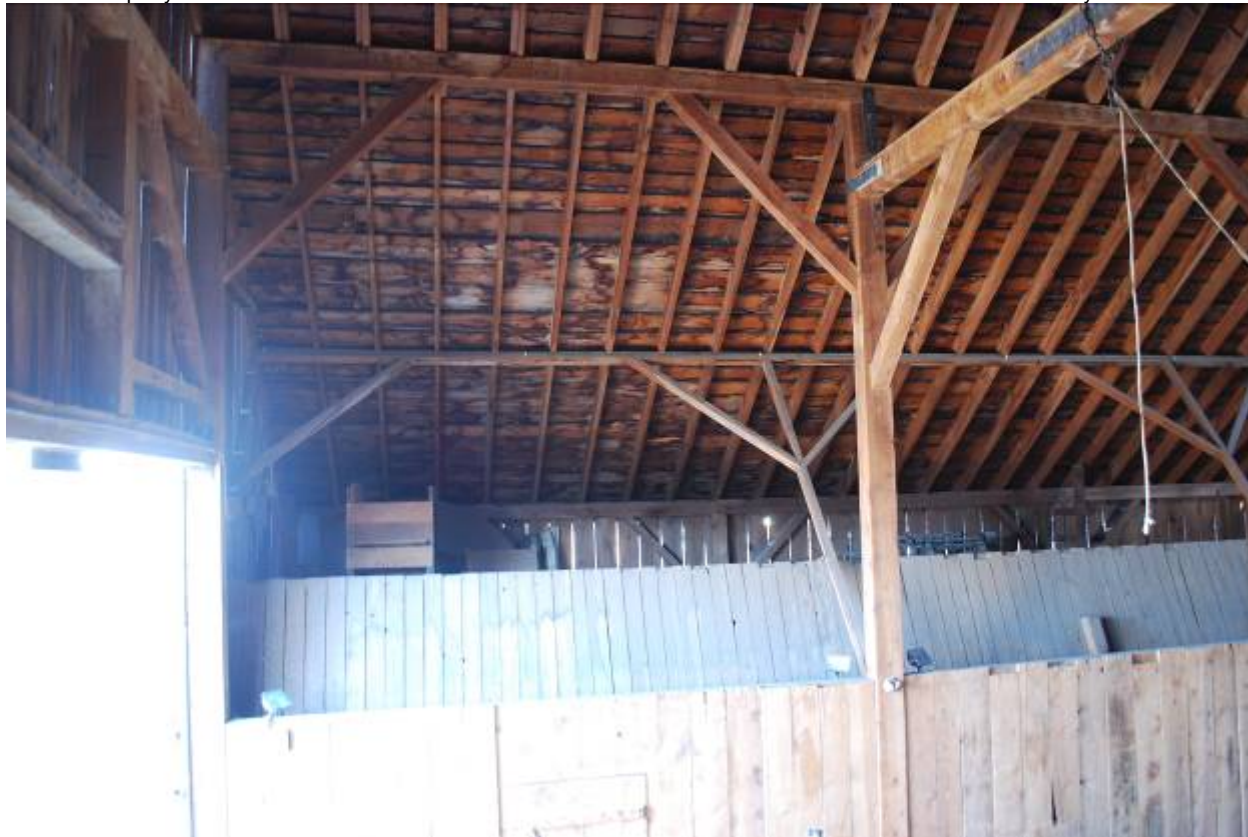
Photograph 27 – Barn roof framing system, showing dropped tie beam (upper right and left) and unique angled truss bracing system along secondary (lower) purlin.
