Attached please find the rehabilitation plan for the Comstock Cemetery Foundation's visitor center.

## Introduction

## Rehabilitation: Adaptive Reuse Identify and Retain Historic Features: Salvage and Reuse

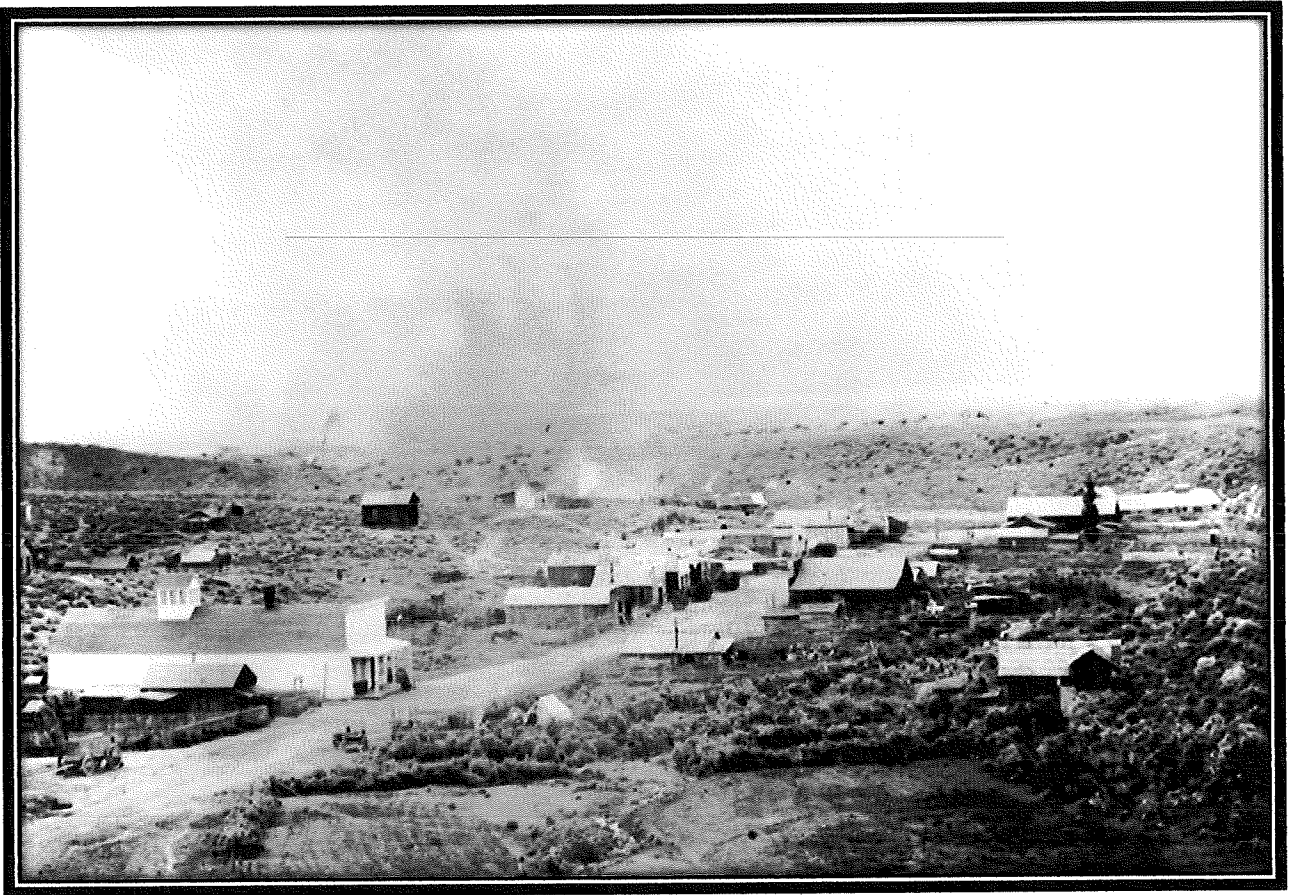
The birth of the miner's cabin most likely occurred during the 1870s in a small community on the Comstock known as American Flat. This area was sparsely populated with farms, residential cabins, and mining. The cabin's board and batten construction was the original structure, covered over at a later date. The CCF created a "window" on the side of the house so visitors could see the first construct of the cabin even though the exterior siding had been altered numerous times.

The cabin was home to a family unit. By the 1870s many families lived on the Comstock in similar housing (Fleiss). The original wood burning stove chimney opening can still be seen on the side of the cabin. The initial floor was dirt, the ceiling was open to the rafters. One roughhewn wall was added during this time period for privacy with evidence of four different wallpaper layers. A roughhewn floor was added at some point during its use in American Flat.

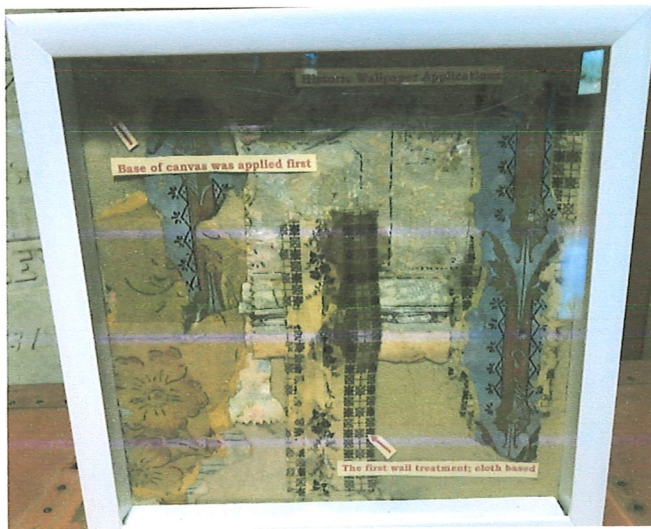
In some cases, our discoveries can't be readily integrated and/or seen. For example, the four layers of wallpaper on the roughhewn dividing wall is of interest; both in type and application. The first layer was a simple pattern printed on material and adhered to a layer of canvas. We removed as much of the remnants of the four layers as we could before installation of the cupboards and created a shadow box display. The wall will be exposed however, kitchen cupboards will be re-installed and as in the past the cupboards will cover a good portion of the wall.

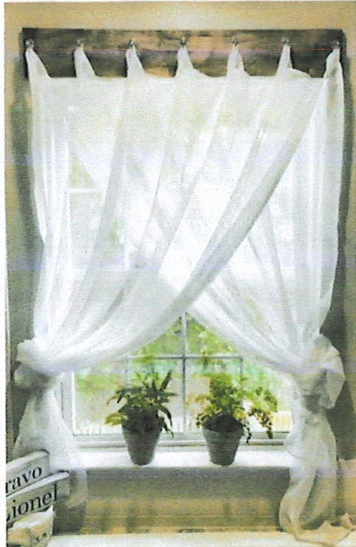
## Rail Spike

***Six rail spikes were found in the miner's cabin during rehabilitation, used to plug holes in the floor, window joints, and walls.***

**Meeting Room Windows-curtains are hanging from the rail spikes found within the cabin.**

- 1870s structure was left open with no interior walls for a time
- Hard board was used as walls - salvaged from elsewhere
- 1950c first installation of dry wall which had 3-4 different paint layers
- 1980s another installation of dry wall
- Molding was salvaged and often did not extend the entire length of the wall and sometimes a 4" piece would be placed up against a 2" piece, sometimes painted in different colors
- 2 rail spikes used to block holes in main room walls

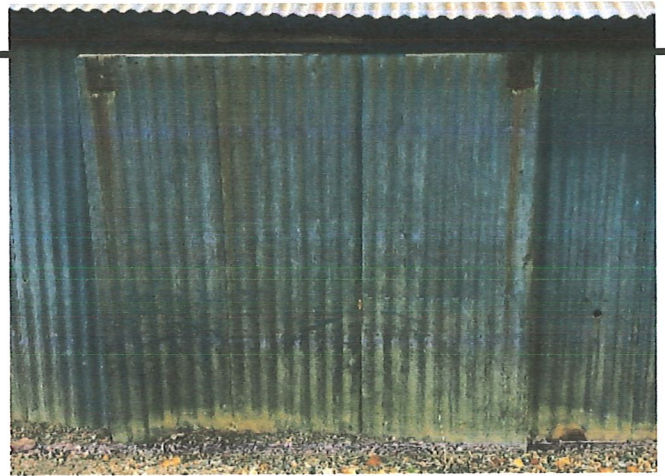
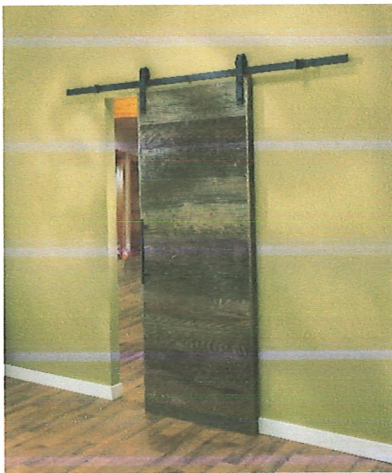
## **Sliding Door-Adaptive Reuse**

Pictured here is a Comstock door; with hardware missing-it was salvaged, and reused elsewhere.

**Sample of door planned on non-historic wall, entrance to bathroom (1980c)  
Saves 12 square feet of space**

- The salvaged door has fallen off and cracked
- By opening the door into the bathroom, we lose 12 square feet of bathroom space. The same is true if we reverse the door and open it into the meeting room (bedroom). In the bedroom it would open against the backdoor and we lose space in an already small room. In the bathroom, when using the toilet, the door would bump up against the occupant's knees.
- We think the first bathroom door used in that space may have been from the old outhouse
