CHDC Meeting Date: August 4, 2026

**Agenda Item # One**

| <b>Significance</b> | Remnant of Retaining Wall – Masonic Hall c. 1876 |

## B Street Wall Repair and Slope Stabilization

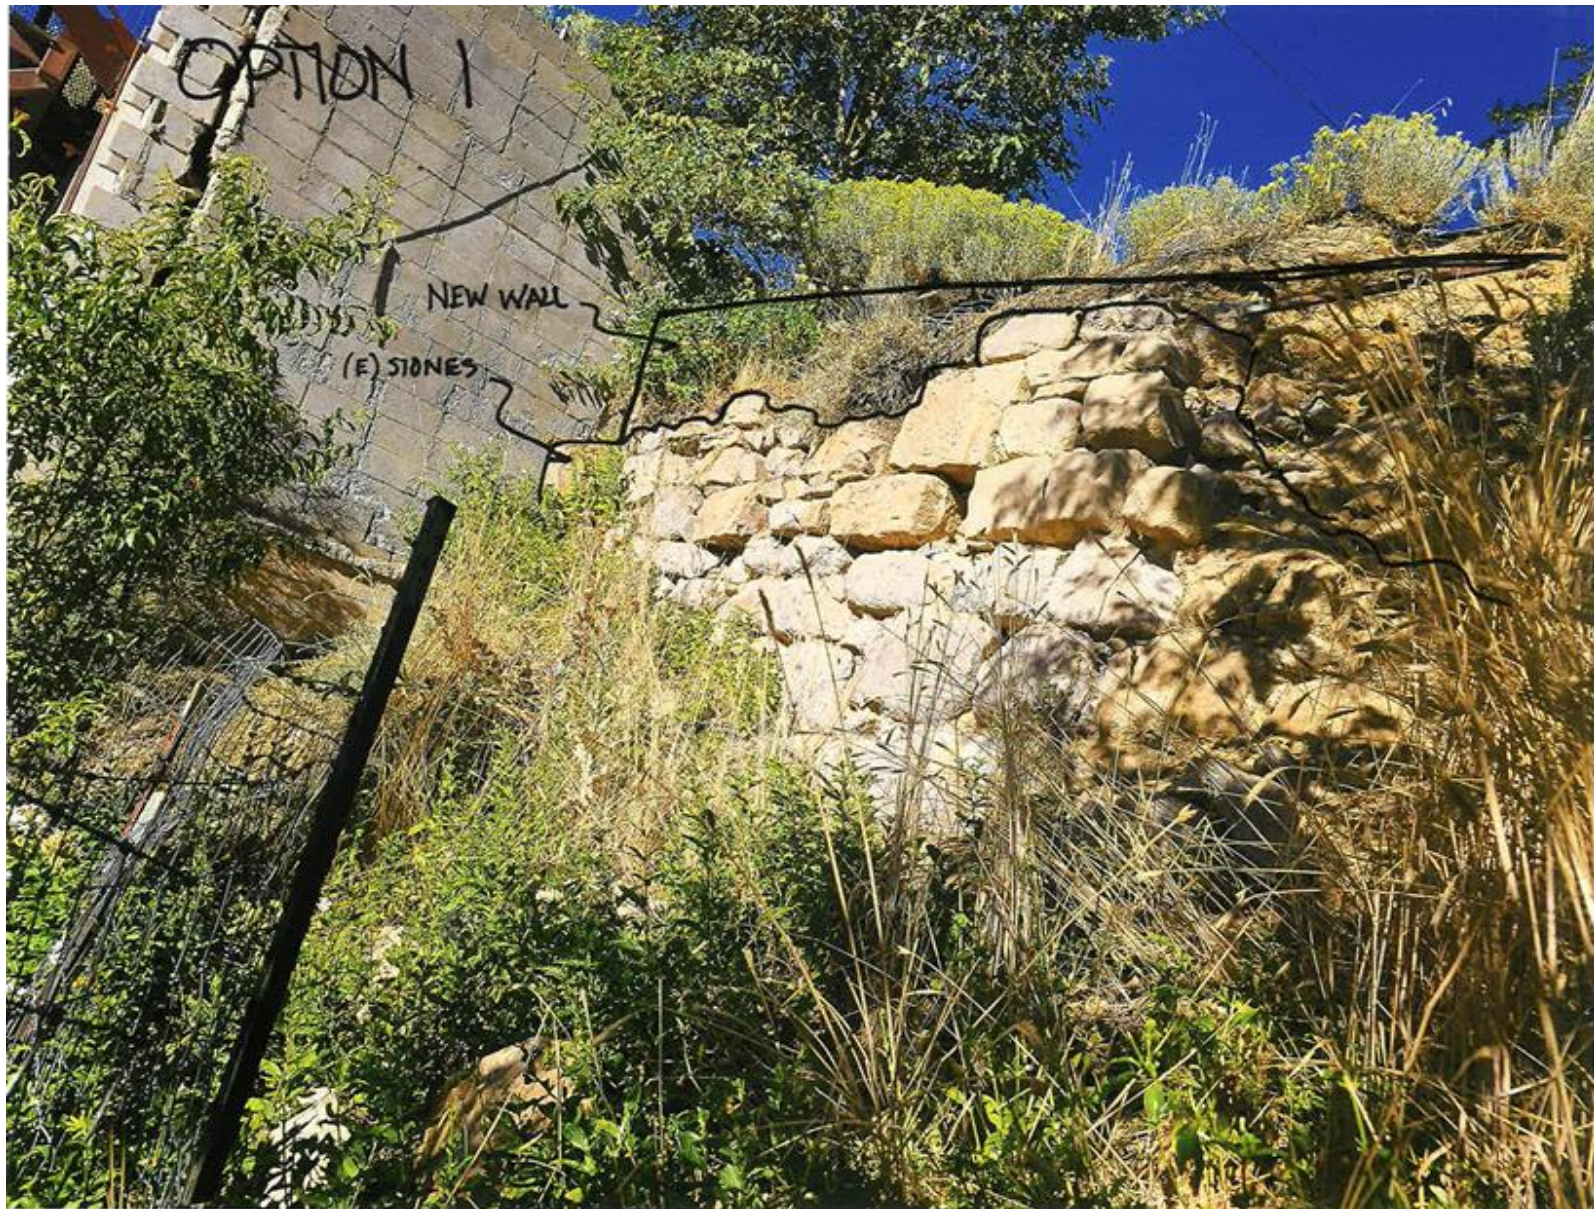
Option 1 – is to remove the stones and construct the CIP retaining wall and face the wall with the existing stones. This option preserves the face look of the wall but is only available to viewers on the Red Dog patio area. This also introduces some difficulties with restraining the stones against seismic forces.

The County engaged Lumos and Associates Engineers to design a retaining wall that will guarantee the stability of the slope, protecting B Street and the private patio area below. This approach will require the removal of the stones. We provided two options for the disposition of the stones.

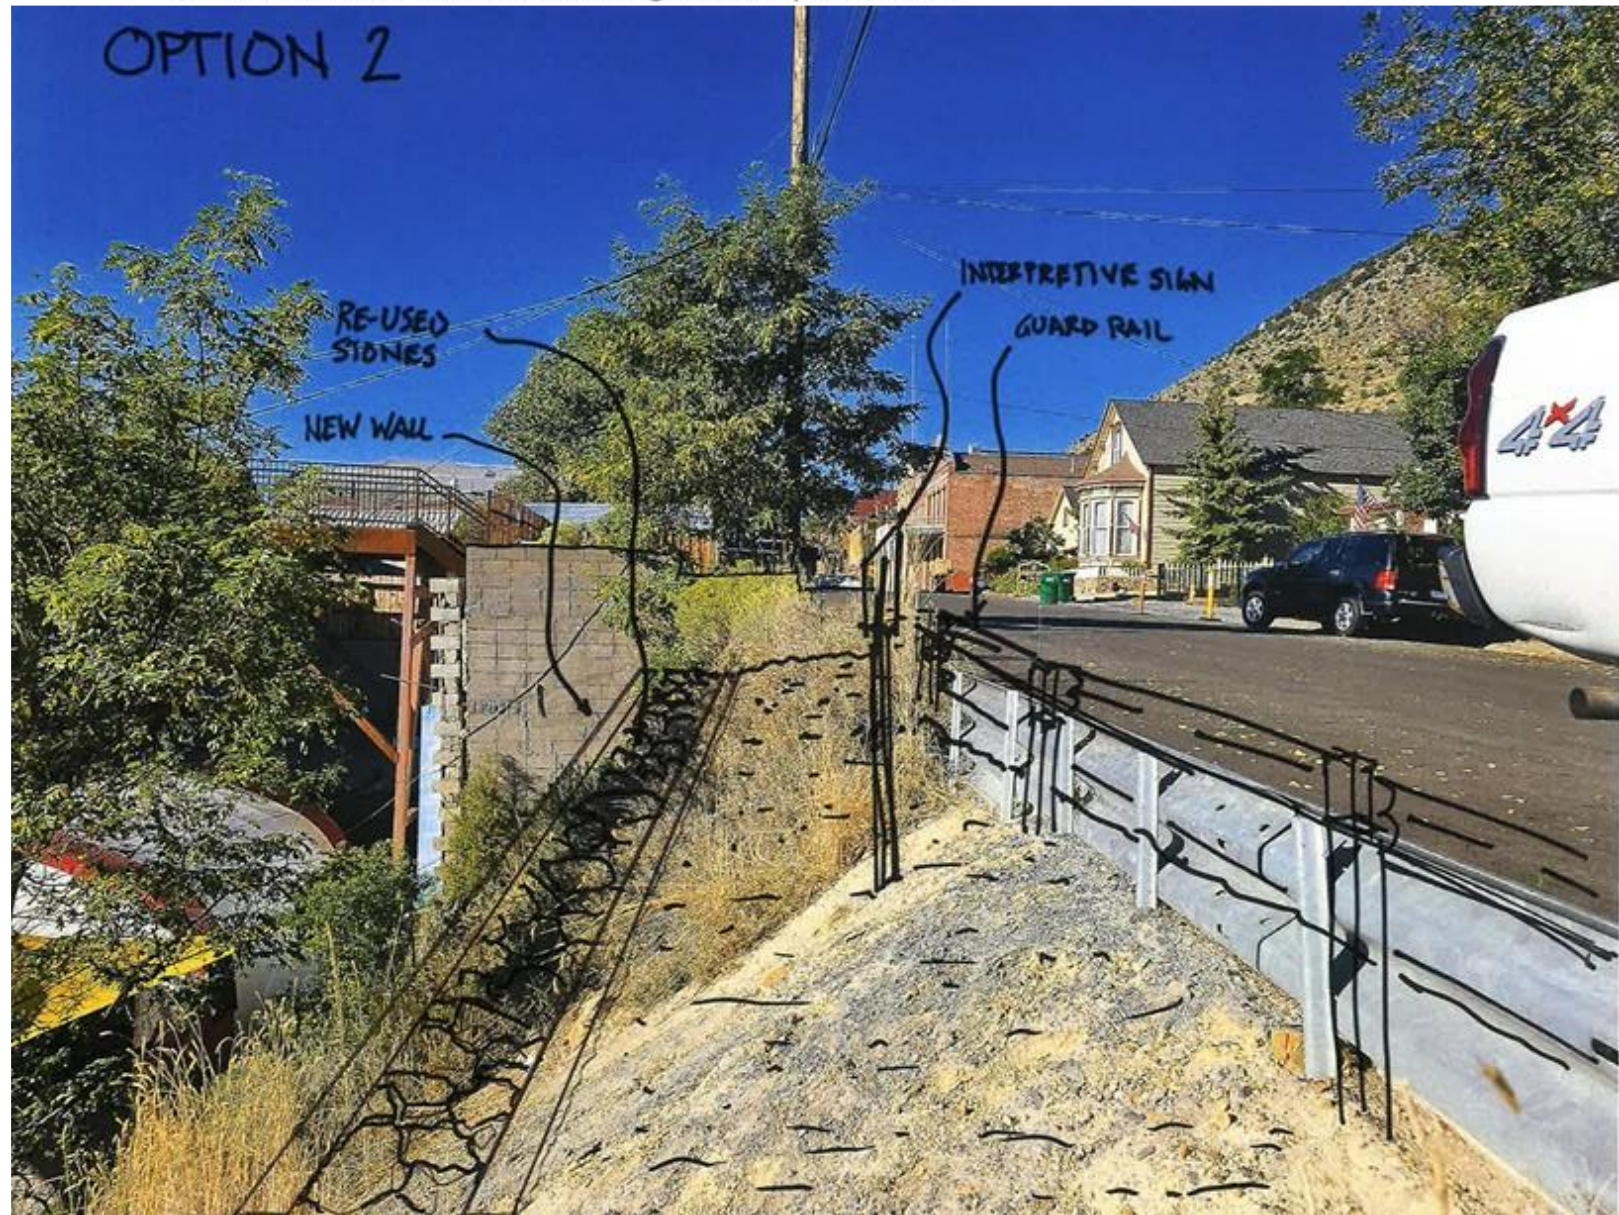
OPTION 2

Option 2 – we will use the stones at the top of the new retaining wall to illustrate the original location of the stone wall and what would have been the top of it (the building was wood framed from this point, upward). We will provide an interpretive sign to inform visitors of the significance of the site. We will also provide modern guardrail to prevent vehicle and pedestrian traffic from encroaching on the top of the wall.

RE-USED  
STONES

NEW WALL

INTERPRETIVE SIGN  
GUARD RAIL

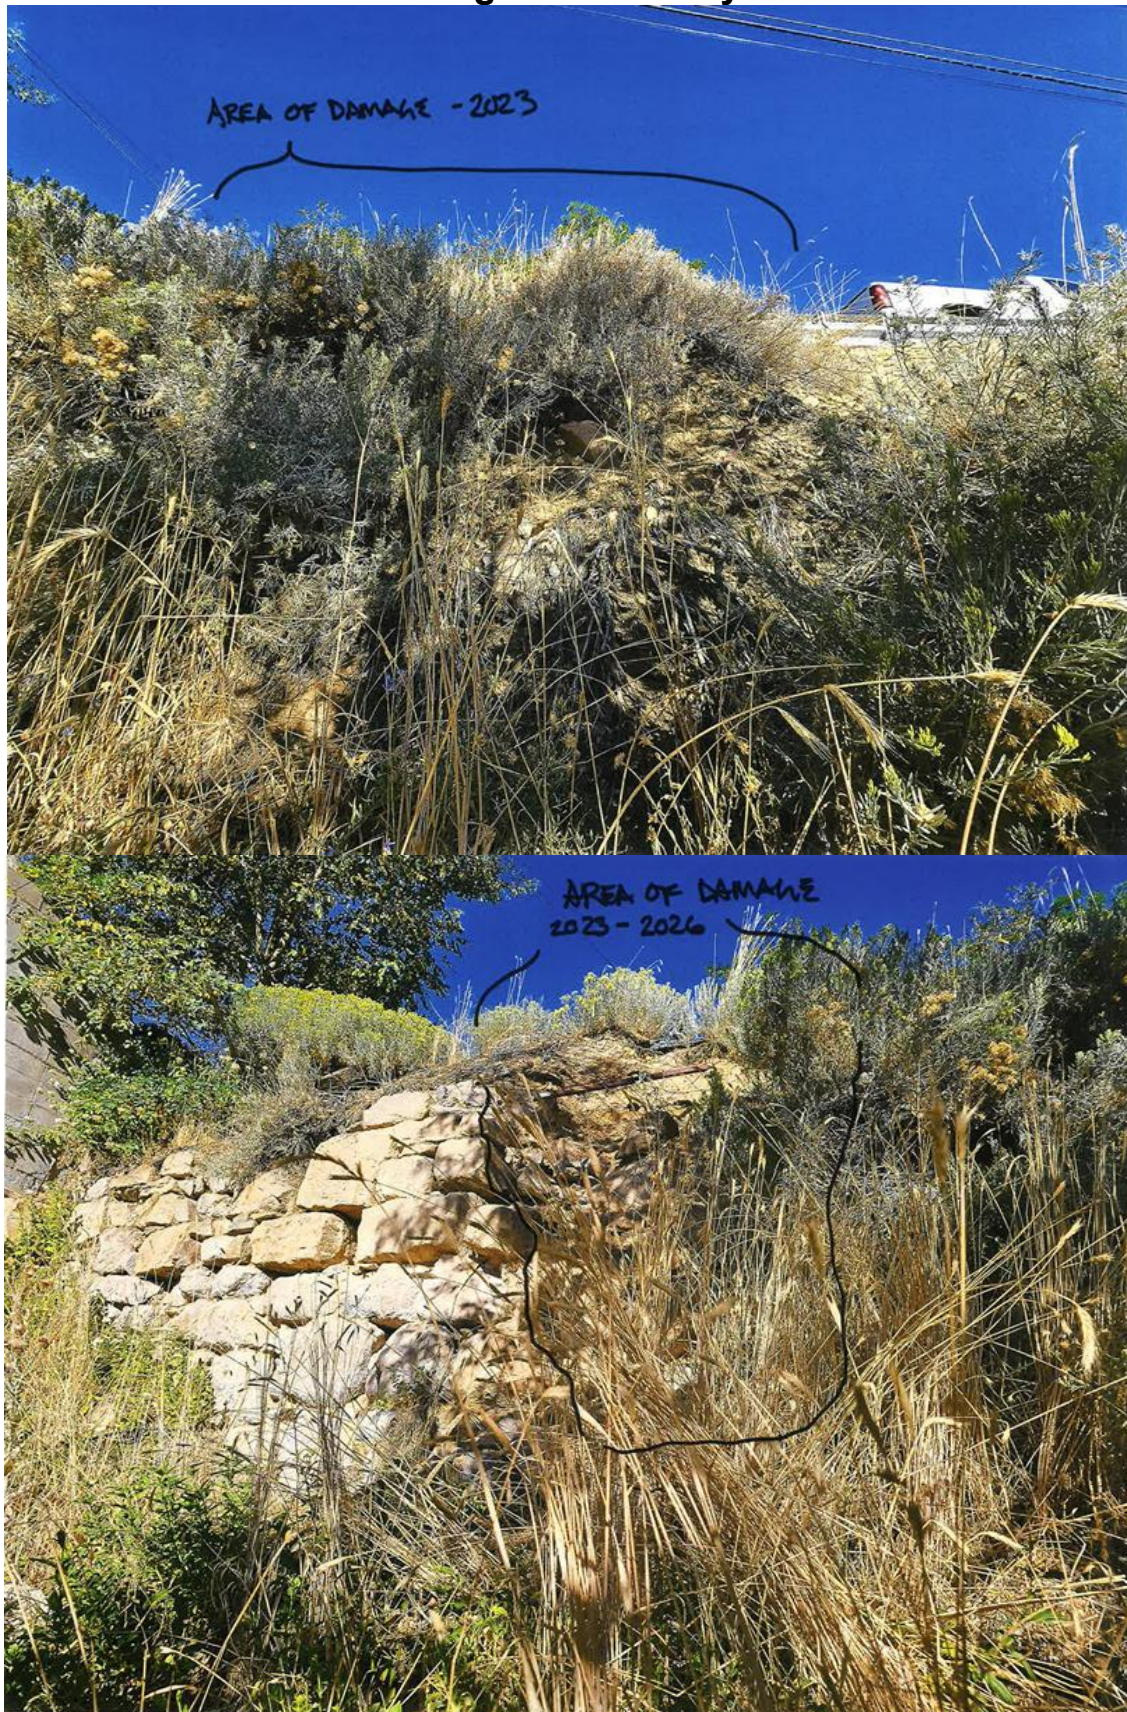
## 2023 Damage From Heavy Rain Event

The damage displaced multiple stones from the wall as well as loose soil from behind the wall and dropped those onto the patio area of the Red Dog Saloon. The stability of the hillside was clearly compromised, which endangers the public area below the wall and also B Street and the utilities within B Street.

As the board may recall, I was here several months ago to propose a repair methodology for the rockery wall behind the Red Dog Saloon. The reason for the repair was damage to the rockery wall from a heavy downpour event in 2023 – which I can go into in further detail if the board wishes.
