NEVADA COMMISSION FOR CULTURAL CENTERS & HISTORIC PRESERVATION (CCCHP) GRANT APPLICATION

Project Title: OLD SANCTUARY PRESERVATION

Our plan is to restore the original Historic First Presbyterian Church Old Sanctuary building to its grandeur, creating a gathering place for residents of Carson City to use and enjoy, and to instill an appreciation for Nevada History. The original sanctuary was completed in 1864 with the bell tower added in 1896. We request funding to Repoint the exterior of the two-story Bell Tower as the first phase of a multi-phase restoration plan.

See Attachment 5 – Melvyn Green & Associates, Inc. – Seismic Rehabilitation Report and recommendations for First Presbyterian Church Carson City, Old Sanctuary Preservation,

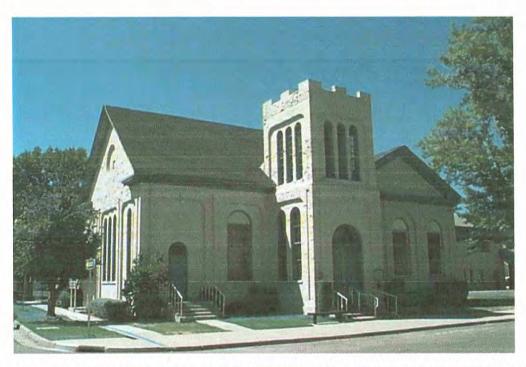
OLD SANCTUARY FRONT & BELL TOWER FACING NEVADA STREET - CURRENT PAINTED BRICK

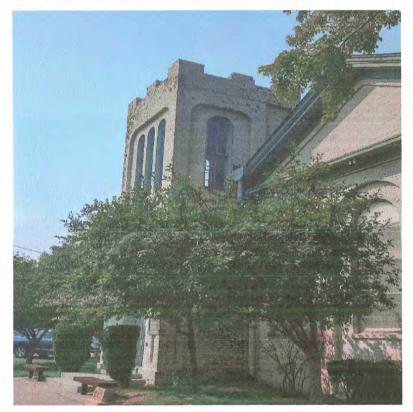
OLD SANCTUARY AND BELL TOWER NE – CURRENT PAINTED BRICK

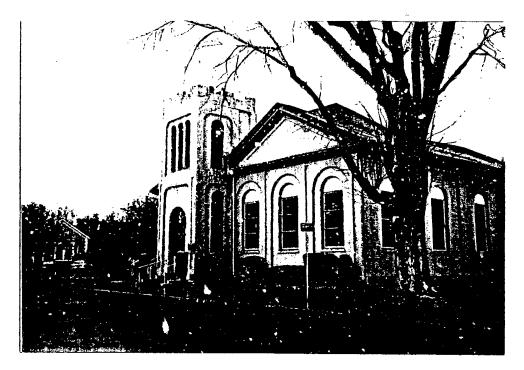
Photo 1. Front, east, elevation showing original church and tower.

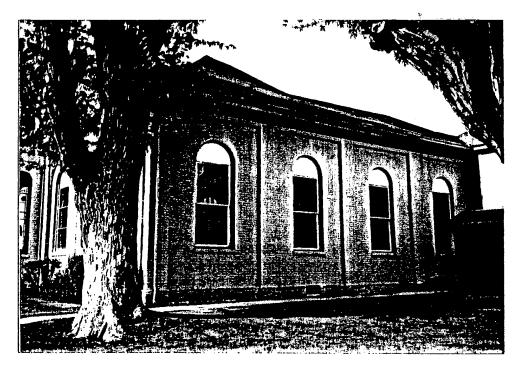
Photo 3. North elevation or original building.

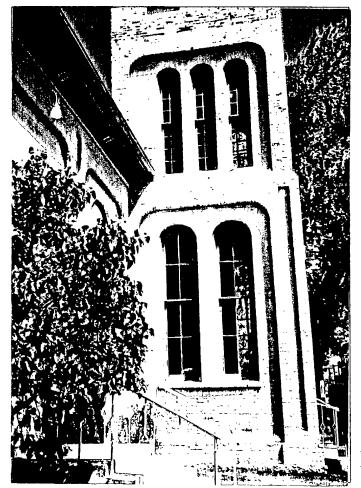
Photo 4. Elevation of tower showing architectural details.

The tower is a two story structure constructed of brick masonry walls. Walls at the first floor are 17 inches thick. Those above the first level are 13 inches thick. The floor and roof framing are conventional joist construction.

The tower will require bond beams at each level to tie the structure together. In addition anchor bolts must be installed at each level and the roof. It is recommended that this be done in the initial phase of the project.
