# NEVADA COMMISSION FOR CULTURAL CENTERS & HISTORIC PRESERVATION (CCCHP) GRANT APPLICATION

Project Title: Piper's Opera House Front Door Restoration Project  
 Project Type:  Rehabilitation/Construction  Planning/Construction  
 Architectural/Engineering Study/Construction

In March of 2020, Dubé Group Architecture (DGA) was retained by Storey County to prepare the following Amendment to the Historic Structures Report for Piper's Opera House, located at 12 North B Street, Virginia City, NV. This document is intended to update the existing conditions and recommendations contained in the Historic Structures Report prepared by van Dijk Westlake Reed Leskosky in 2002.

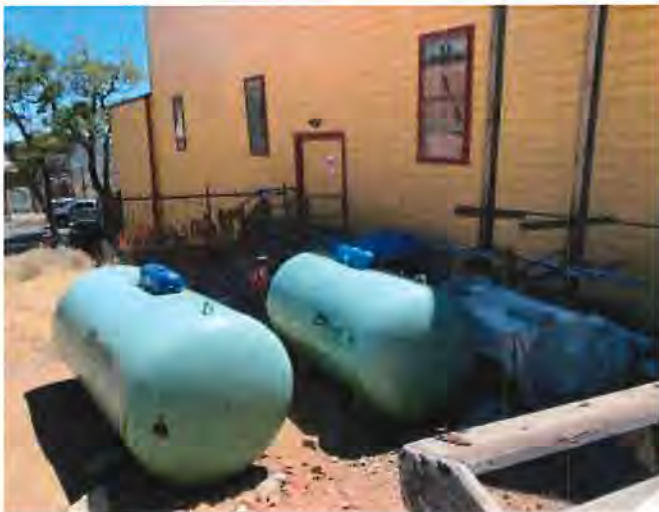
The heating system's fuel source is now propane, which feeds a single boiler. Two propane tanks are located on the north side of the building, at the second-floor level. The piping is routed on north face of building to boiler room. A regulator is installed just outside of the boiler room.

Photo 1 Propane Storage Tanks on north side of Piper's Opera House

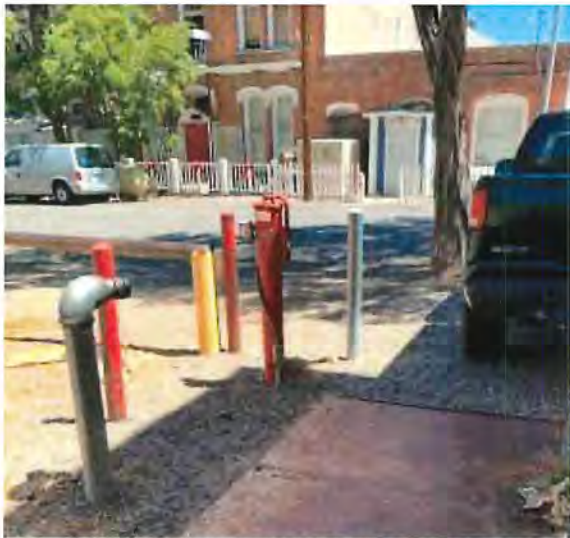
The Piper's Opera House did not include any provisions for fire protection of the structure as witnessed by the three fires that occurred during the early days of this building's lifespan. In 1999 a wet fire sprinkler system was added to the structure. A fire department connection and post indicator valve are located outside on the northeast corner of the property. The service entrance is on the first floor of the north side, just to the west of the elevator. This riser is 4" in size and connected to the fire alarm system via a flow switch. The system serves all levels of the building including the attic space. This system has an incoming water pressure of 130 PSIG and adequately serves the building. The only modifications necessary to the system would be because of any remodels. Annual inspections of the system are required by the fire code to ensure it is in proper working order.

Photo 2 Fire Department Connection and Post Indicator

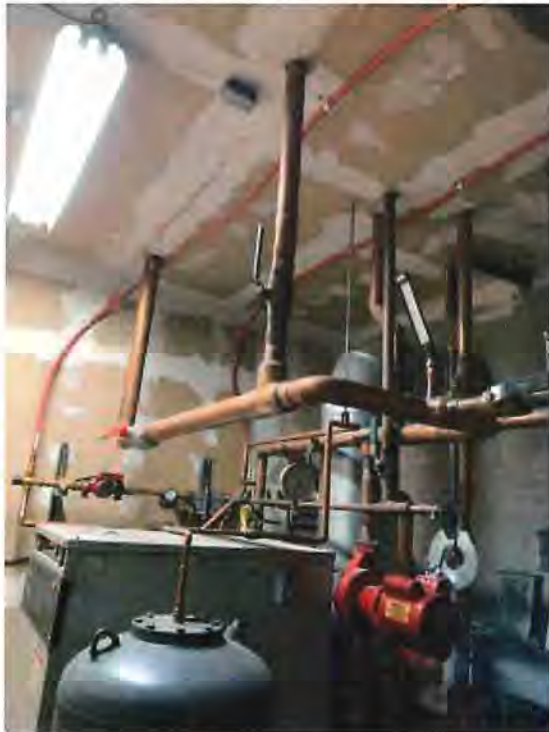
The current HVAC system includes a propane-fired, fin tube boiler that feeds a hydronic loop and various point of use heating and cooling systems. The boiler and associated system were installed in 1999. This heated water loop serves a radiant floor heating system on the first level (B Street) at the main entry. The hydronic system is distributed around the facility and is connected to multiple hydronic fan coils located in the following rooms: first floor corridor, two in the auditorium, and kitchen. These fan coils

Photo 4 Boiler and Hydronic Equipment

The appendix to the previous Historic Structure Report proposed the use of hydronic heat and distribute to terminal devices for delivery of heat through air to each space. The actual type of heater was noted to be subject to discussion and agreement for each room depending on practical and aesthetic factors. This approach is still the most viable approach for heating the facility. Radiant floor heating should be entertained for the auditorium

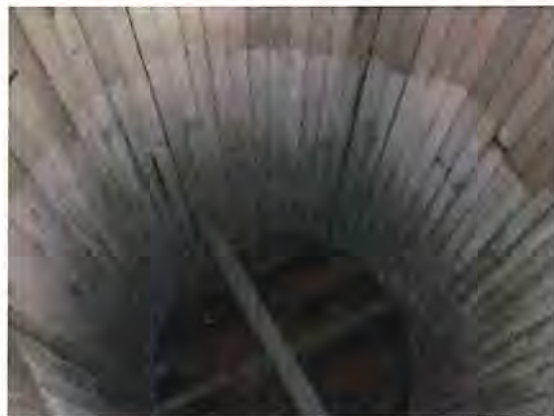
Photo 5 Existing Ventilation Shaft from Auditorium

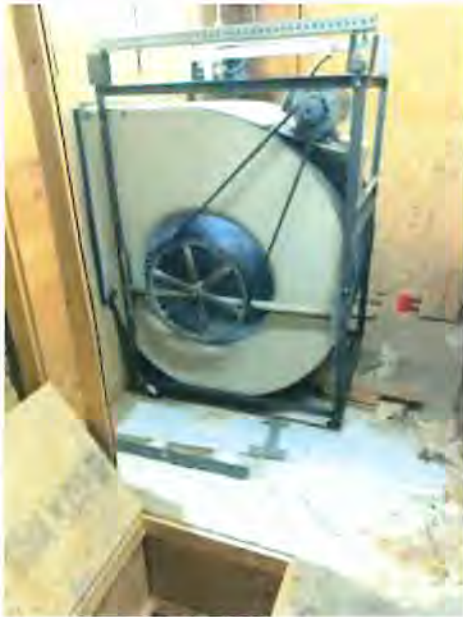
Photo 6 Exhaust Fan in Attic

The existing 7,000 CFM exhaust fan should remain and be interlocked to operate with the evaporative cooler or makeup air unit.

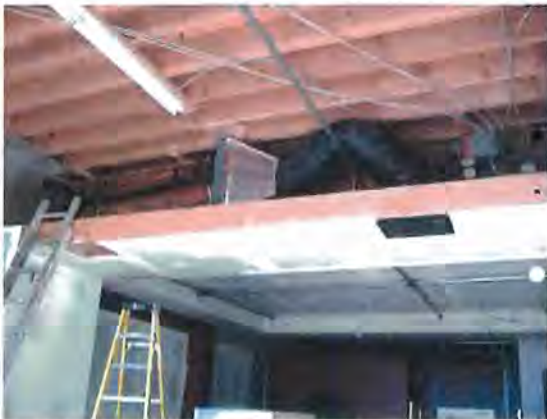
Photo 7 Heater above Old Corner Bar ceiling

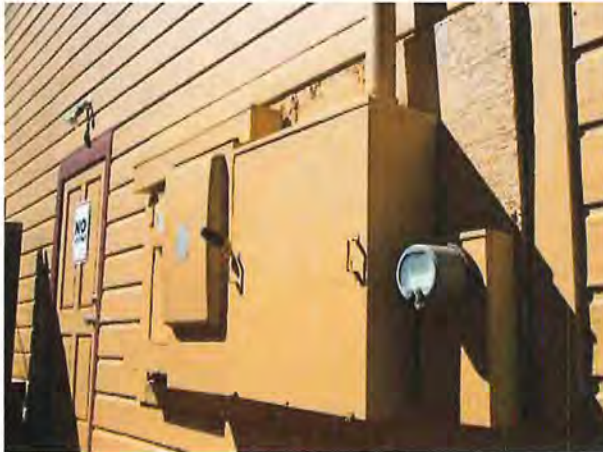
The existing electrical service is on the exterior south side of the building. The service is 120/208 volts, 3-phase, 4 wire, 400 amps disconnect switch, fed overhead from an NV Energy power pole at the southeast corner of the building on "B" Street. This service then distributes to the interior panels. This service currently seems adequate for the limited power usage of the building, but any major added power requirements will probably require the service to be upgraded. An electrical load study should be done first to determine the power loads of the existing building.

Photo 8 Existing 120/208 volts, 3 phase, 4 wire, 400 amp electrical service on south auditorium elevation

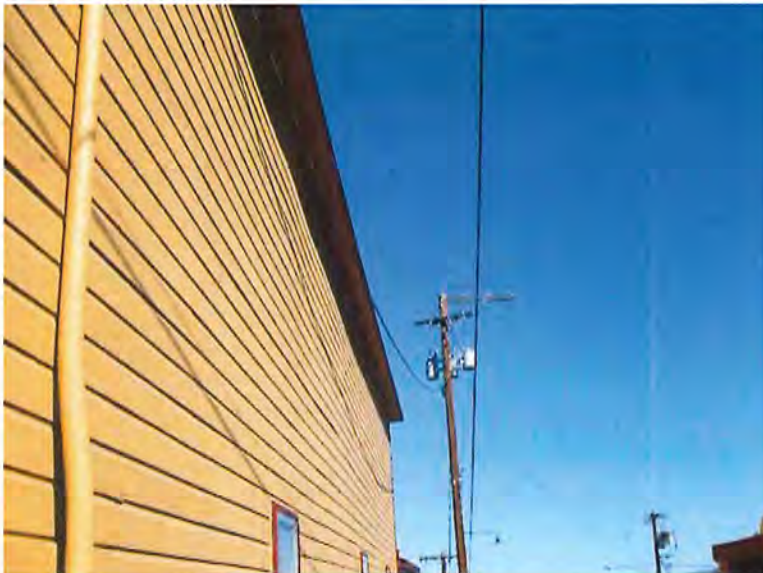
Photo 9 Existing electrical overhead service from power pole at B Street

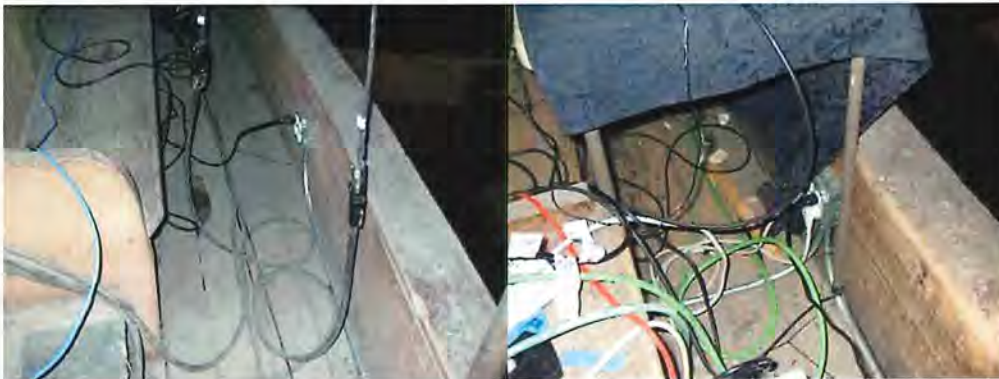
The Balcony is provided with some electrical boxes and conduits to provide 120-volt power outlets on the Balcony. Extension cords and cable are laying along parts of the Balcony floor that make for tripping hazards for someone trying to walk in the Balcony. Additional power outlets should be provided to minimize or eliminate these cords and cables.

Photo 10 Extension cords and cables lying about in the balcony

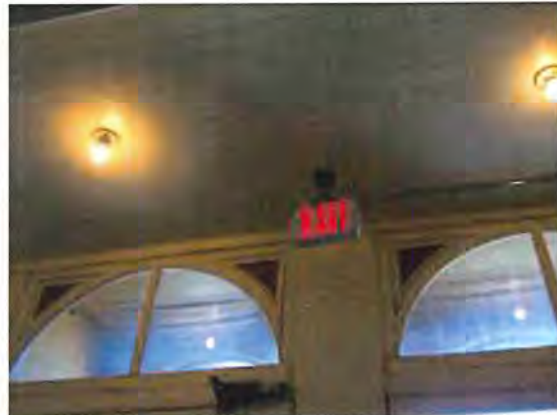
Photo 12 No emergency light at Main Entrance

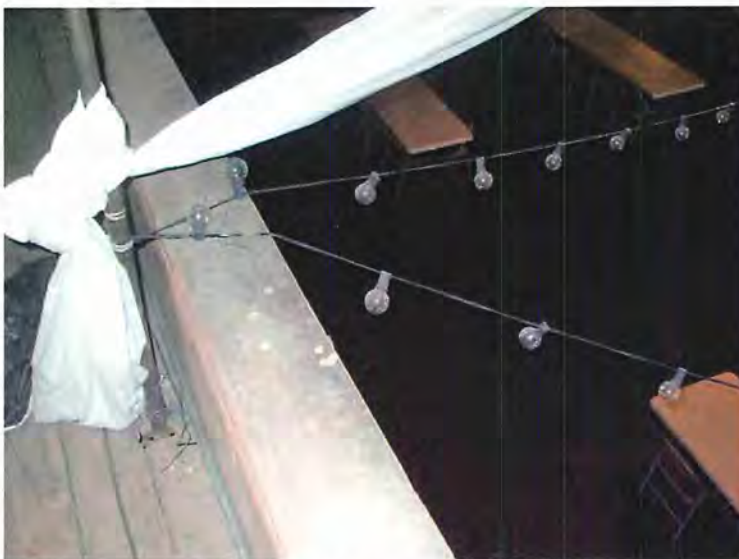
Photo 14 Auditorium – string lights hung from Balcony

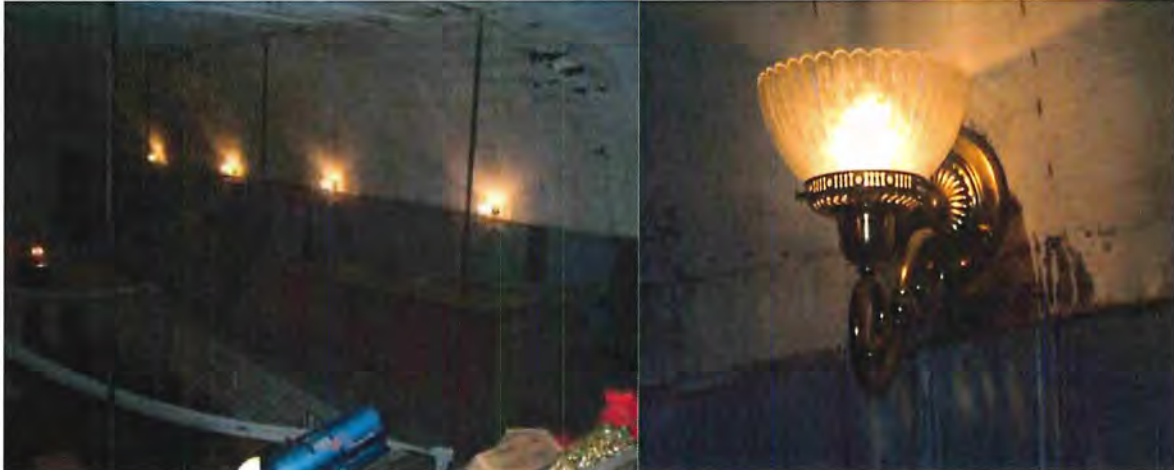
Photo 15 Balcony wall sconce lights

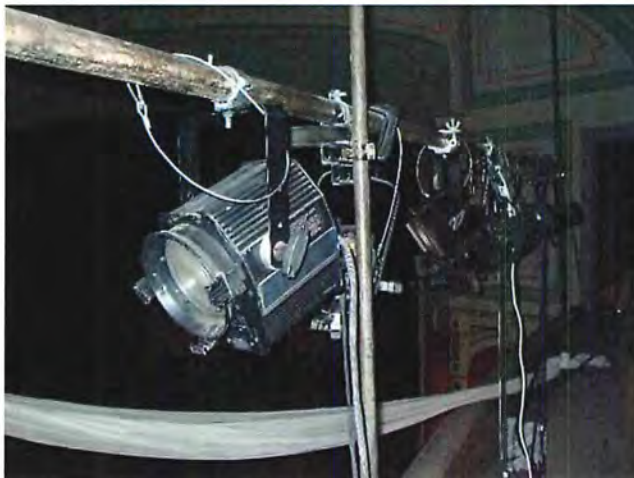
Photo 16 Balcony stage lights and pipe rigging

A stage lighting system was installed in 2008 that includes piping and lights on the north and south sides of the Balcony. The lighting control console is also located in the Balcony to provide a good view of the Stage. This location is at the bottom of the Stairs down to the lower row of the Balcony and would be in the way for people to occupy the Balcony.

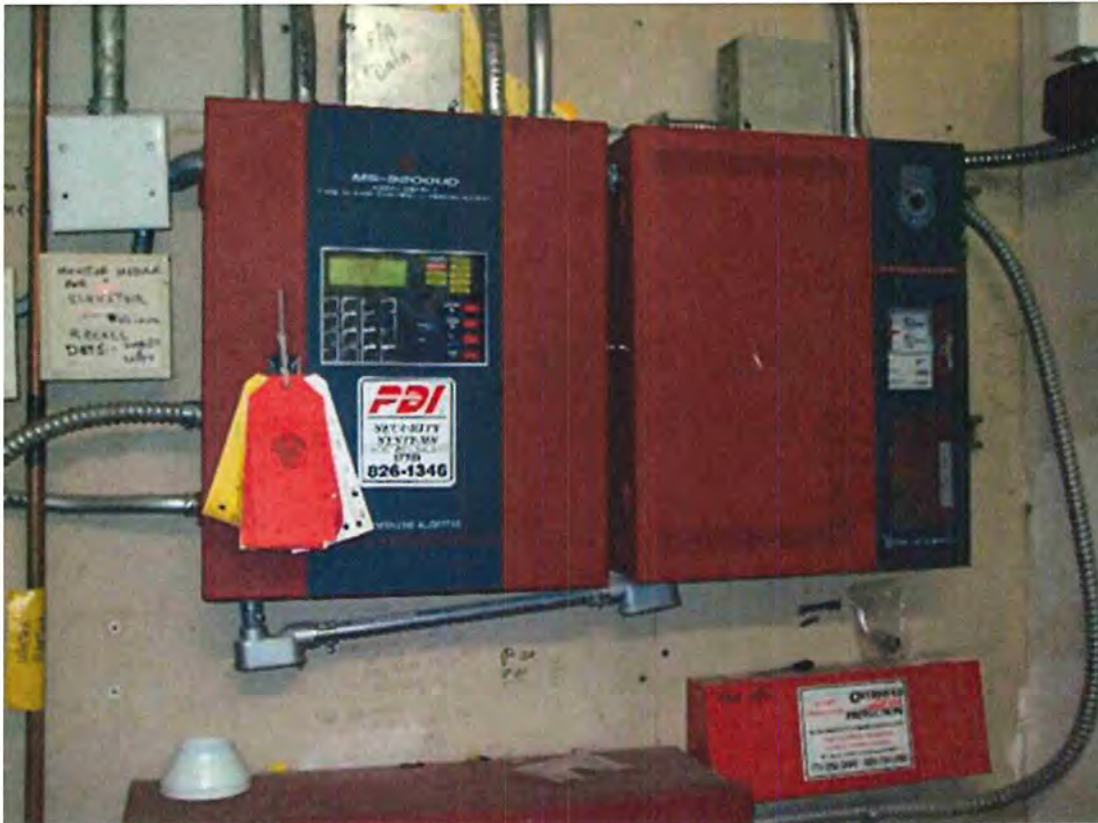
The building is provided with an addressable fire alarm system by Fire-Lite Alarms. The fire alarm panel is in the Fire Riser Room. The system provides supervision of the fire sprinkler system flow and tamper switches and fire alarm audio/visual devices are provided throughout the building and appear to be adequately provided for alerting Building Occupants in case of an alarm. Smoke detectors are provided in the Lobby areas of the elevator to provide recall operations. The system with a voice evacuation feature. The system has been recently inspected and tagged in compliance with the State Fire Marshal.

Photo 17 Existing Fire Alarm panel in Fire Riser Room

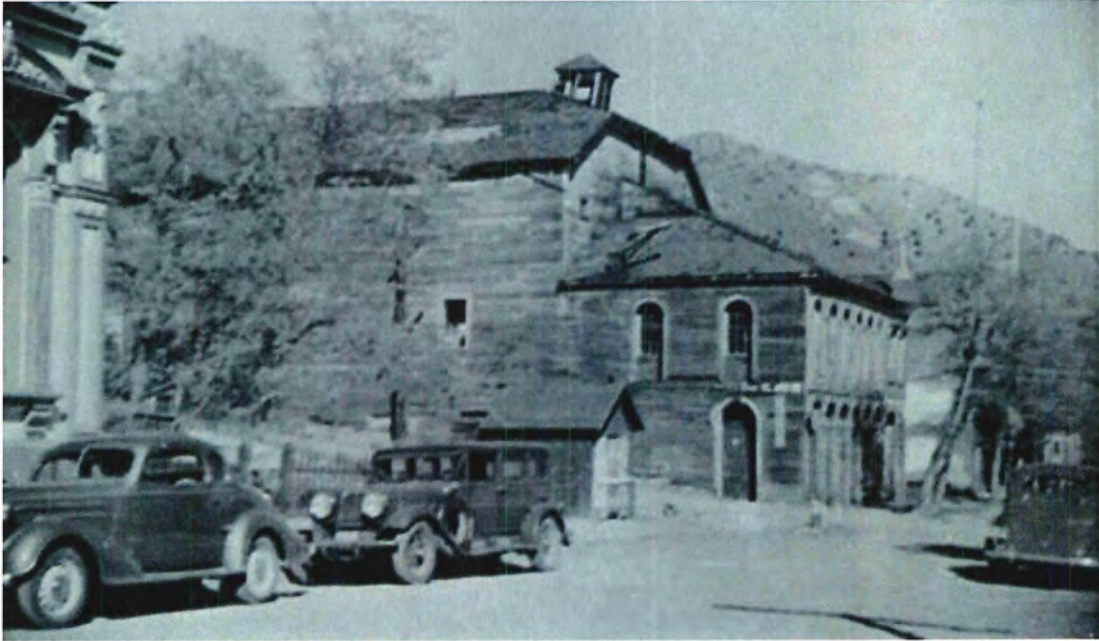
There has been discussion in the past about reconstructing the hip roof ventilator (cupola) on the east slope of the upper roof. As noted in the HSR, "A ventilation shaft was placed above the balcony. The shaft extended through the attic area, opening directly into an exterior ventilator. This feature had louvers on all sides, and a shallow hip roof. The rooftop element has been removed, but its size and appearance is sufficiently documented in photographs and in the roof framing to enable accurate reconstruction". If the ventilator is reconstructed, it could be incorporated into a new exhaust air system as discussed in Section F Part 3.0 HVAC.

Photo 18 Hip roof ventilator, circa 1939

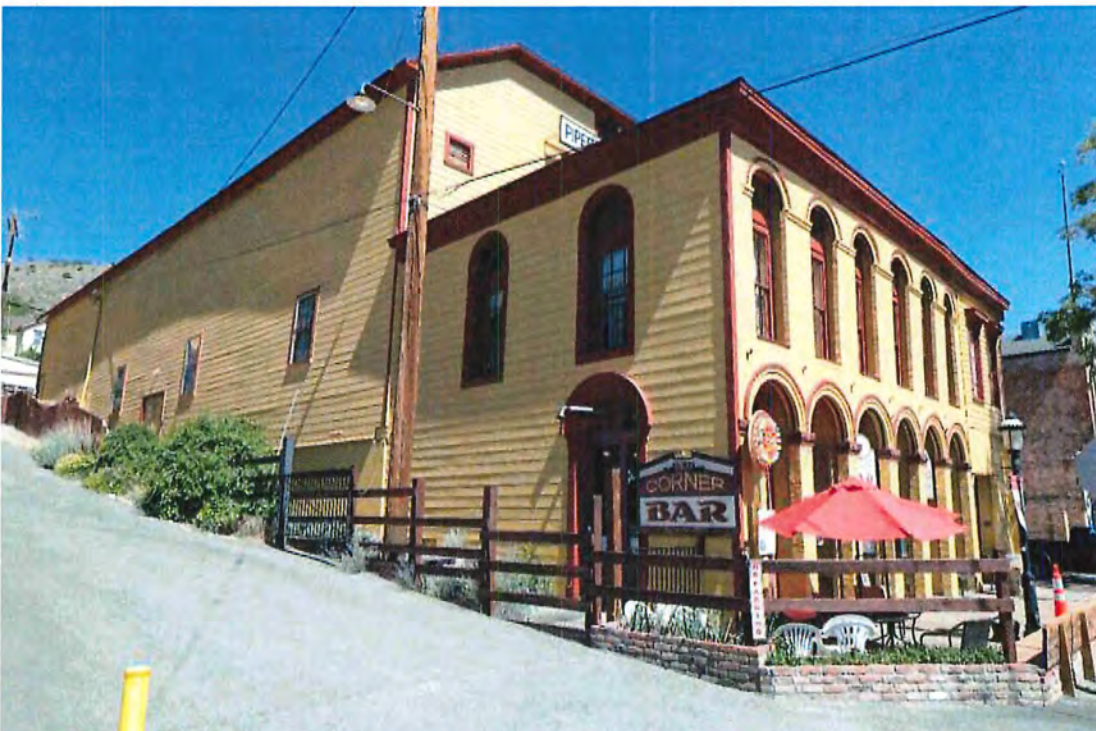
Photo 21 View looking northwest from B Street. Shiplap siding covering brick on south elevation of 1863 building. Flue coming out of arched window vents pellet stove used to heat Old Corner Bar. Seven doors with archways and eight second level windows (facing south and east) were refurbished in 2003. Note high window facing east in upper balcony.

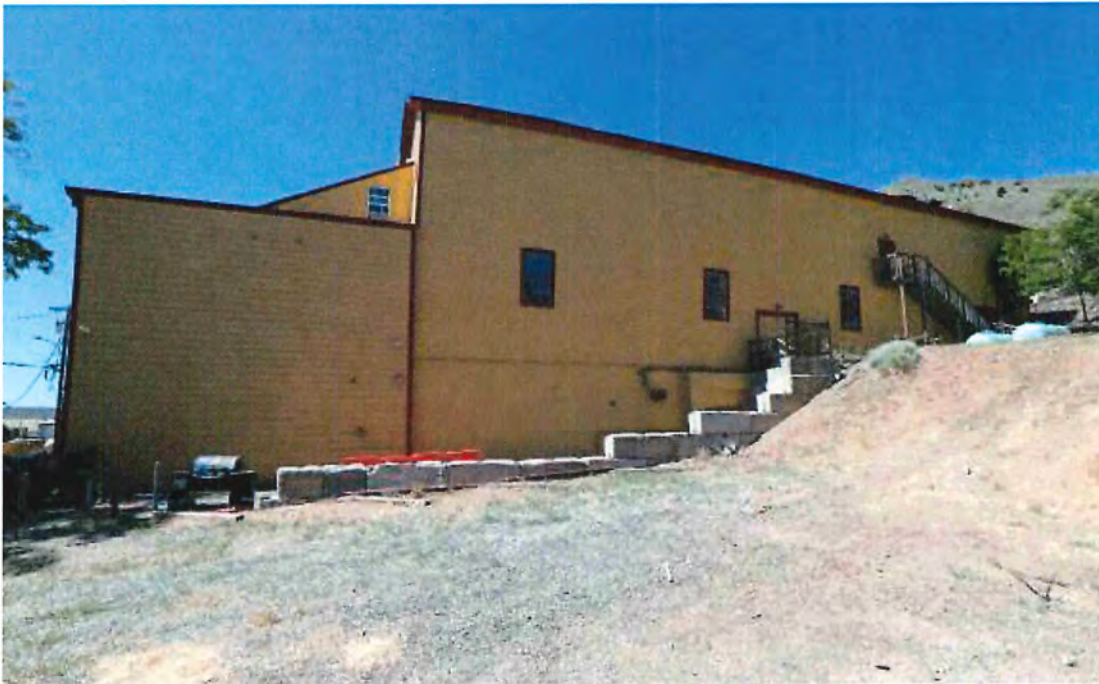
Photo 22 View from B Street looking south. Note eight openings – window in tech office, three windows in auditorium, basement egress doors (visible beyond retaining wall), 1970s oversize egress doors, upper balcony egress door, and stage egress doors (far right in photo)

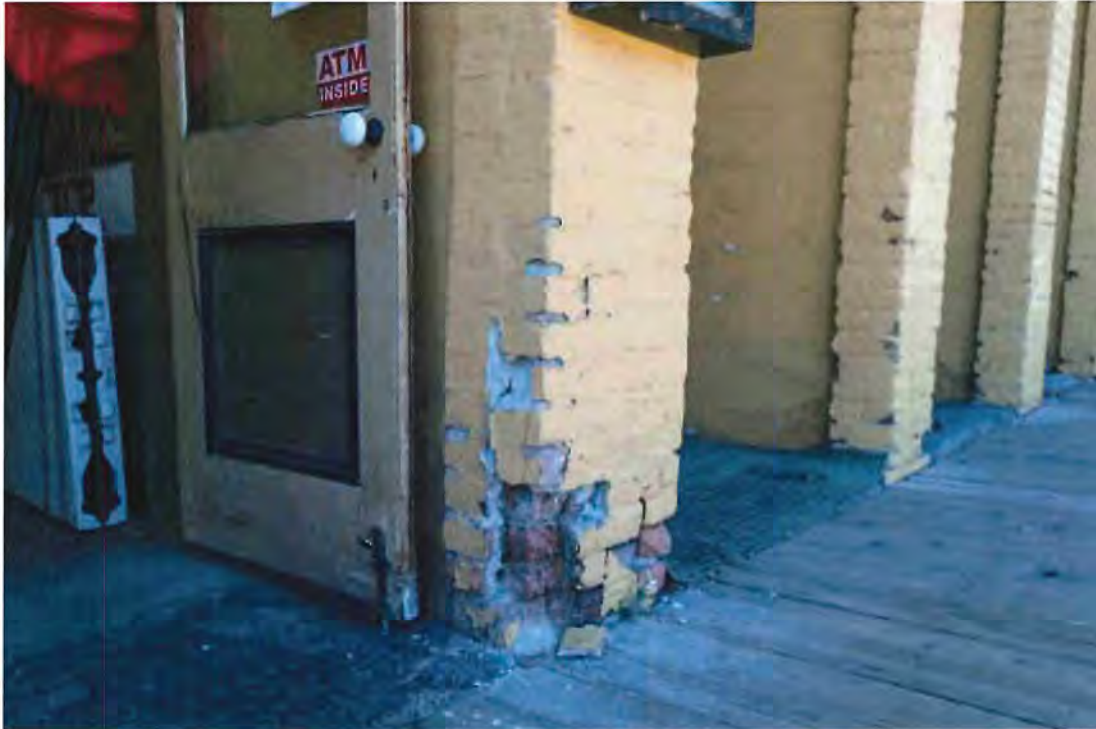
The van Dijk Westlake Reed Leskosky drawings indicated columns and capitols were to be rebuilt and repointed. However, there has been recent damage particularly near the base of the columns flanking main entry to Old Corner Saloon and Piper’s Opera House.

Photo 24 Damaged brick column on B Street façade at entry to Old Corner Saloon

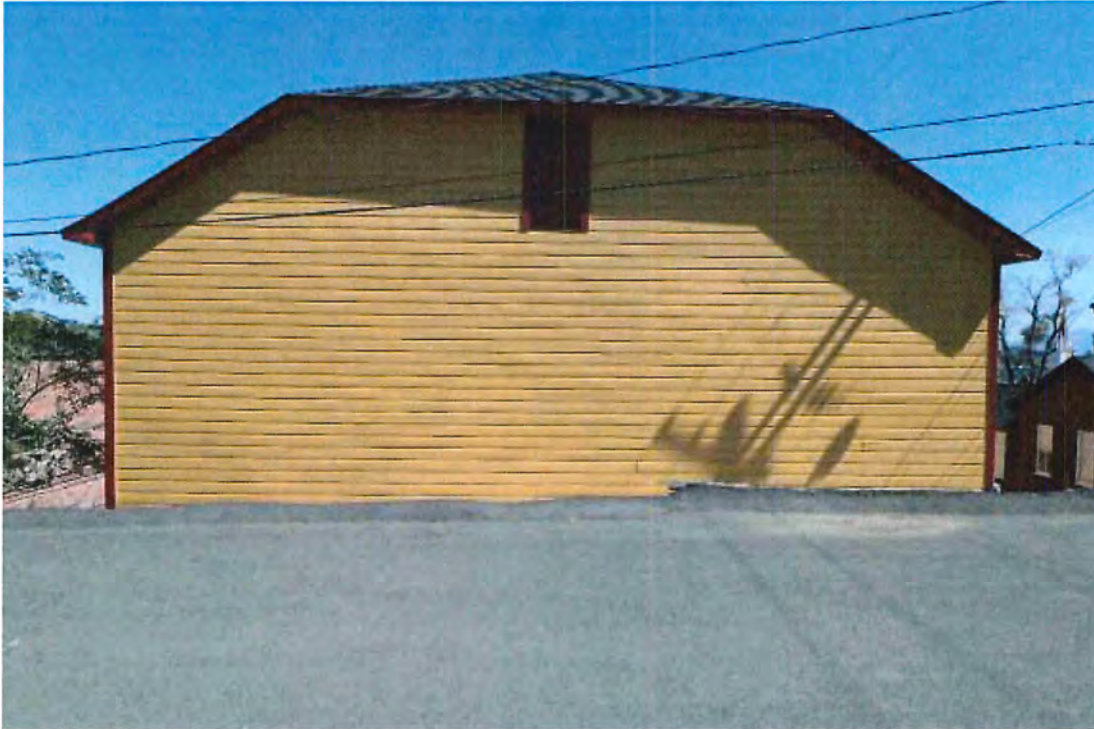
The shiplap siding is in good condition and was recently repainted (2016). Northern Nevada's dry climate, hot sun, and seasonal temperature swings are tough on painted wood surfaces, which require repainting every 7 to 10 years.

*Photo 25 West elevation from A Street looking east. Door above stage provides additional attic access. Siding was replaced over new plywood sheathing.*

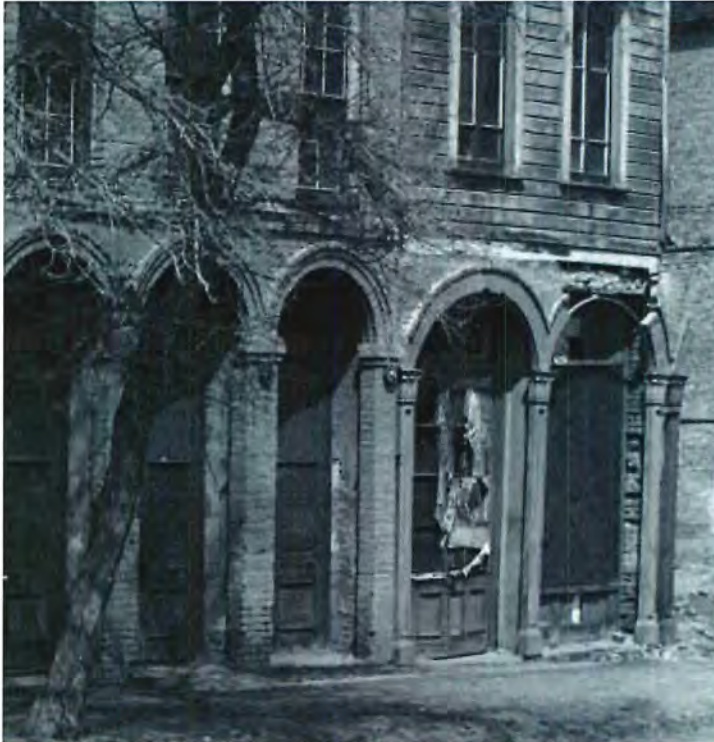
Photo 26 Four cast iron piers visible in photo to right. Pier at north end appears to support adjoining building which has been demolished

Two cast iron piers have been fastened in place, primed, and painted. They are in good condition. The remaining two piers are displayed in the corridor alcove on the basement level and should be retained on site for interpretive purposes.

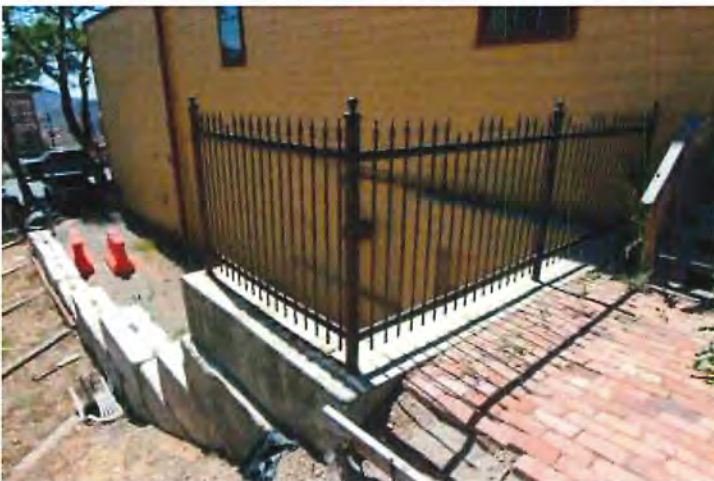
Photo 27 Note missing finials

The wrought iron railing is in good condition except for 10 missing finials, which should be replaced.

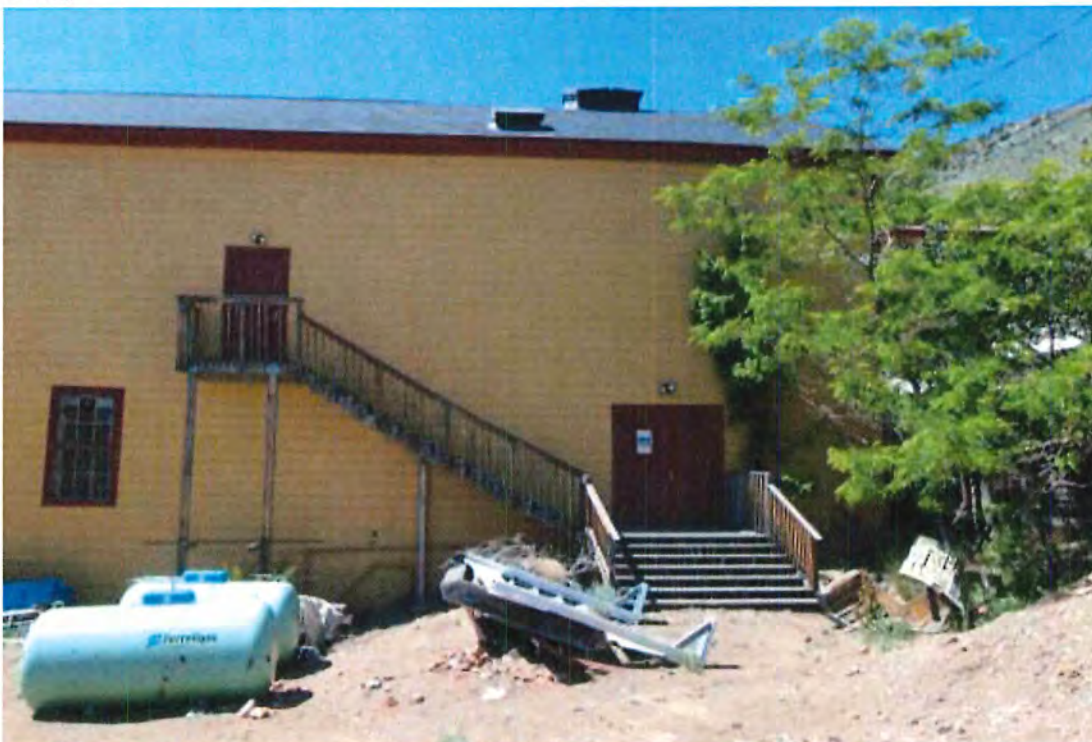
Photo 29 New exit at north balcony and stage left with staircase and landing constructed 1999

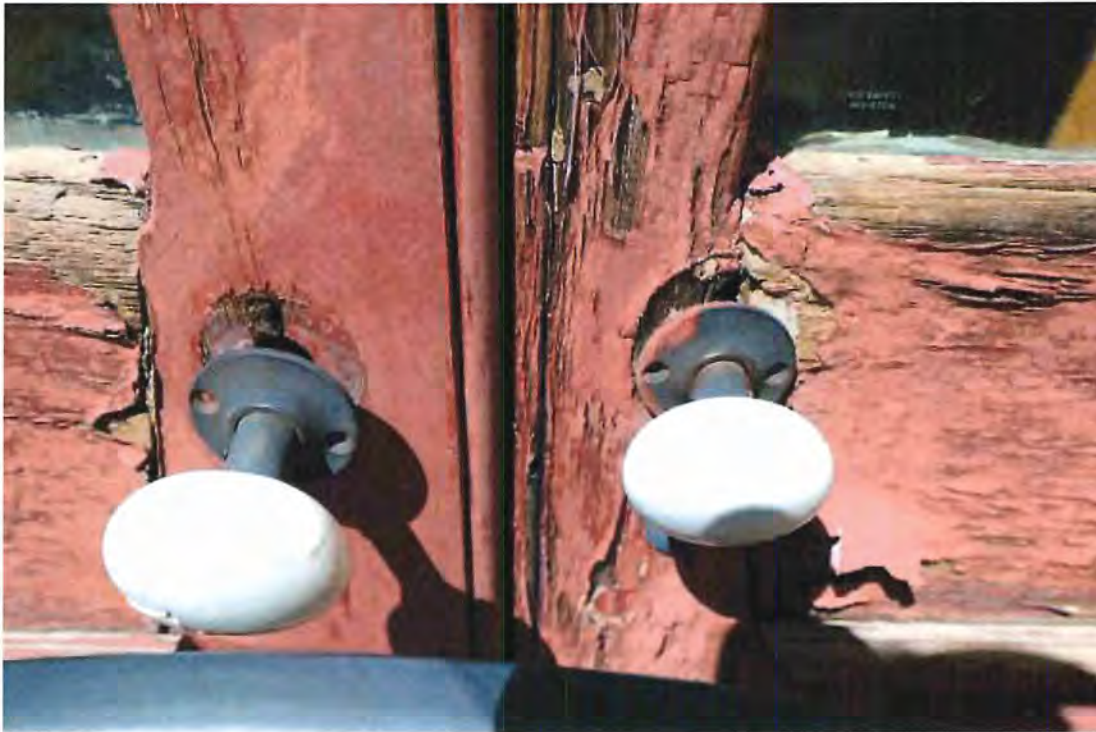
The doors are in fair to poor condition. It is recommended they be refurbished and re-painted. There is an immediate need for maintenance repairs - some of the hardware needs to be re-attached.

Photo 30 Main entry doors at B Street. Screws missing at door knob escutcheons. Paint peeling.

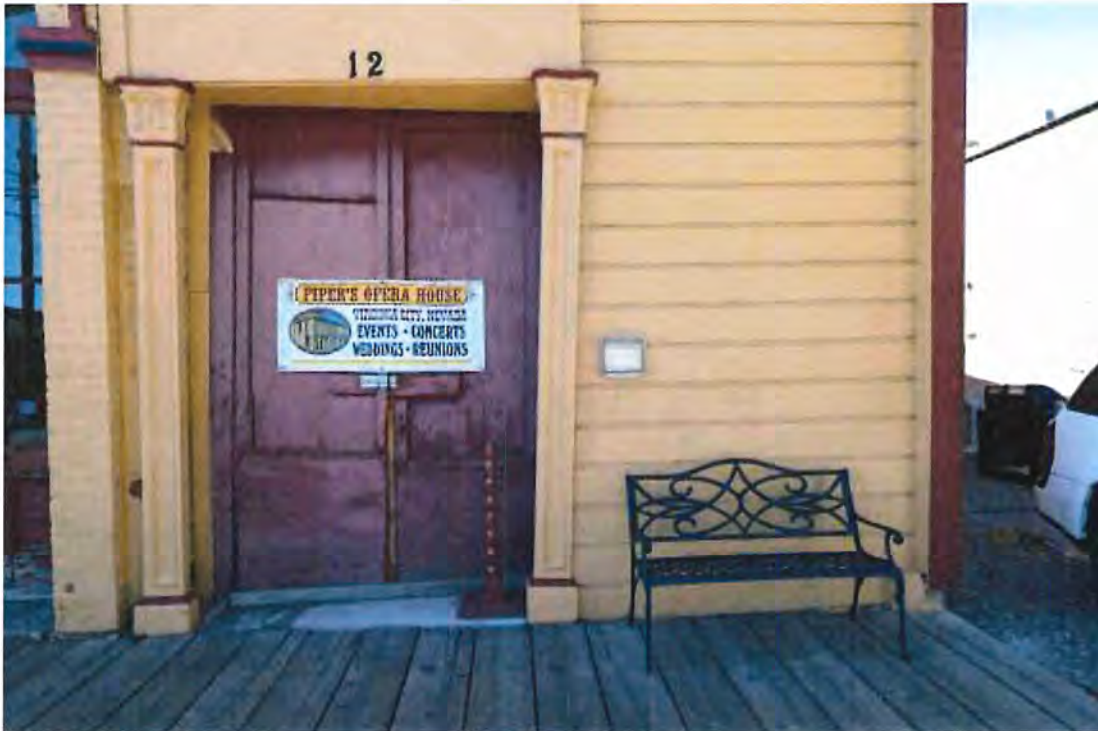
The carriage house double doors and transoms were not rebuilt. One of the archways is flanked by cast iron piers and the doors are visible, although in poor condition and inoperable; there is a plywood panel covering the transom. The other archway has been completely covered and the opening obscured with shiplap siding installed and painted to match the second floor. It is recommended that the extant doorway be refurbished including double doors with arched transom.

Photo 31 Carriage House doors. Note the cast iron piers. Doors are in poor condition and arch obscured by plywood panel

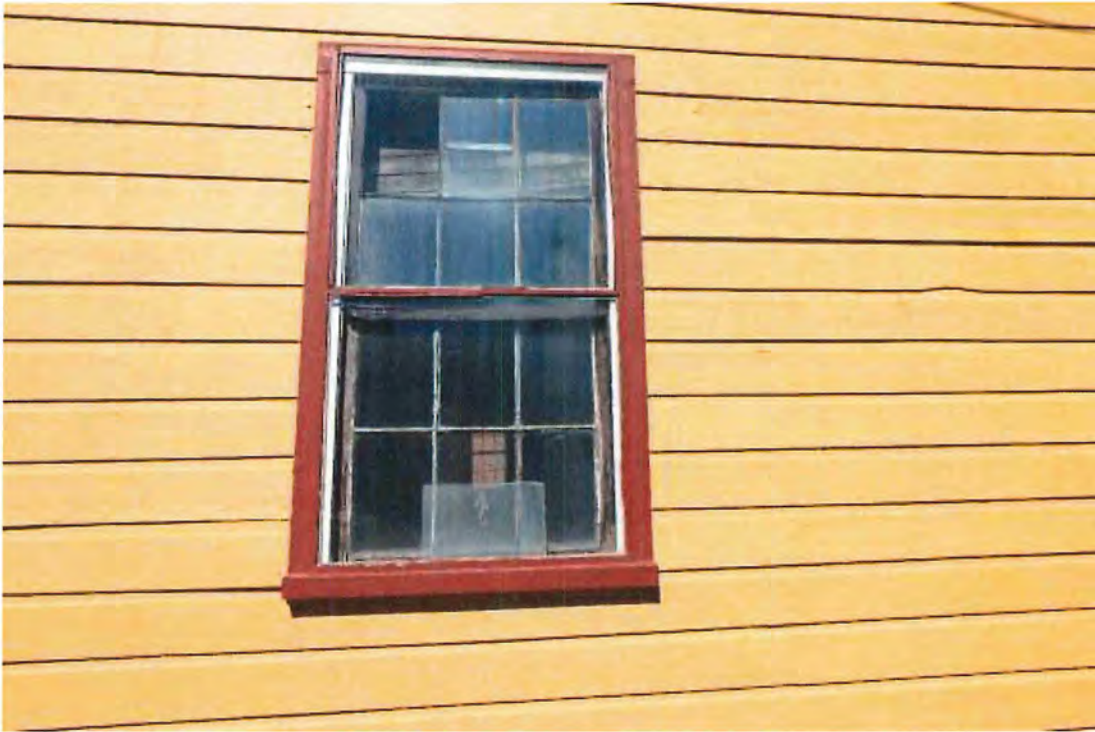
*Photo 32 Exterior mounted 1 over 1 storm window, typical of three on south side and three on north side. Note deteriorating condition of window sashes beyond.*

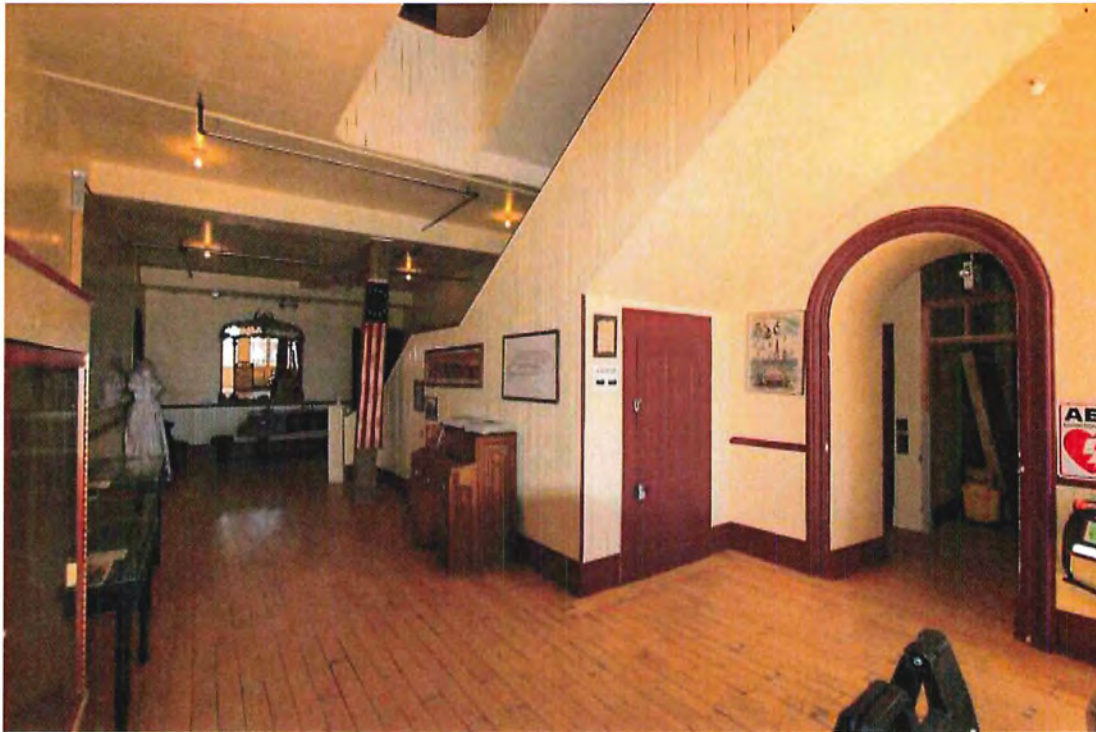
Photo 33 B Street lobby looking west. Walls are plastered and painted with bead board wainscoting and cap. Wood ceiling with soffits to hide piping. Wood column in middle of photo leaning. Stairs complete. New maple flooring over hydronic heating tubes. New director's office visible through archway.

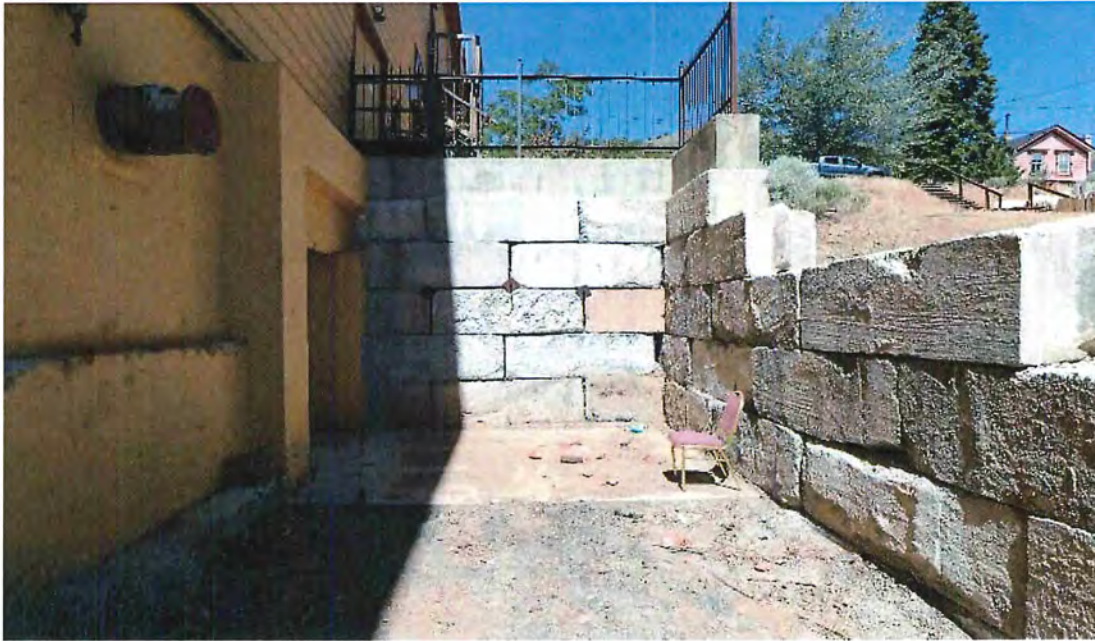
Photo 37 Excavation at north side for access to double egress doors. Existing concrete pad with snow melt system. Pour new 3 inches of a/c pavement over 6 inches of compacted aggregate base from edge of concrete pad to B Street

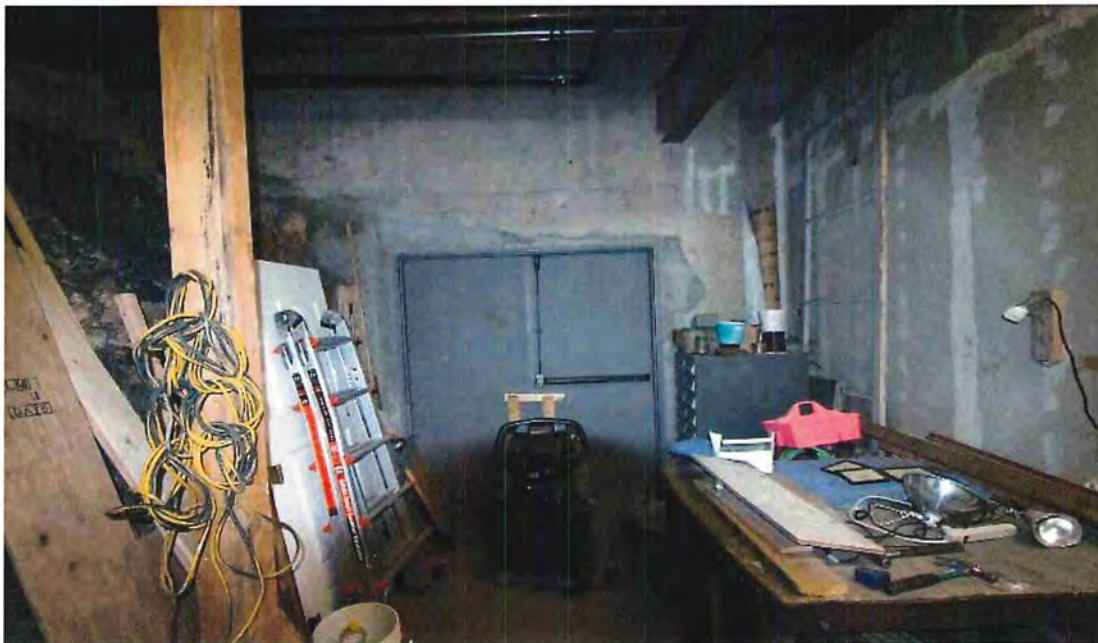
Photo 38 View of double egress doors looking north. Note blocked exit. New partition wall will align with the footing supporting the column.

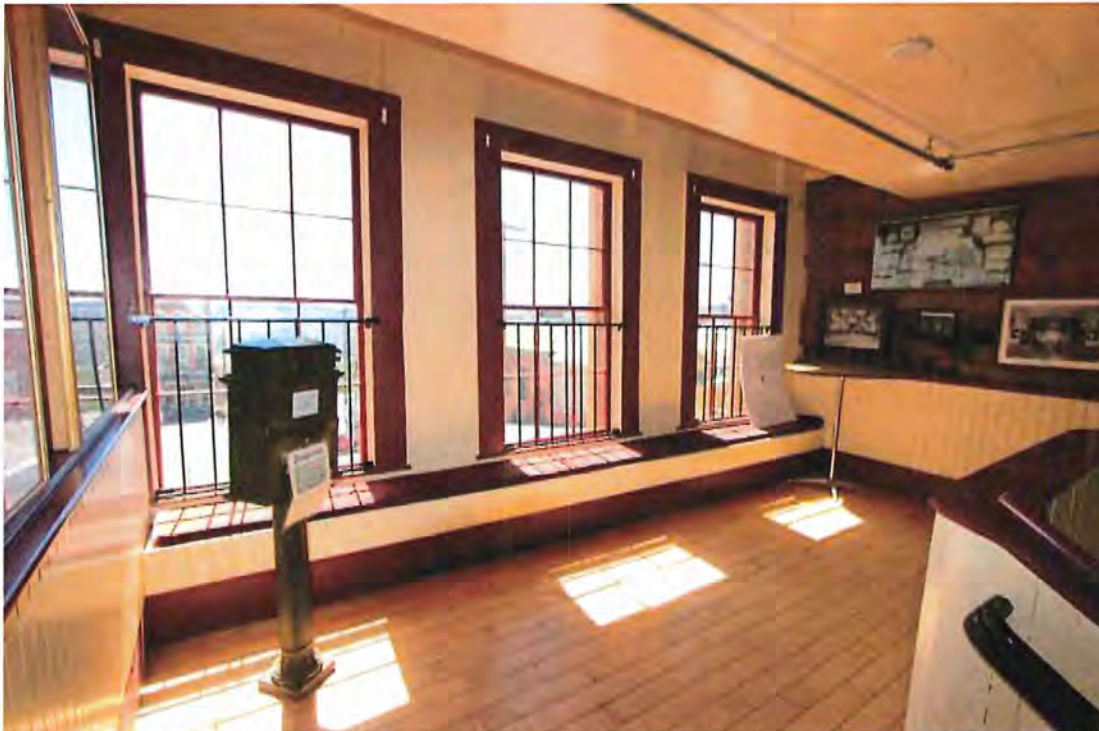
Photo 39 Looking east at auditorium lobby landing. Grills were added for fall protection. Salvaged lumber exposed above wainscot.

The north wall exposed sheathing, shown in Photo 39 is part of the historic fabric and should be protected in place. That wall, which separates the kitchenette from the Auditorium lobby, has two openings, a ticket window and a weapons check window. Both are character defining features and should be protected in place.

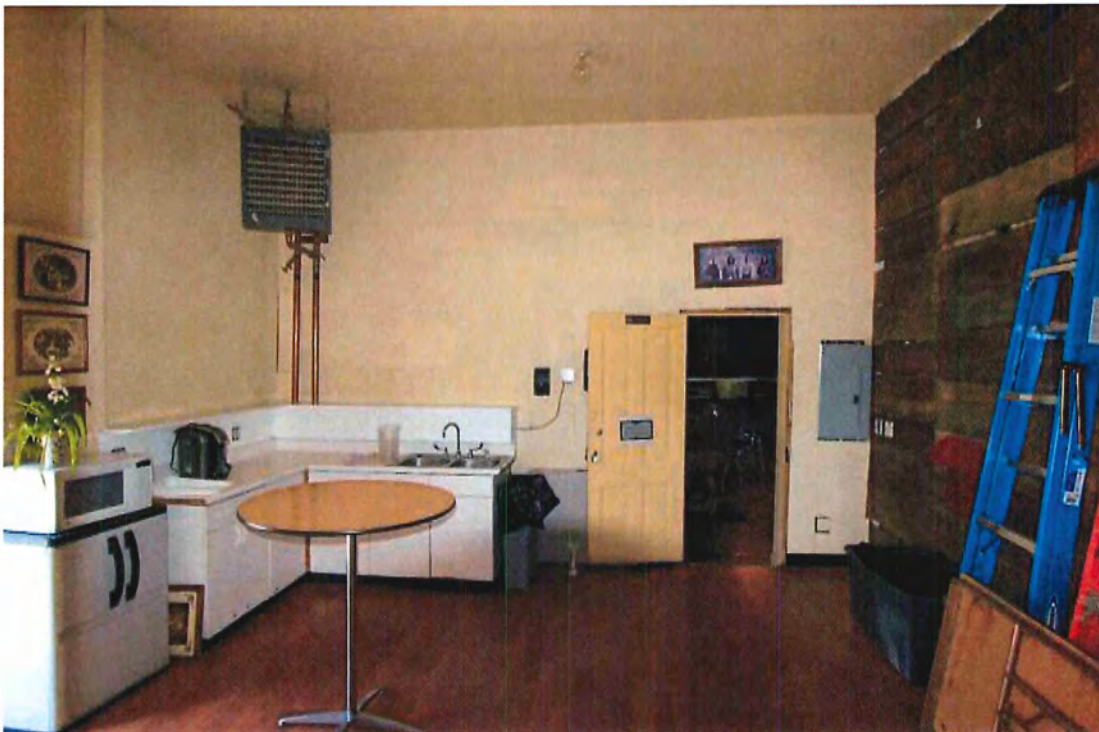
Photo 43 View of existing kitchenette looking west. Auditorium visible through open doorway. Exposed wall sheathed in salvaged lumber shown on right side of photo should be protected in place and left exposed for interpretation or covered with fabric and new wall paper attached. Electrical subpanel to right of doorway. Fan coil unit for heating in kitchenette and adjoining Bridal Room. New flooring overlaid on existing wood floors

The kitchenette occupies a room roughly 16' x 18' measured from interior face of the walls with a ceiling height of roughly 11'-6" above finished floor. There is a two compartment sink set into an L-shaped plastic laminate countertop with laminated base cabinets, a microwave, two residential refrigerators with freezer compartments, and a couple of café tables.

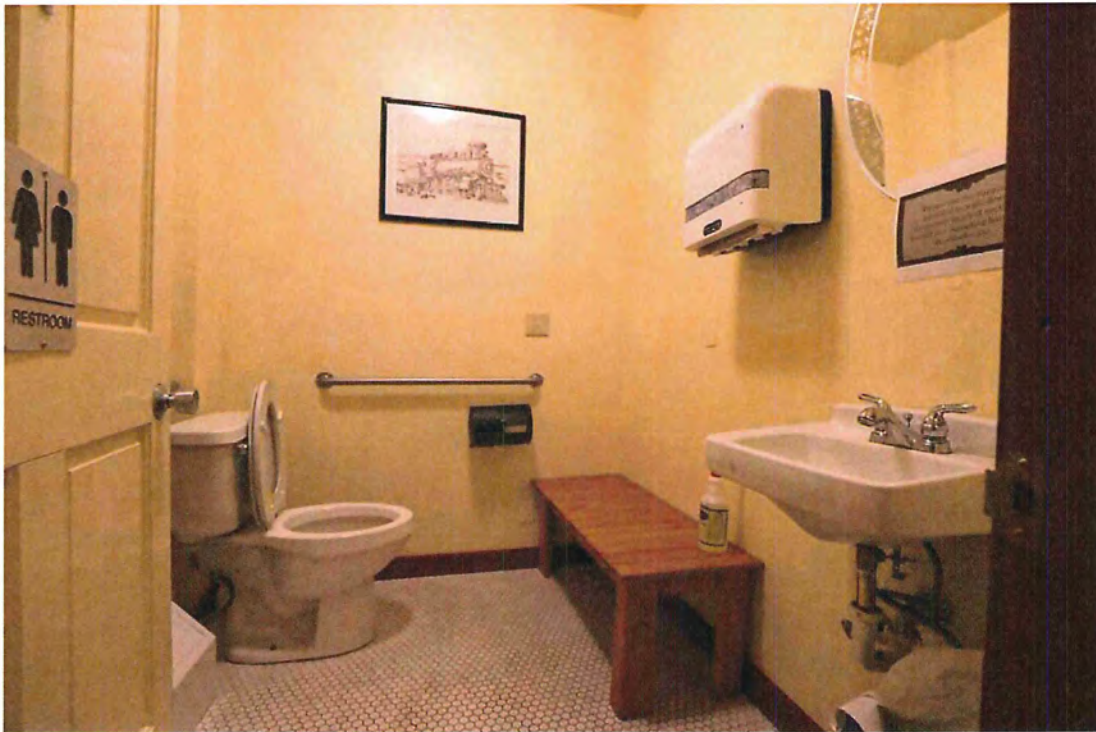
Photo 44 Auditorium level single occupancy restroom. Does not meet accessibility standards

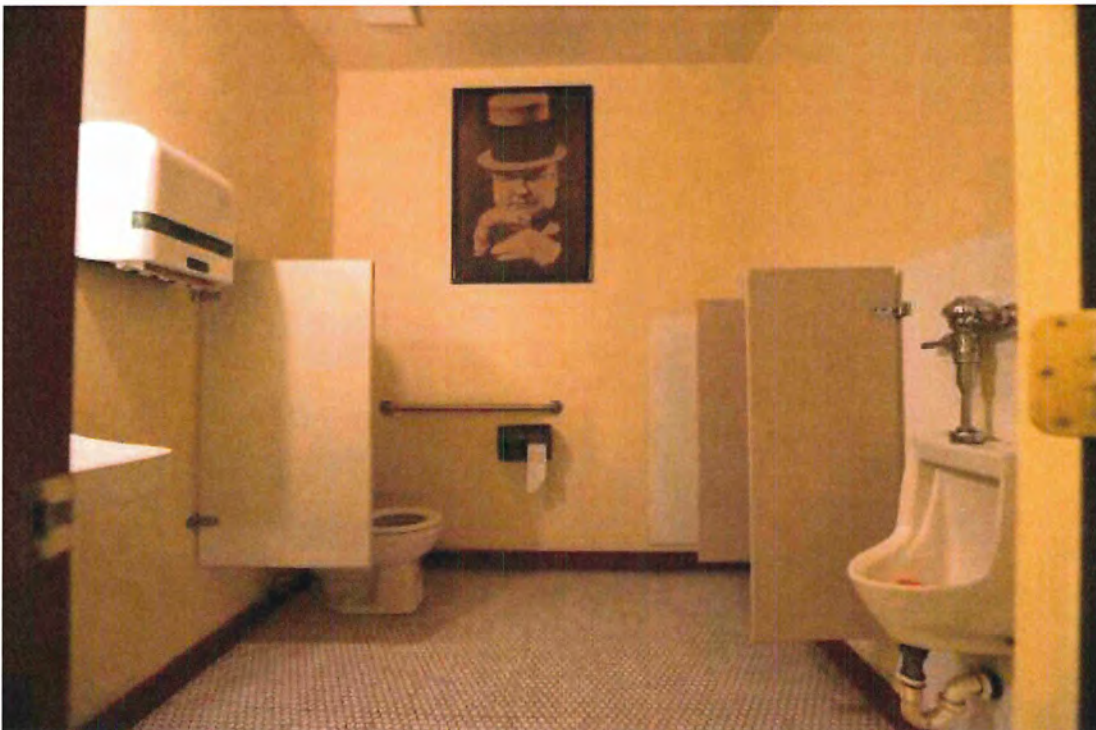
Photo 45 Auditorium level Men's Restroom. One lavatory, three urinals, and one water closet. As configured, single occupancy restroom while water closet in use. Does not meet accessibility standards as currently configured. Door is too narrow into restroom.

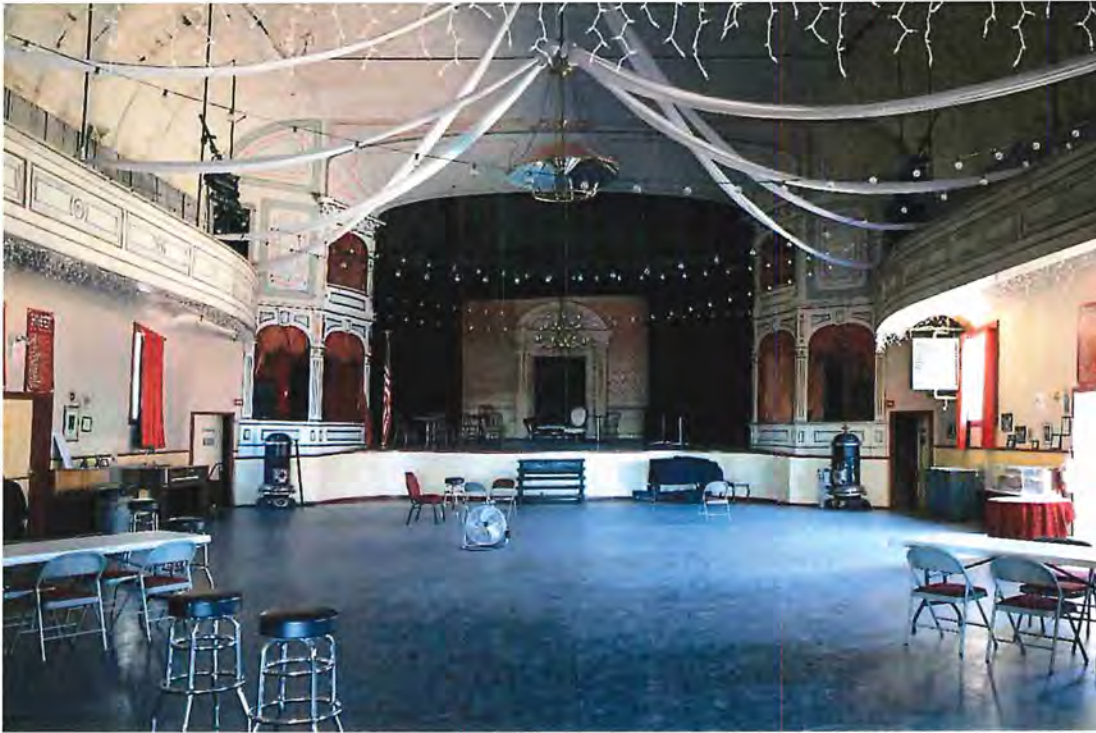
Photo 47 “Sunburner” gasolier intact. Painted plywood floor installed 2007 covers 1907 maple floor. In 2004, underside of balcony and walls sprayed with fire retardant and covered in fire-retardant muslin. Wood elements in good condition.
