# NEVADA COMMISSION FOR CULTURAL CENTERS & HISTORIC PRESERVATION (CCCHP) GRANT APPLICATION

Project Title: Piper's Opera House Front Door Restoration Project  
 Project Type:  Rehabilitation/Construction  Planning/Construction  
 Architectural/Engineering Study/Construction

In March of 2020, Dubé Group Architecture (DGA) was retained by Storey County to prepare the following Amendment to the Historic Structures Report for Piper's Opera House, located at 12 North B Street, Virginia City, NV. This document is intended to update the existing conditions and recommendations contained in the Historic Structures Report prepared by van Dijk Westlake Reed Leskosky in 2002.

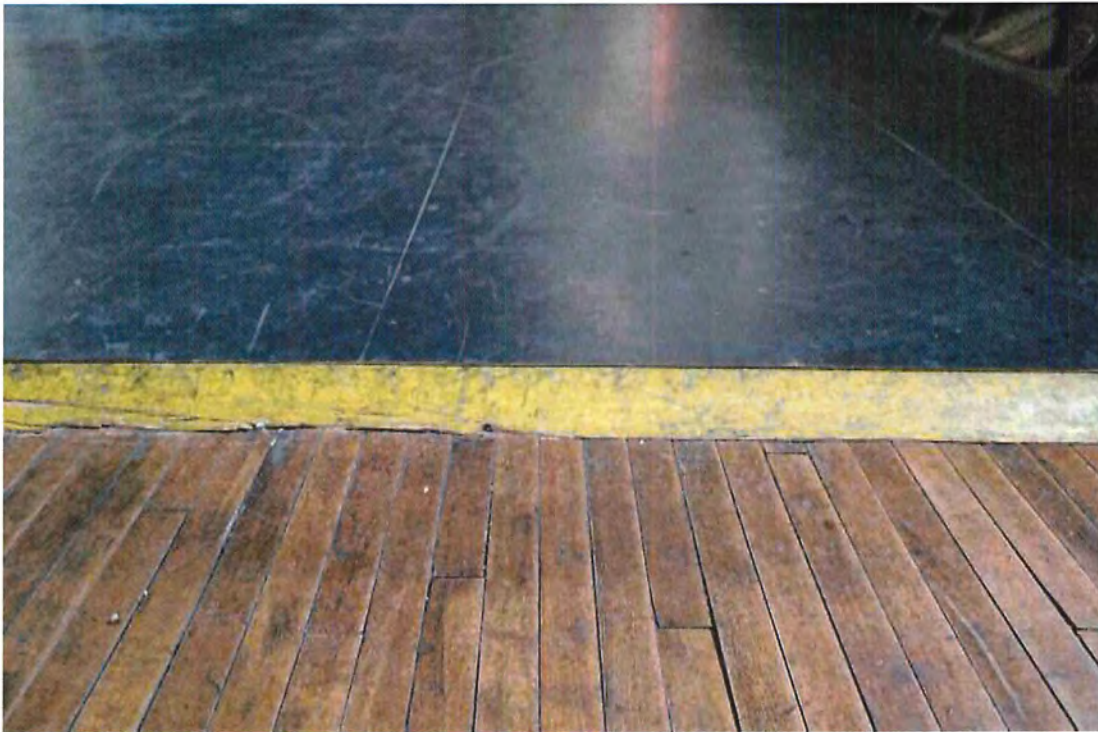
Photo 48 1907 maple flooring visible in foreground. In 2007, HBO set up production studio and added 2 layers of plywood, painted black, over maple flooring. Note beveled transition strip painted yellow. Maple flooring appears to be in fair to good condition.

To accommodate the future hydronic radiant heating system, the painted plywood should be removed and a new floor installed consisting of 3/4” plywood sleepers to support tubes overlaid with 3/8” plywood subfloor and topped with a floating wood floor. The entire assembly should be less than 2 inches thick and will match the existing finish floor elevation.

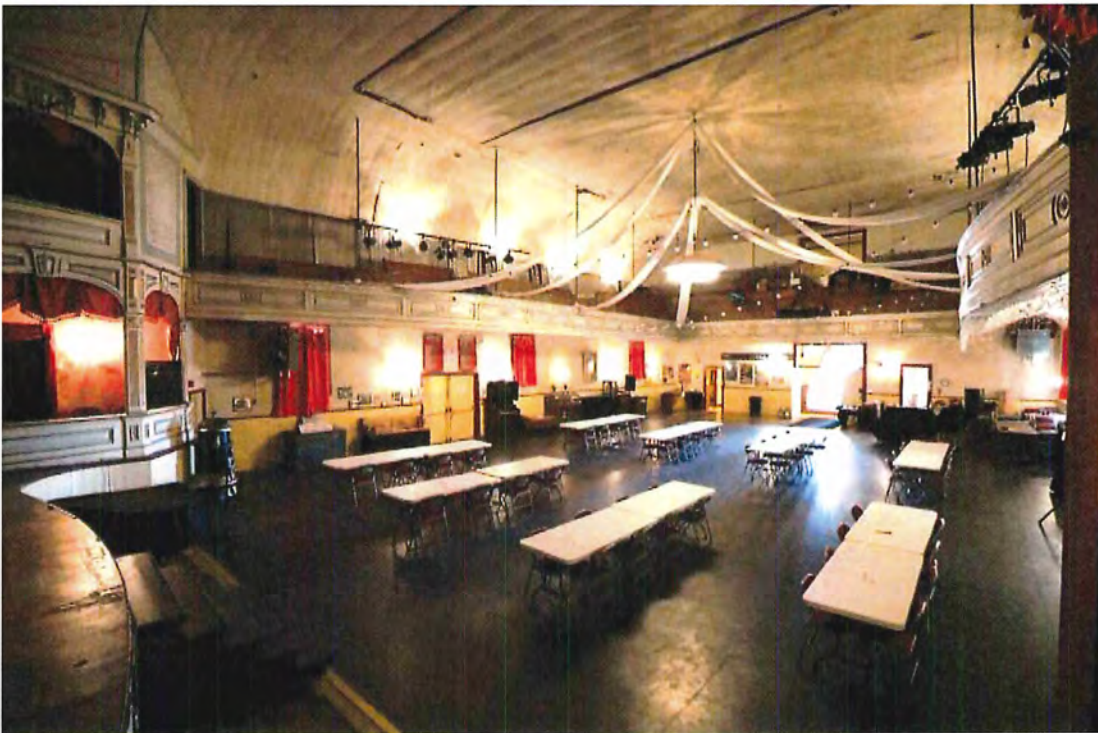
Photo 49 View from stage right looking at auditorium chamber. Typical table and chair layout. Note stage lighting on balcony

In 2004, possibly funded by CCA-03-15, the water-damaged 1960s muslin (or possibly canvas) was removed from the underside of the balcony and wood walls. The exposed wood surfaces were treated with “FLAMORT-WC”, which the manufacturer described as “a non-toxic, water-base, fire retardant coating, and then covered with muslin sprayed with flame retardant (possibly manufactured by Rose Brand Textile Fabrics). The flame retardancy has an expected lifetime of at least one (1) year and recommends annual testing.

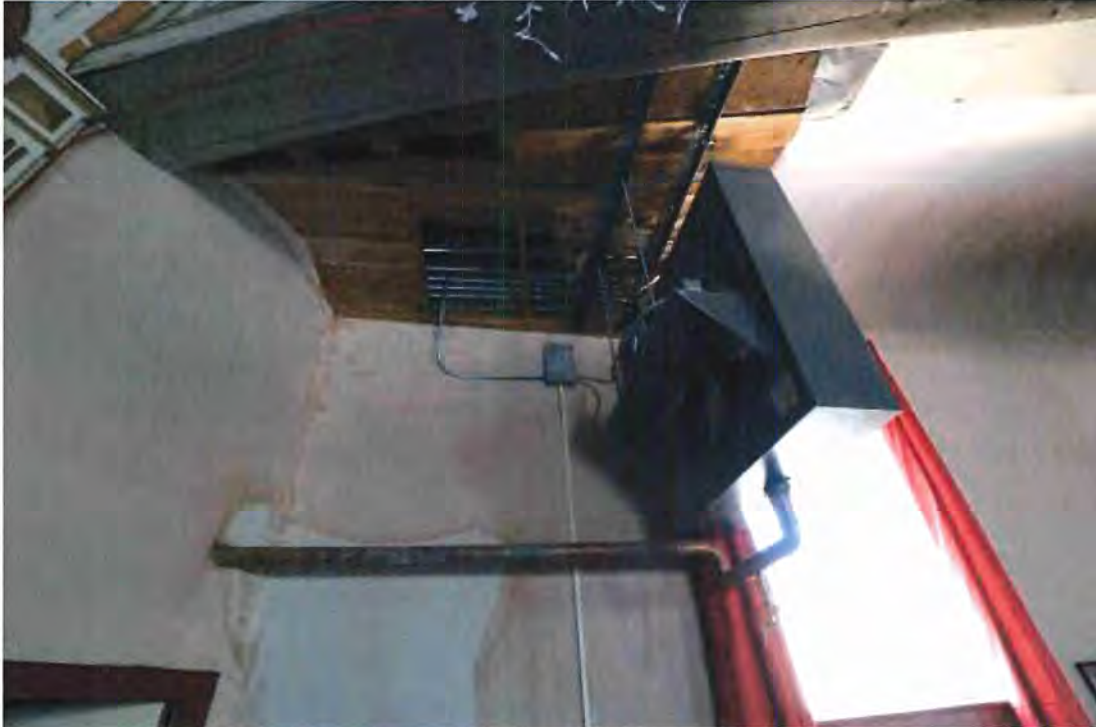
*Photo 50 View of exposed lath under balcony at north side above door to stage and boxes. Unit heater visible to right in photo.*

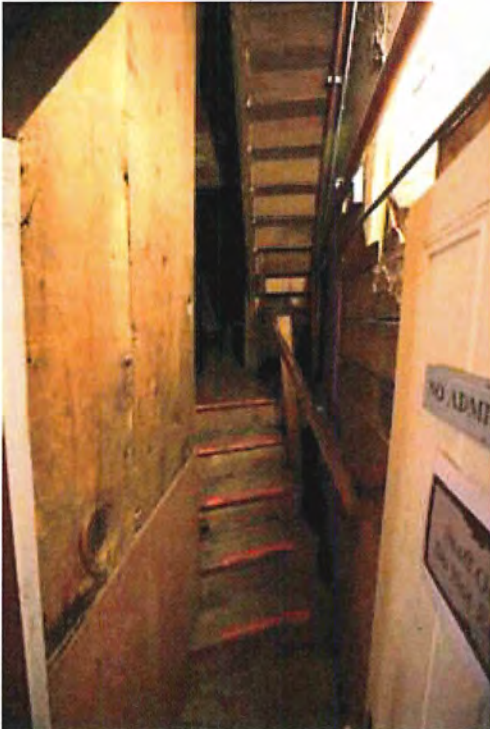
The opera boxes are original and in fair condition. The wall paper remains intact but is substantially covered with red felt; the floors have been covered with contemporary carpeting. Valances and drapery drops are contemporary. Access to each of the lower boxes is through a narrow doorway and up five steps. There is another steep, narrow stairway leading to each of the upper boxes from the stage and a secondary access through the balcony. As noted in the HSR, “Limited access from the rear. Not viable for contemporary seating” and we concur with this statement unless the AHJ is willing to allow the boxes to be occupied as a non-conforming use. The remaining treatment recommendations noted in van Dijk Westlake Reed Leskosky report are still valid.

Photo 51 Stairs to opera boxes at stage left

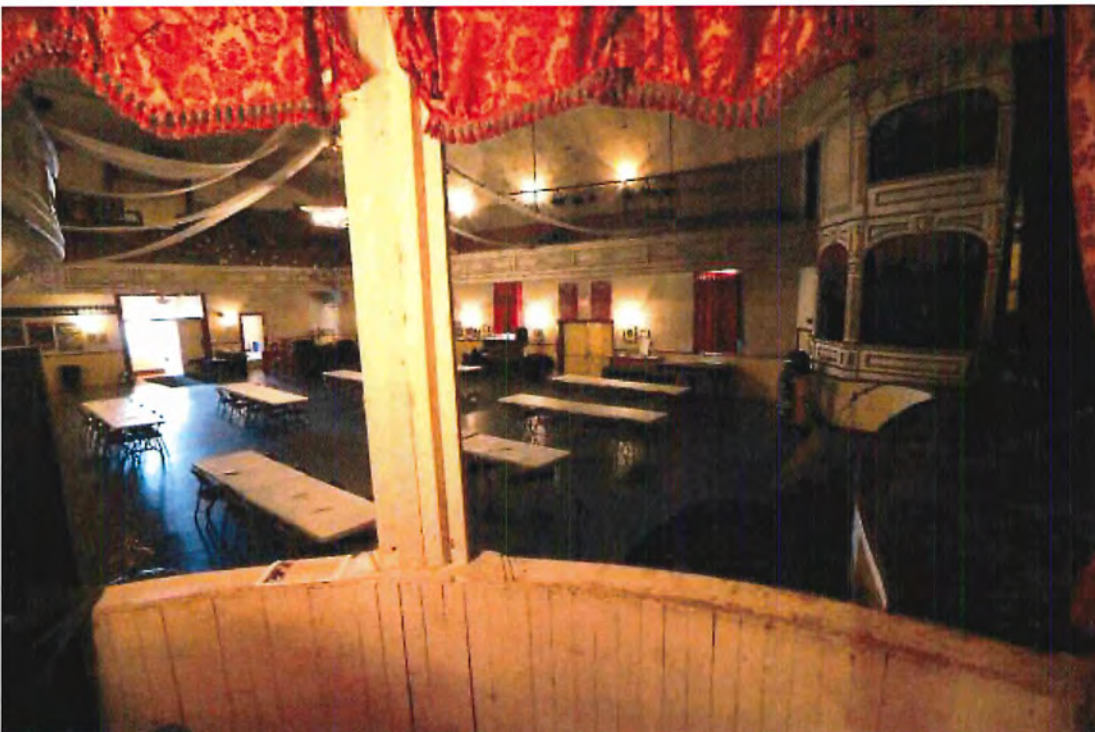
Photo 52 View of stage and auditorium chamber from lower opera box at stage left. Existing wood elements in fair condition.

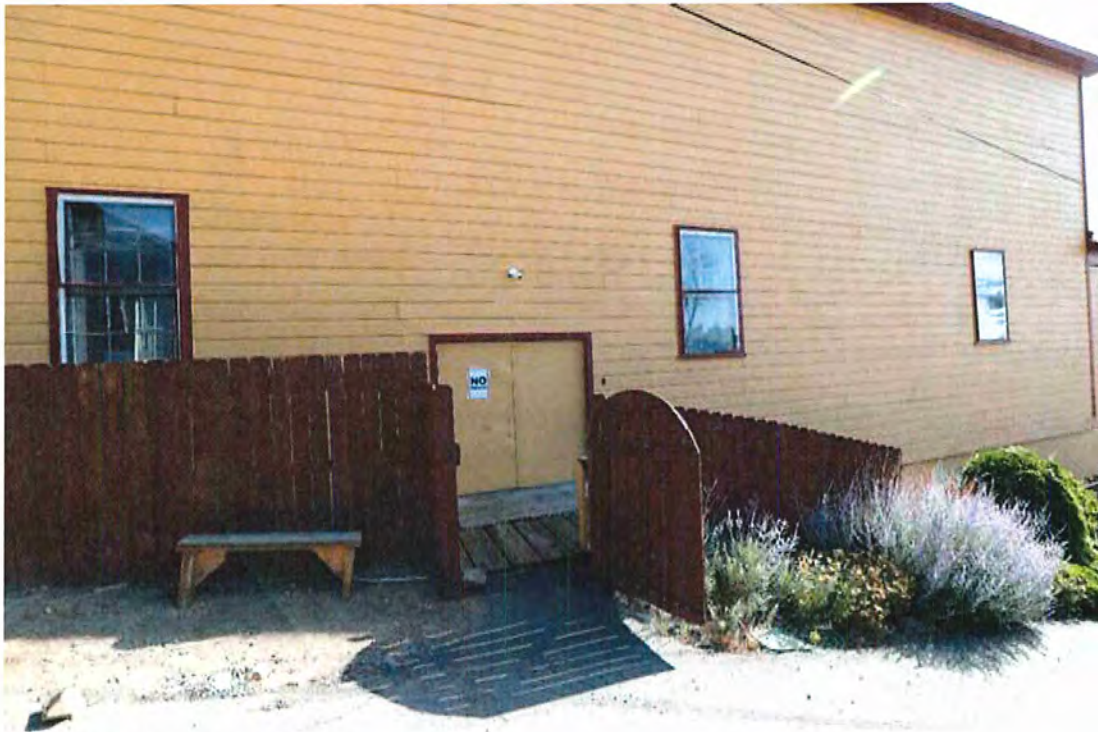
Photo 53 South exit from auditorium

The north-facing exit doors swing out onto a level landing with two steps down to grade. This could be reconfigured as shown in Figure 4 to include a deeper landing with a switchback ramp to grade. The ramp is held back 4 feet from the building for a snow drop area. In lieu of continuing a ramp down to B Street (public way) which has been proposed in the past, a safe dispersal area could be maintained on the north lot.

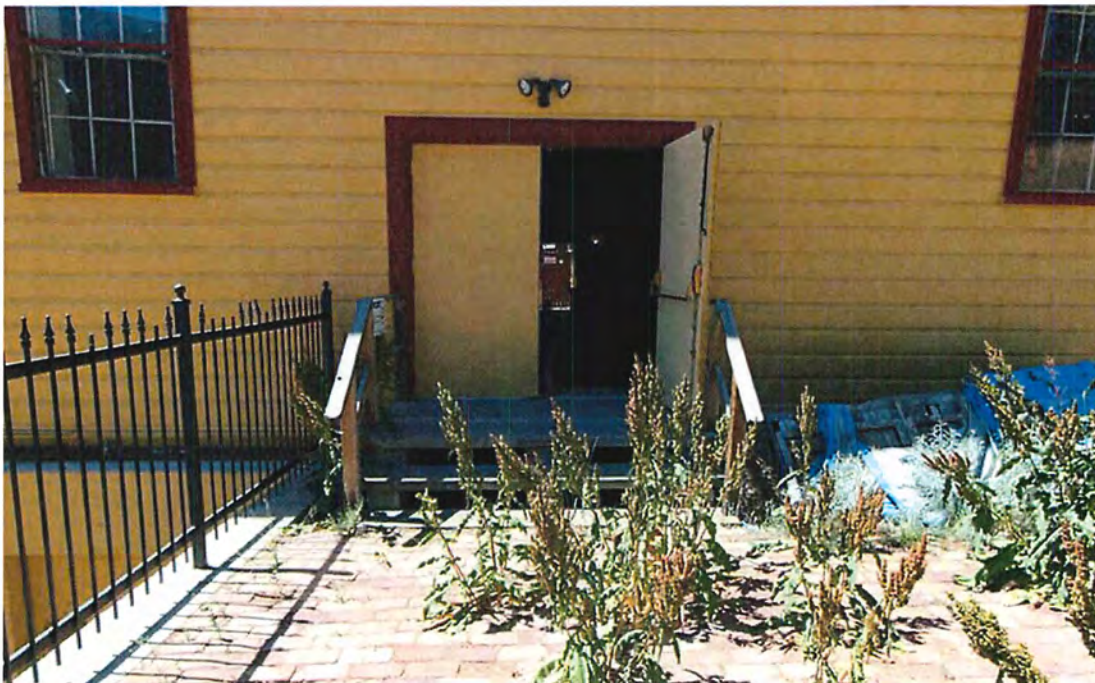
Photo 54 North exit from auditorium

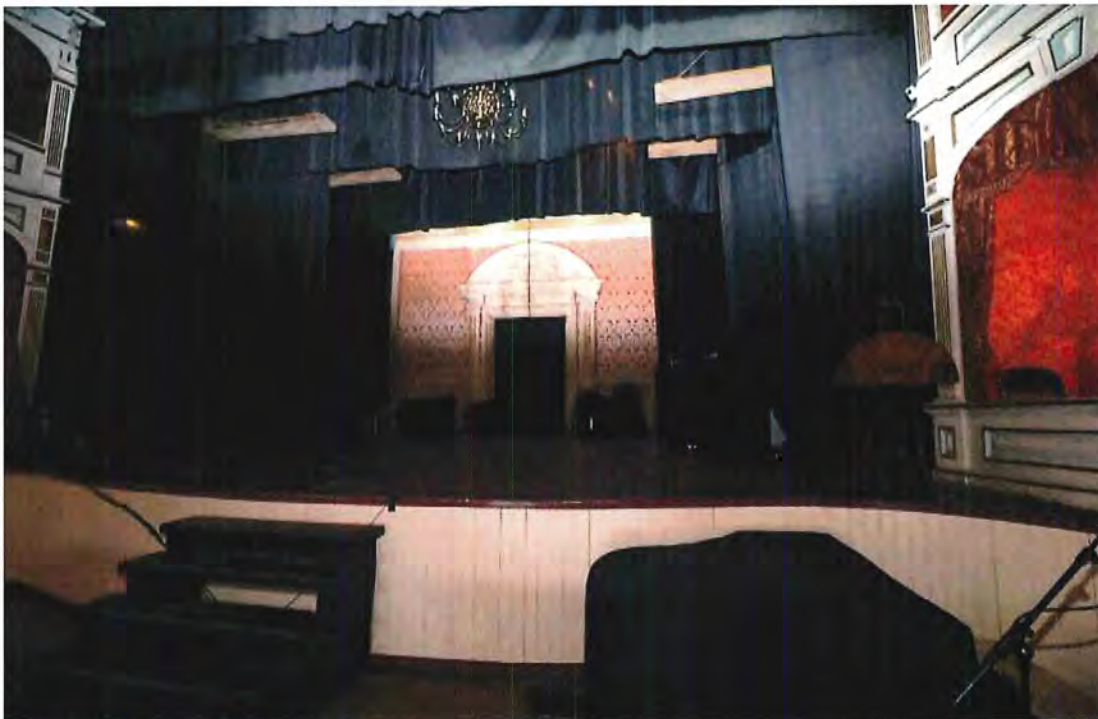
The staging area has been upgraded with new draperies, lighting, and sound systems. The remaining treatment recommendations noted in van Dijk Westlake Reed Leskosky report are still valid.

*Photo 55 View of stage with curtains and valances*

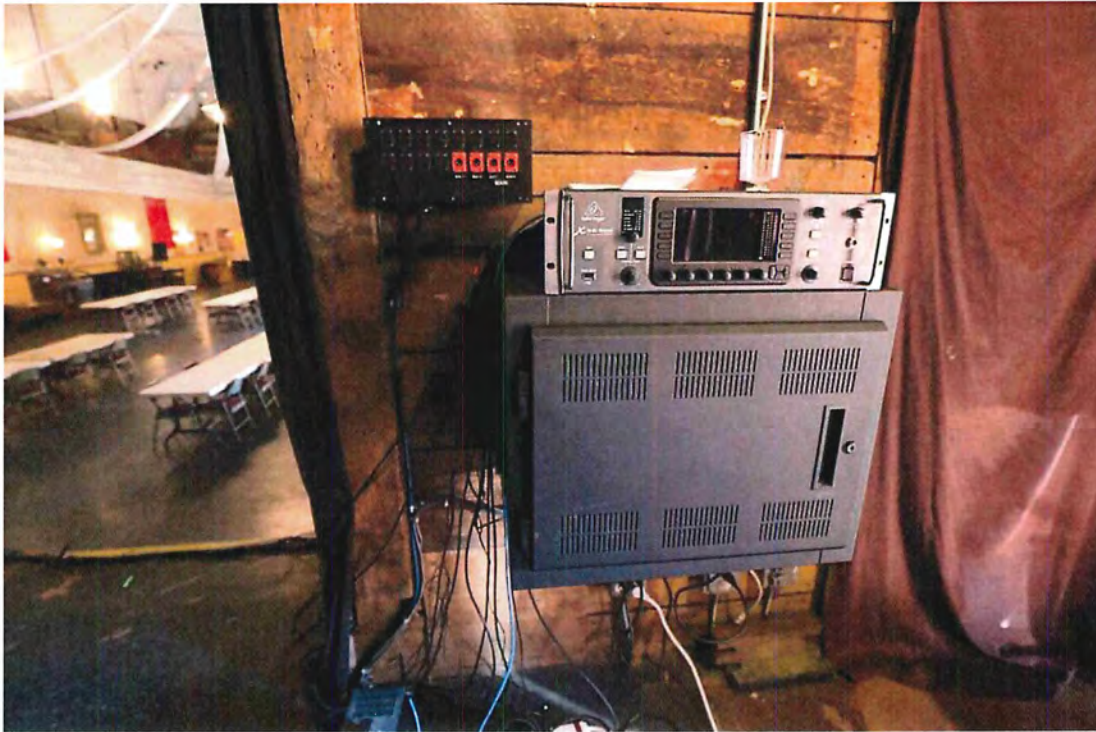
Photo 56 40-channel digital live mixer rack installed stage right

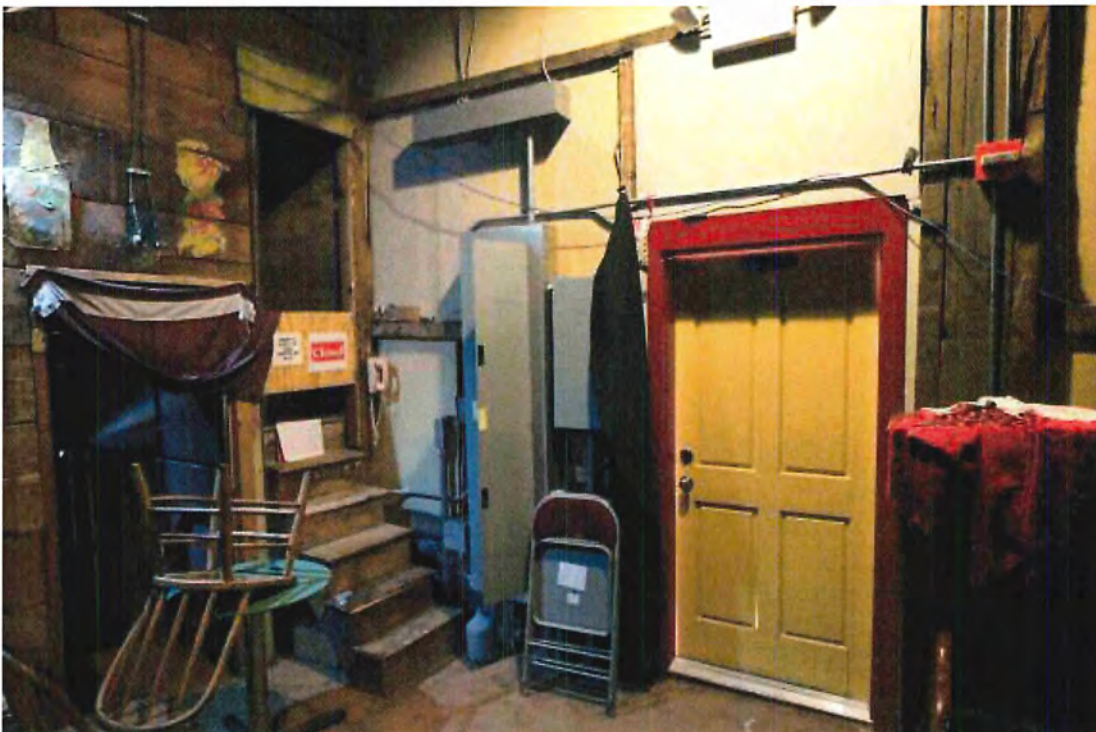
Photo 57 view from stage right. Stairs on right go up to balcony, stairs to left go down to auditorium. Stage exit door facing south. Note electrical panels to left of door.

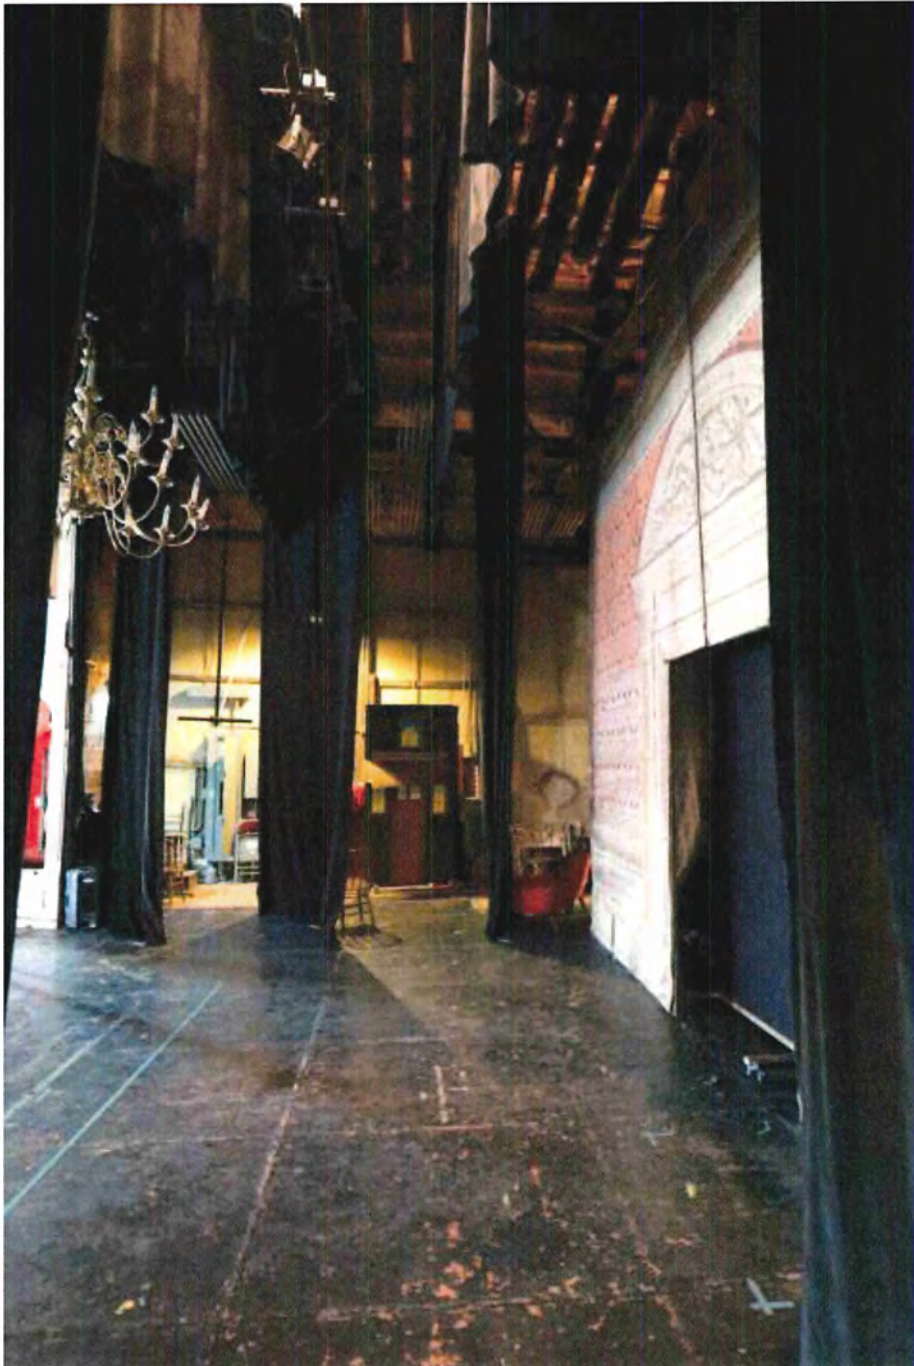
Photo 58 View from stage left looking south. Note light through floor boards of loft area in attic above stage.

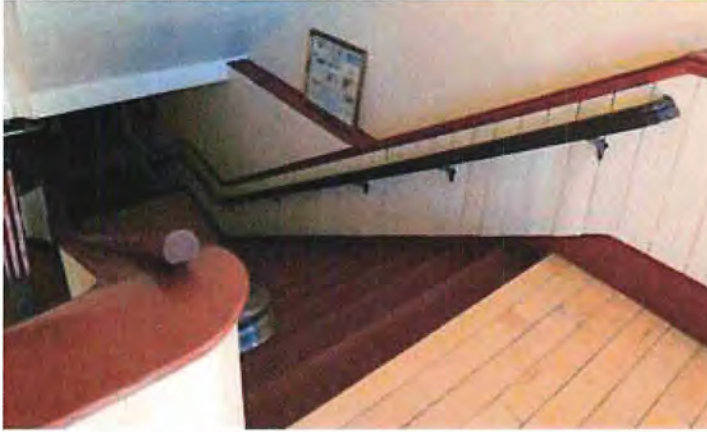
Photo 59 Existing stairs complete with handrails on both sides of stairs; half-round bannister cap, bead board wainscoting, and vinyl treads and risers

Currently, the grand staircase is partially completed from the auditorium level to the balcony level and should be finished to match existing hand rails, half-round bannister cap, bead board wainscoting, and flooring including pre-molded slip-resistant vinyl treads and risers. Materials stored on the landing and stairs should be removed. The iron grill work obtained from the International Hotel that was across the street from Piper's Opera House was repurposed in 2007 as the guardrail, shown clamped in Photo 58, and should be welded after verifying it can resist a concentrated load of 200 pounds (it might be necessary to strengthen the connections to the floor deck). Lighting and life safety components including horn / strobes are required and exposed gypsum board surfaces above wainscoting should be textured and painted to match adjacent finishes.

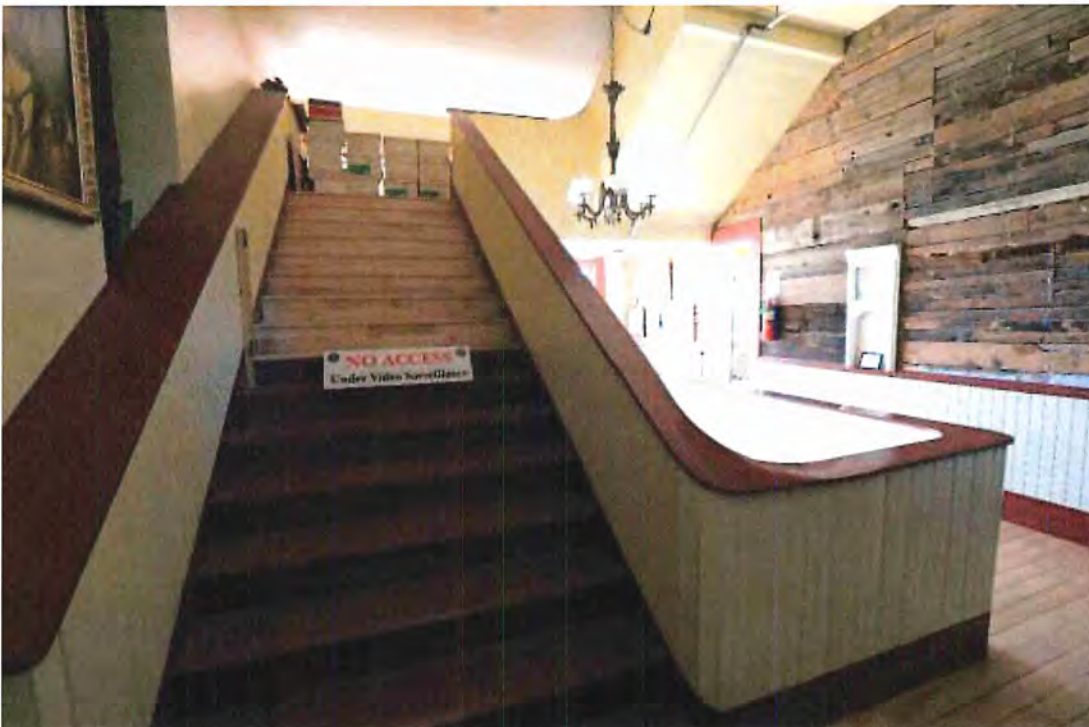
Photo 60 View looking east of partially completed stairs to balcony level.

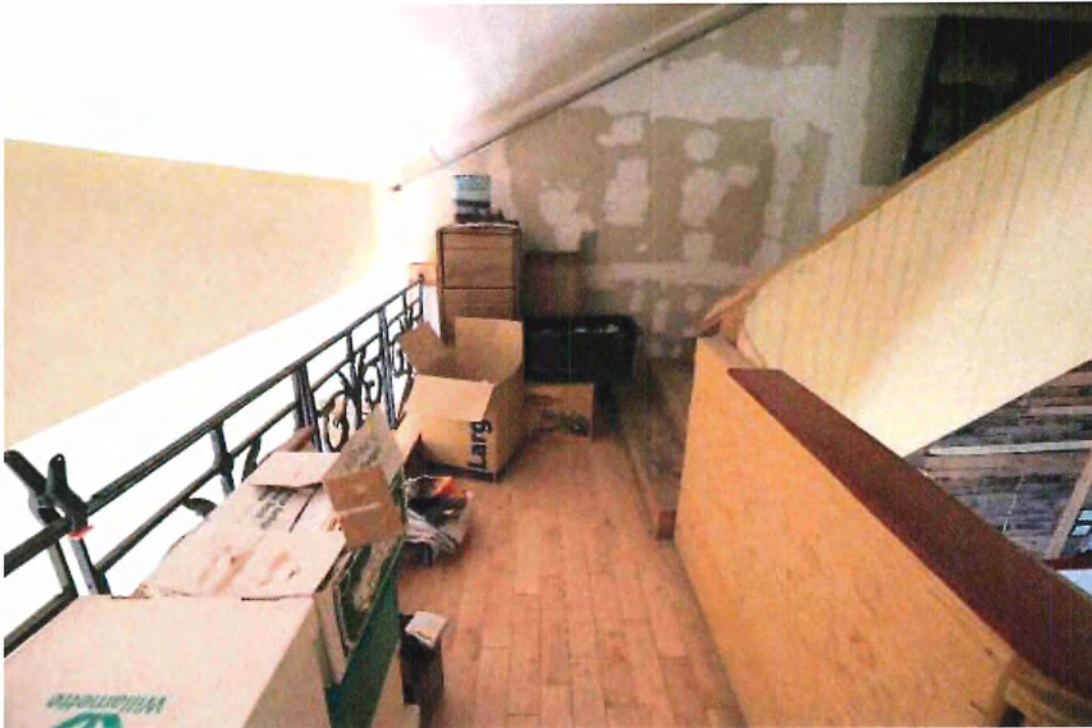
Photo 61 View of landing to balcony level. Note clamp at guardrail.

The iron grill work obtained from the International Hotel that was across the street from Piper's Opera House was repurposed in 2007 as the guardrail, shown clamped in Photo 58, and should be welded after verifying it can resist a concentrated load of 200 pounds (it might be necessary to strengthen the connections to the floor deck). Lighting and life safety components including horn / strobes are required and exposed gypsum board surfaces above wainscoting should be textured and painted to match adjacent finishes.

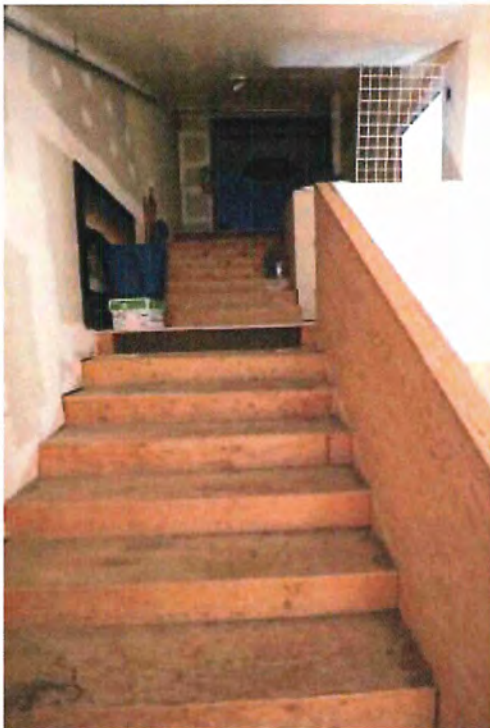
Photo 62 Unfinished stairs to balcony level. Door to current VCTC office shown at right on intermediate landing

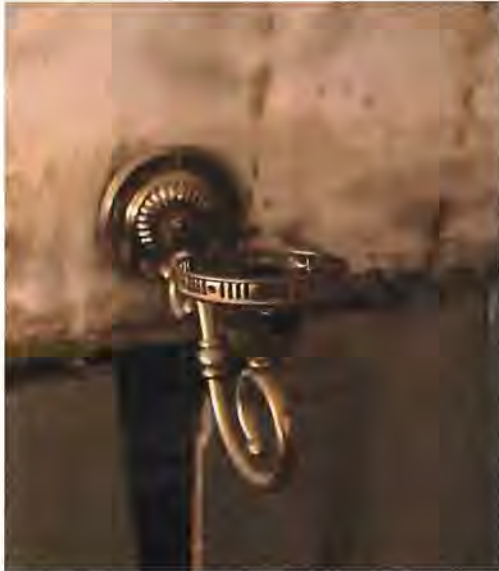
Photo 63 balcony light fixture missing glass shade and bulb

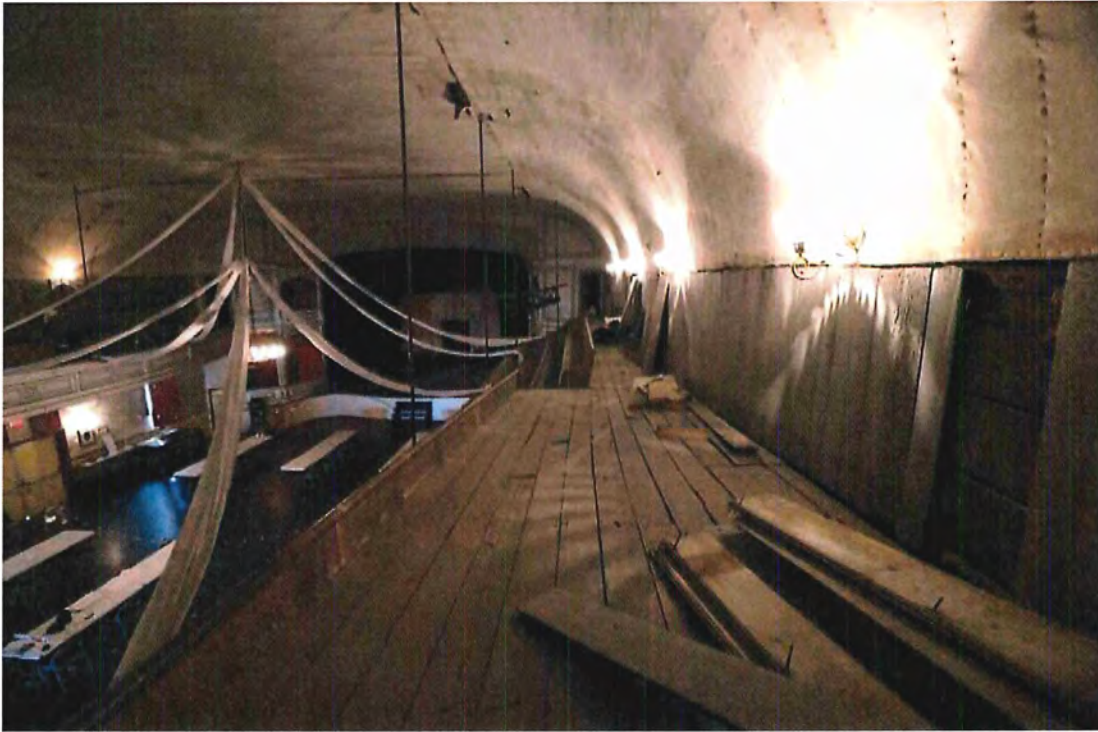
Some pews are missing, there are loose and missing pieces of wainscot, floor boards are damaged or missing, and the guardrail cap is damaged in areas. Missing wood elements should be custom milled and loose pieces reattached. The tattered remains of carpet runner on the main stairs could be removed for display and replaced with like kind material. Missing lamp shades should be replaced and all lights inspected.

Photo 64 View of north balcony looking west toward doorway which exits behind upper opera box. Boards should be reattached to wainscot and missing pieces custom milled.

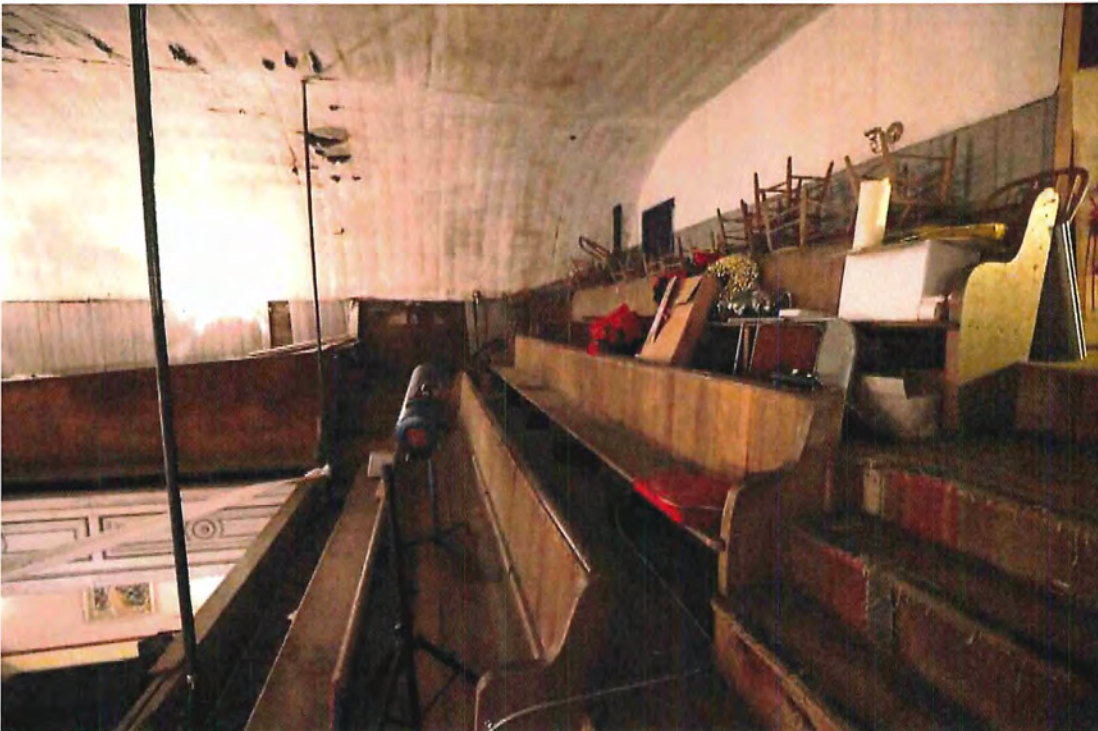
Photo 65 Stairs descend from main balcony entrance to right in photo. Pew bottom missing. Note damaged guardrail cap left of rod supporting balcony

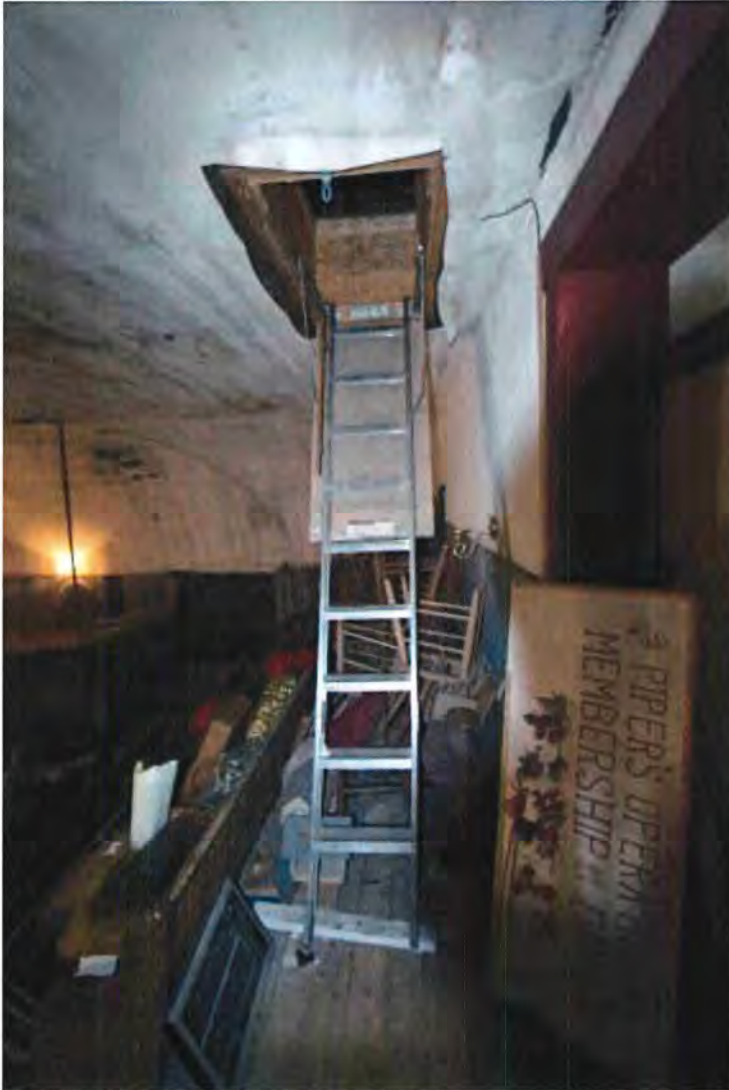
The attic is accessed through a pull-down ladder just inside and to the right of the main entry to the balcony level. The opening size is 22.5" x 54" and the attic lights are controlled by a switch on the side of the opening before you step onto a wooden platform. There is an exhaust fan on casters that ventilates the auditorium and is discussed in detail in Section E Part 3.0 Heating, Ventilation, and Air Conditioning, along with the round ventilation shaft.

Photo 66 Attic access via pull down ladder

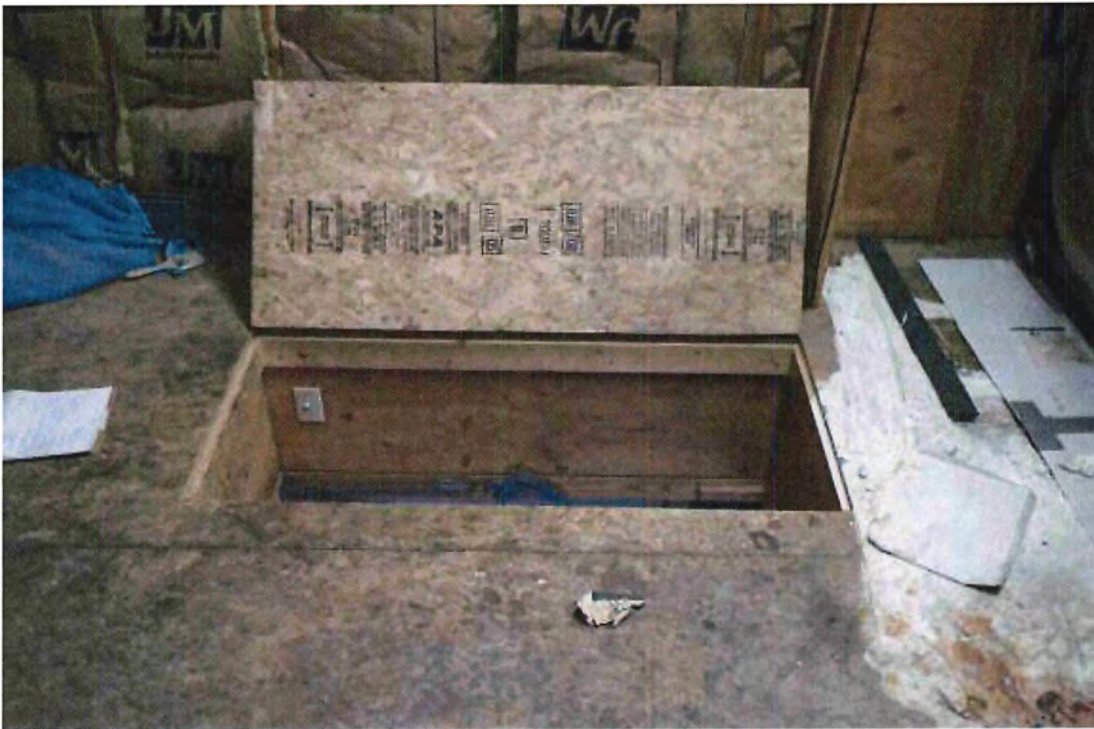
Photo 67 View of ladder access from platform in attic. Note location of light switch

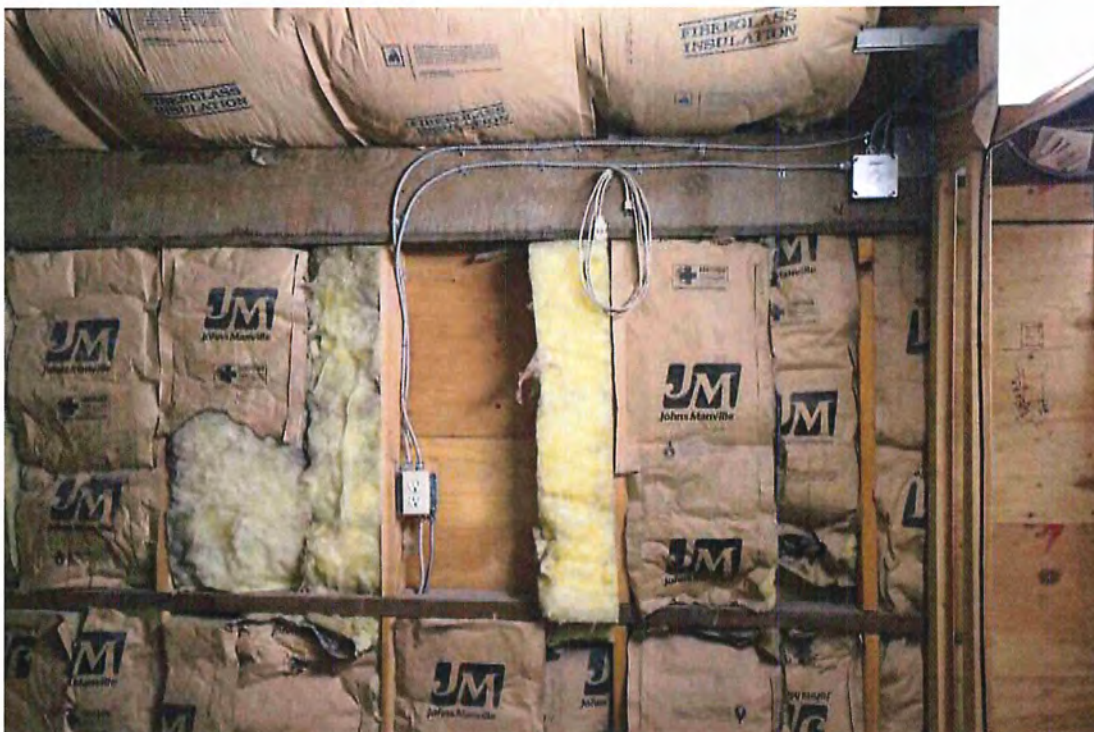
Photo 68 Kraft-faced fiberglass batt insulation at walls (R19) and roof (R38). Note plywood sheathing

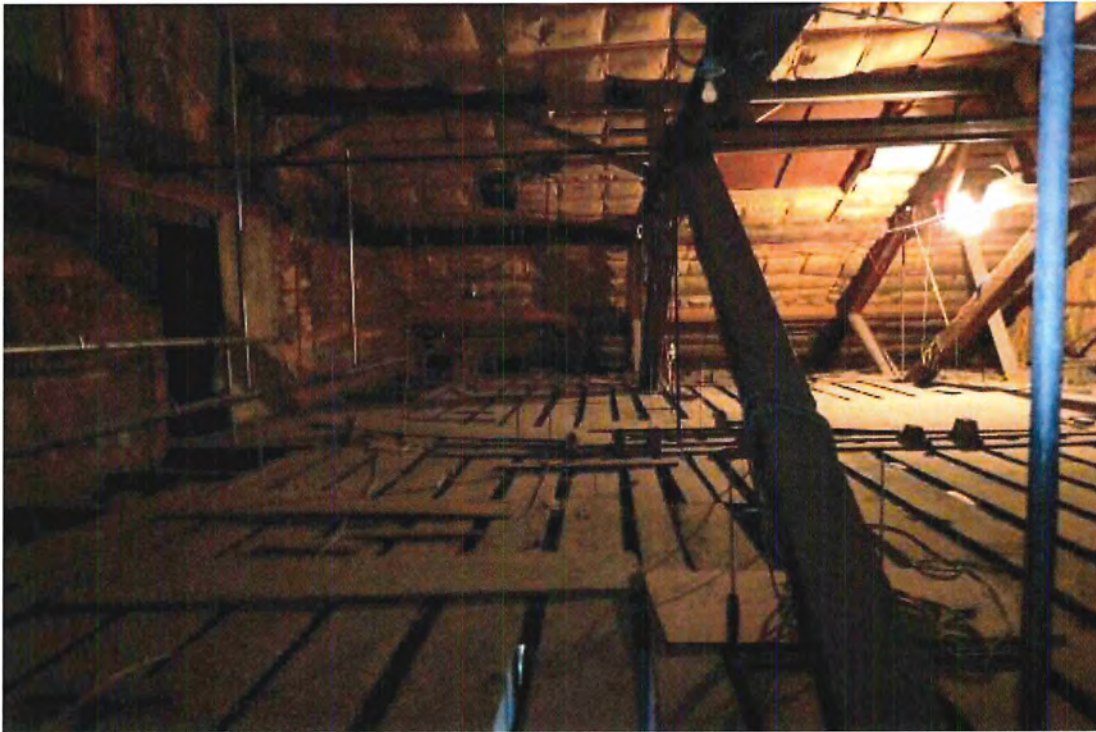
*Photo 69 View of loft area above stage taken from ladder platform looking south.*

The stage rigging components including the wood grid floor pictured below will need to be repaired and reinforced for continued use and to support new HVAC equipment such as the evaporative cooler.

- Repair / reinforce wood grid floor

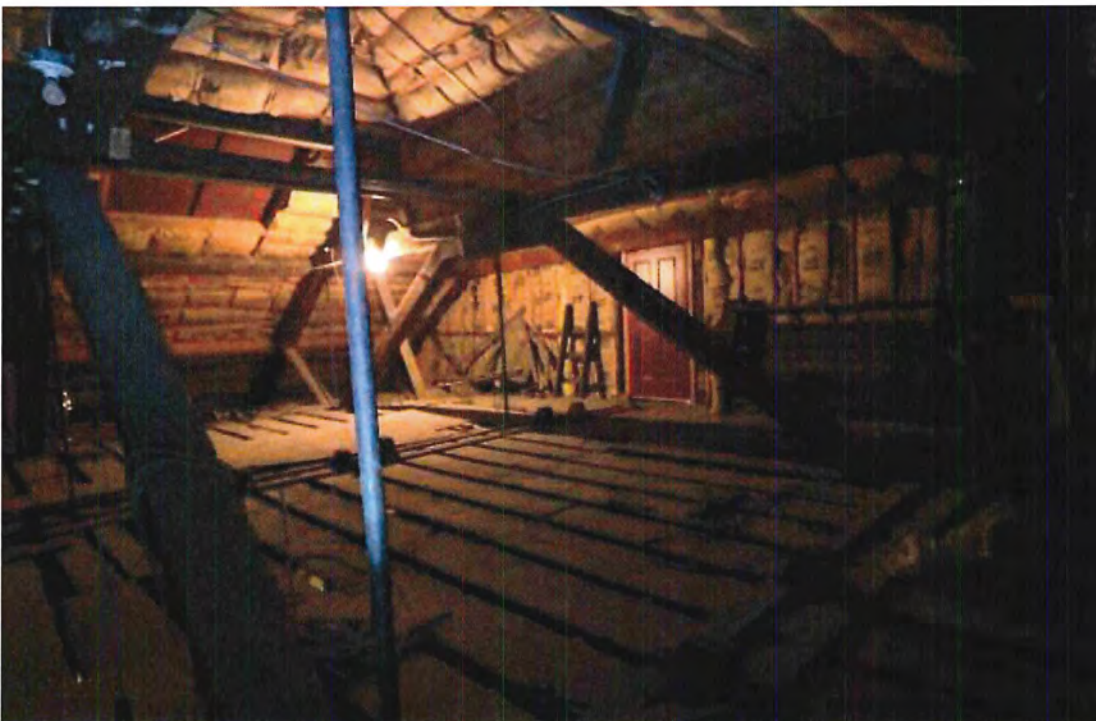
*Photo 70 View of loft area looking southwest. Note door in middle center of photo – this is the door in the west gable end visible from A Street.*

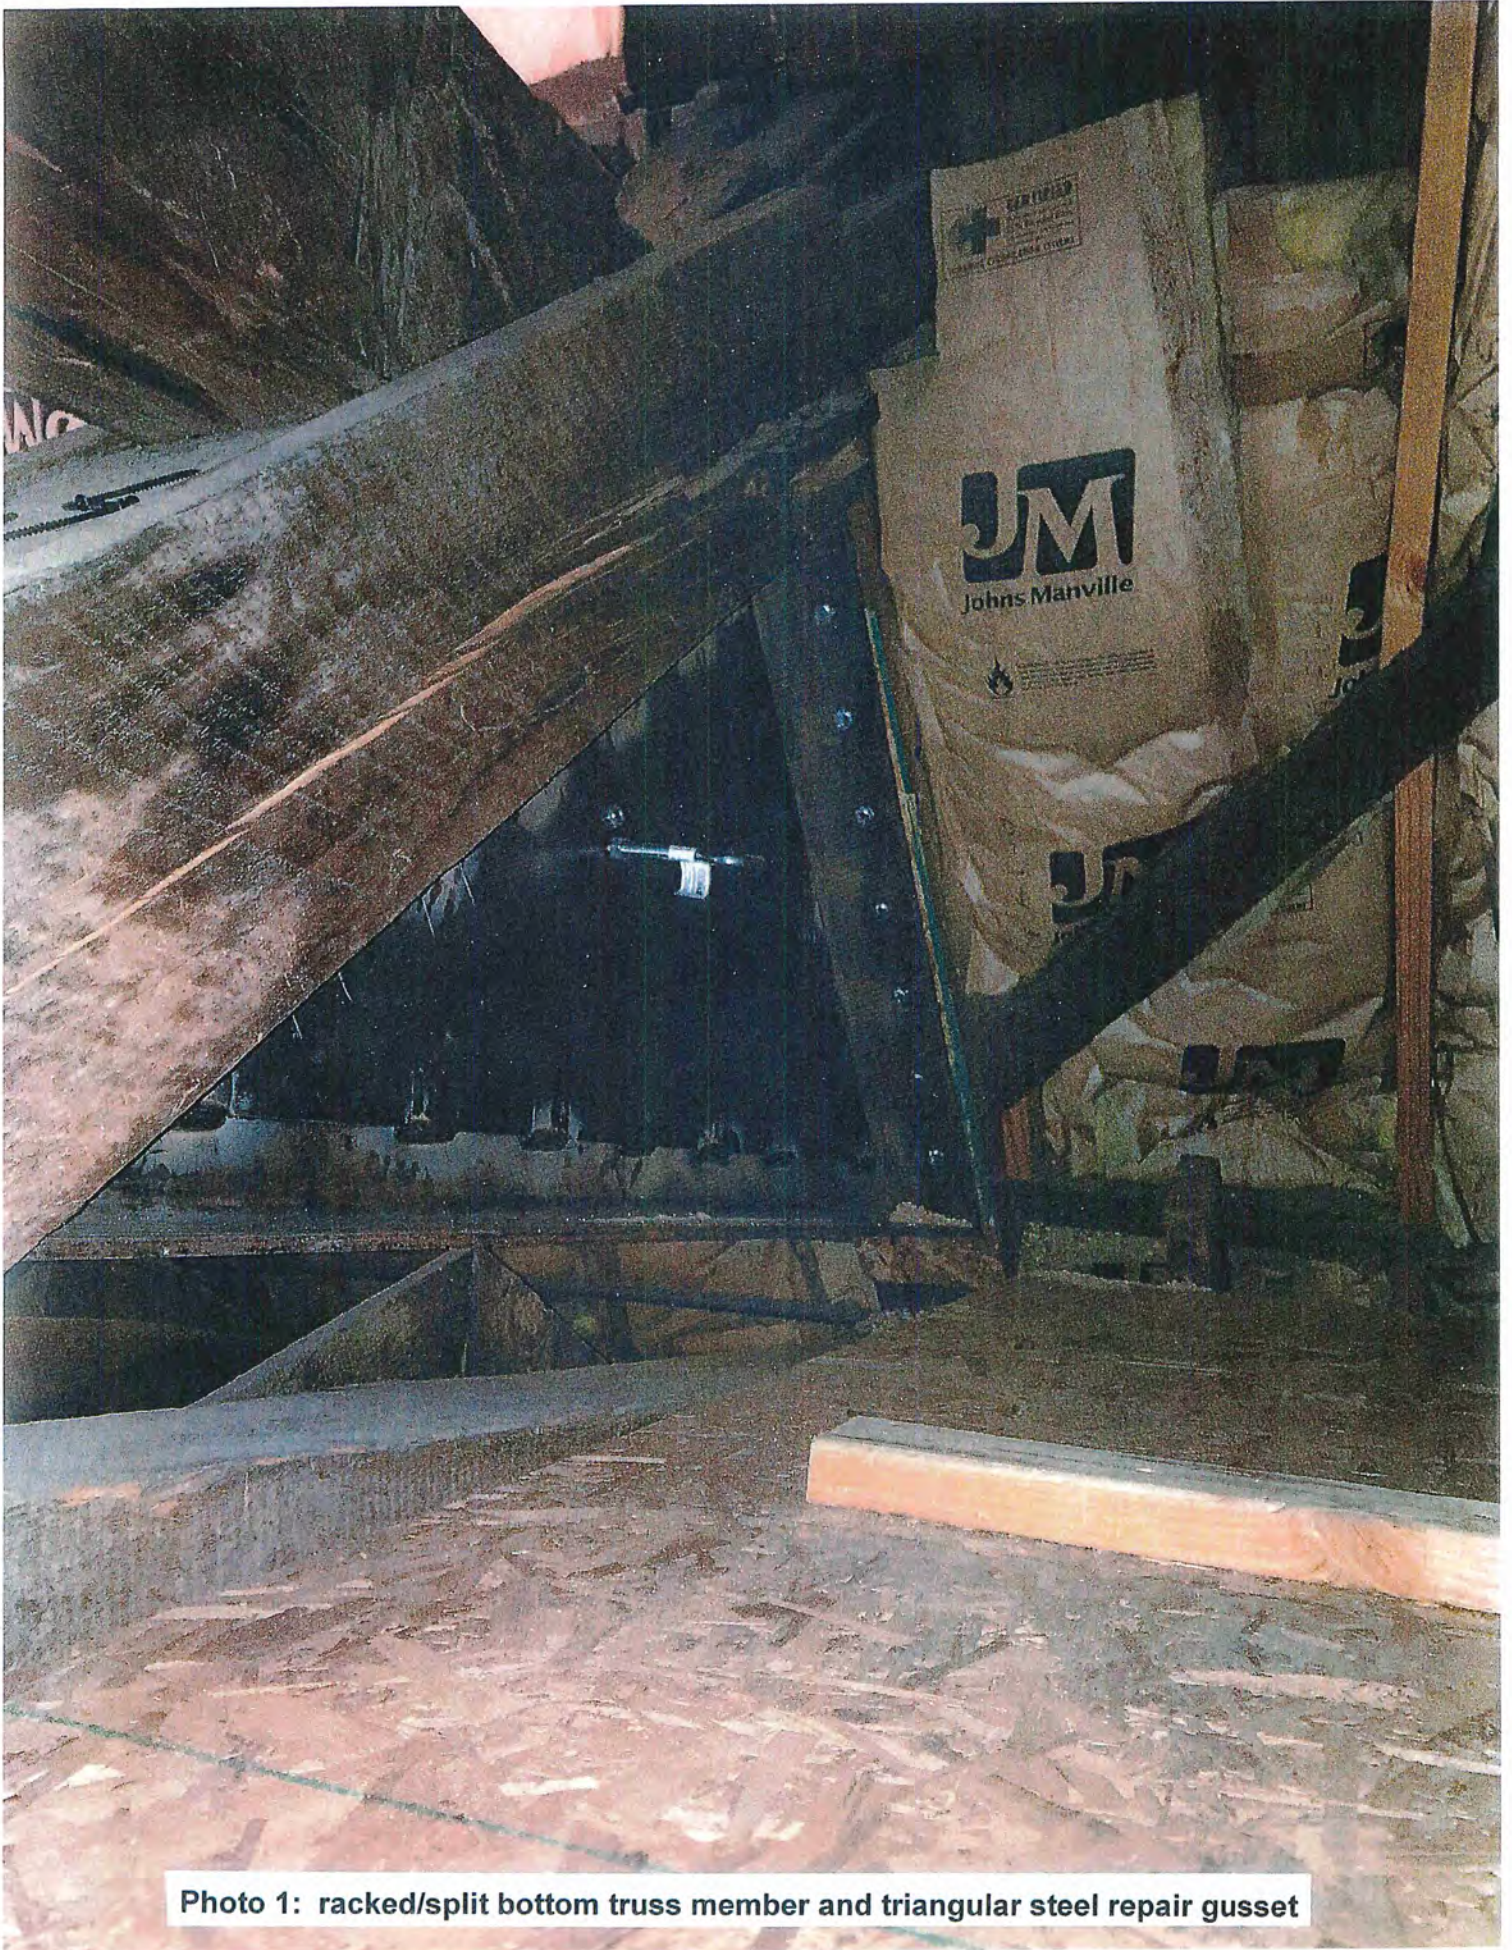
Photo 1: racked/split bottom truss member and triangular steel repair gusset
