# NEVADA COMMISSION FOR CULTURAL CENTERS & HISTORIC PRESERVATION (CCCHP) GRANT APPLICATION

Project Title: Piper's Opera House Front Door Restoration Project  
 Project Type:  Rehabilitation/Construction  Planning/Construction  
 Architectural/Engineering Study/Construction

In March of 2020, Dubé Group Architecture (DGA) was retained by Storey County to prepare the following Amendment to the Historic Structures Report for Piper's Opera House, located at 12 North B Street, Virginia City, NV. This document is intended to update the existing conditions and recommendations contained in the Historic Structures Report prepared by van Dijk Westlake Reed Leskosky in 2002.

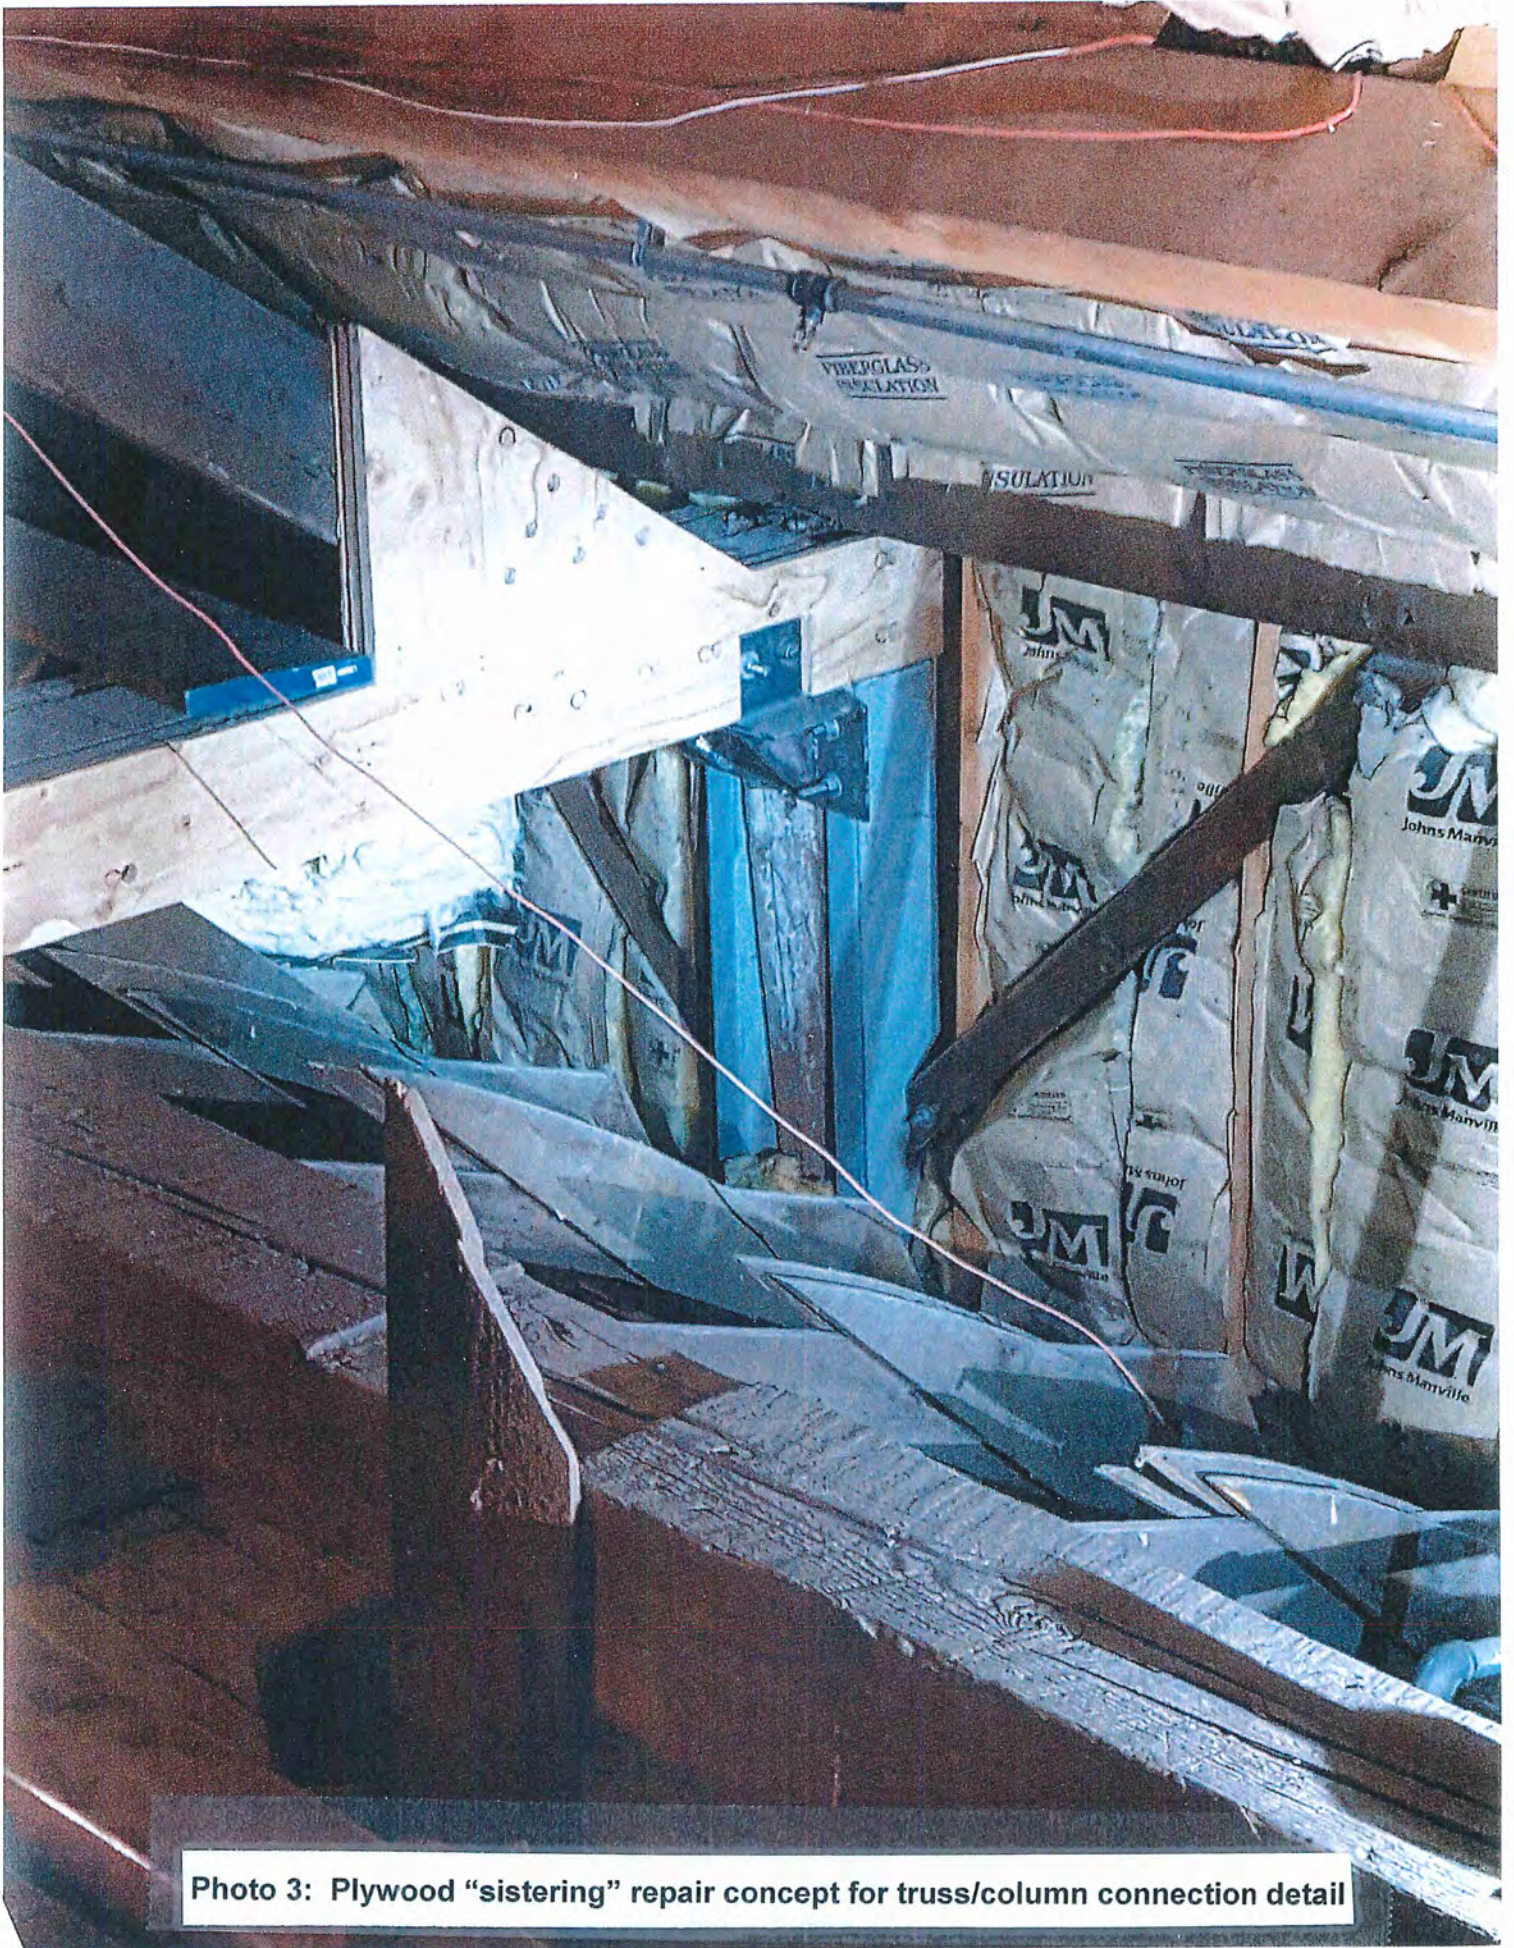
Photo 3: Plywood "sistering" repair concept for truss/column connection detail

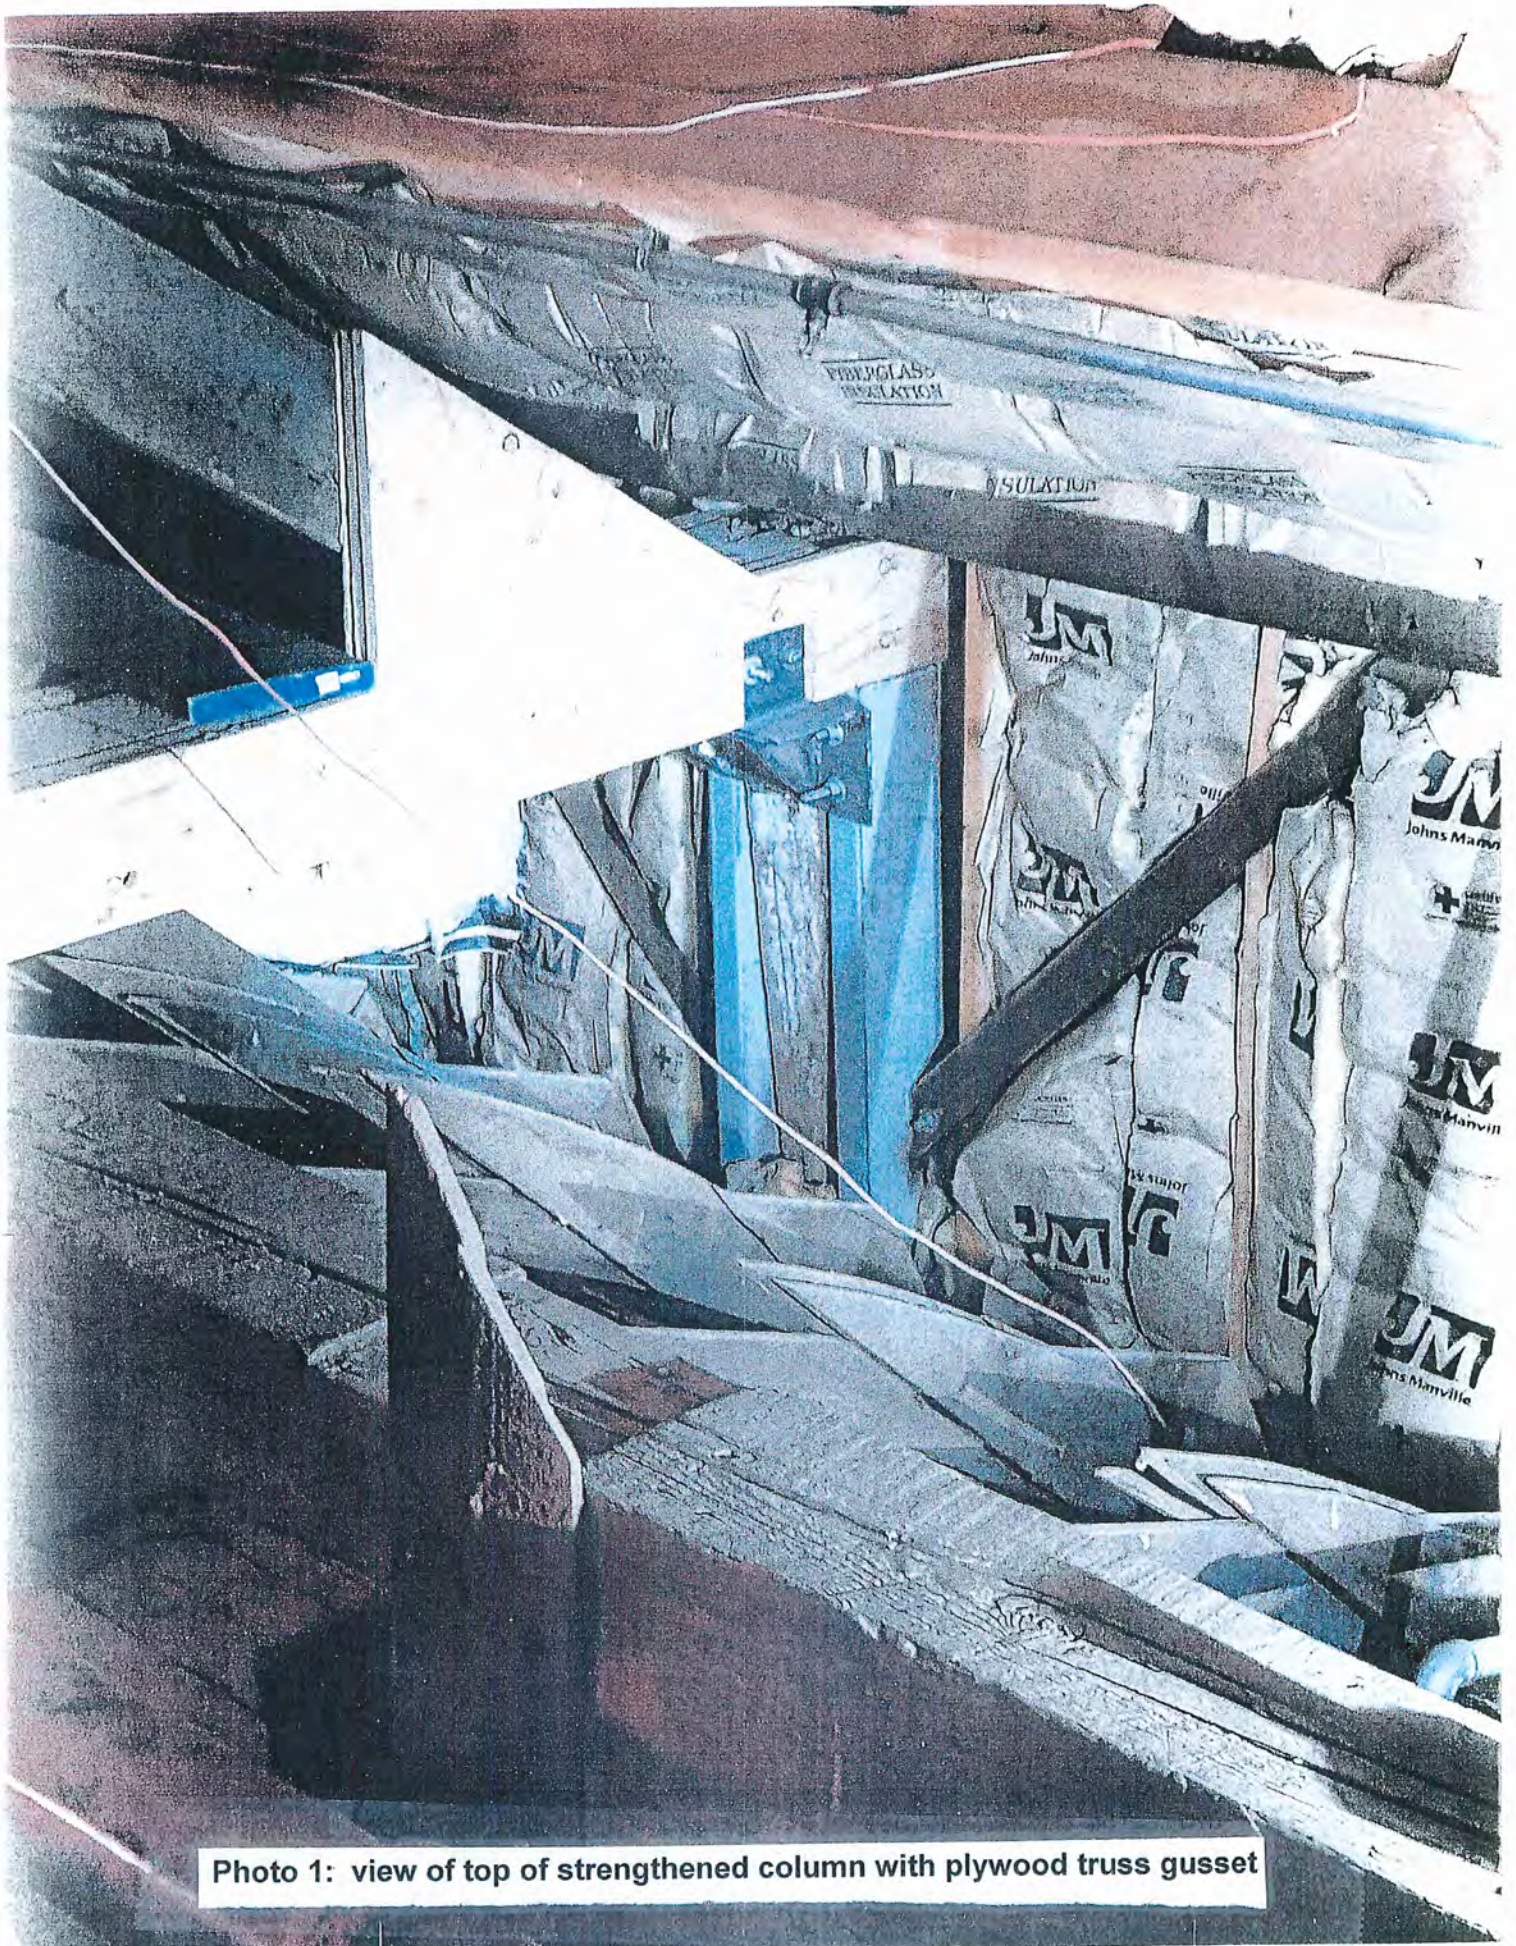
Photo 1: view of top of strengthened column with plywood truss gusset

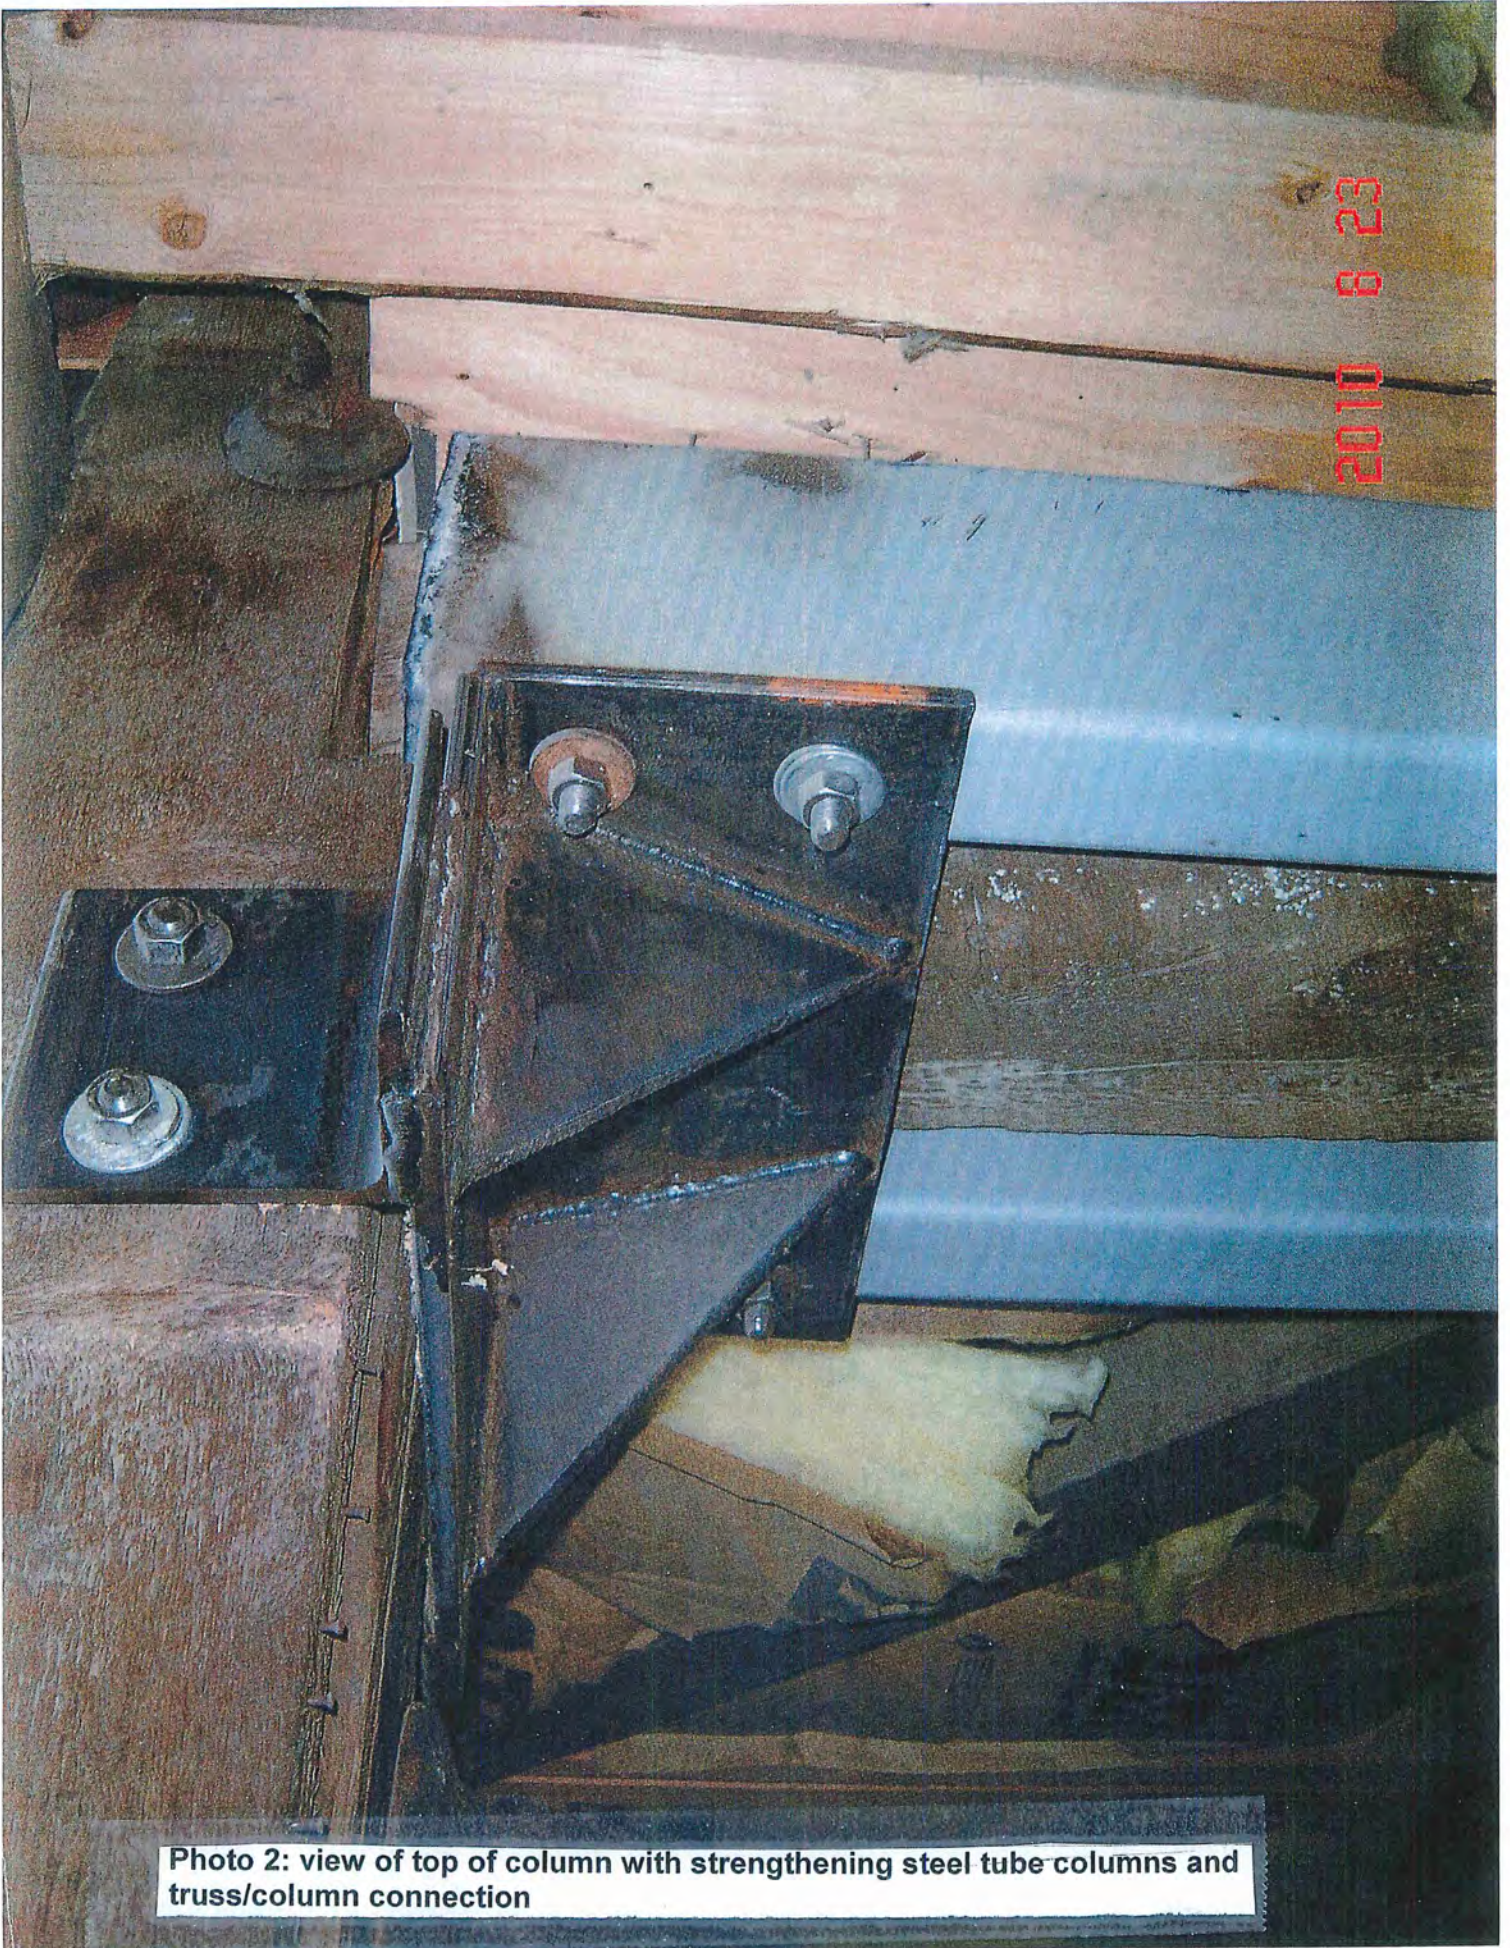
Photo 2: view of top of column with strengthening steel tube columns and truss/column connection

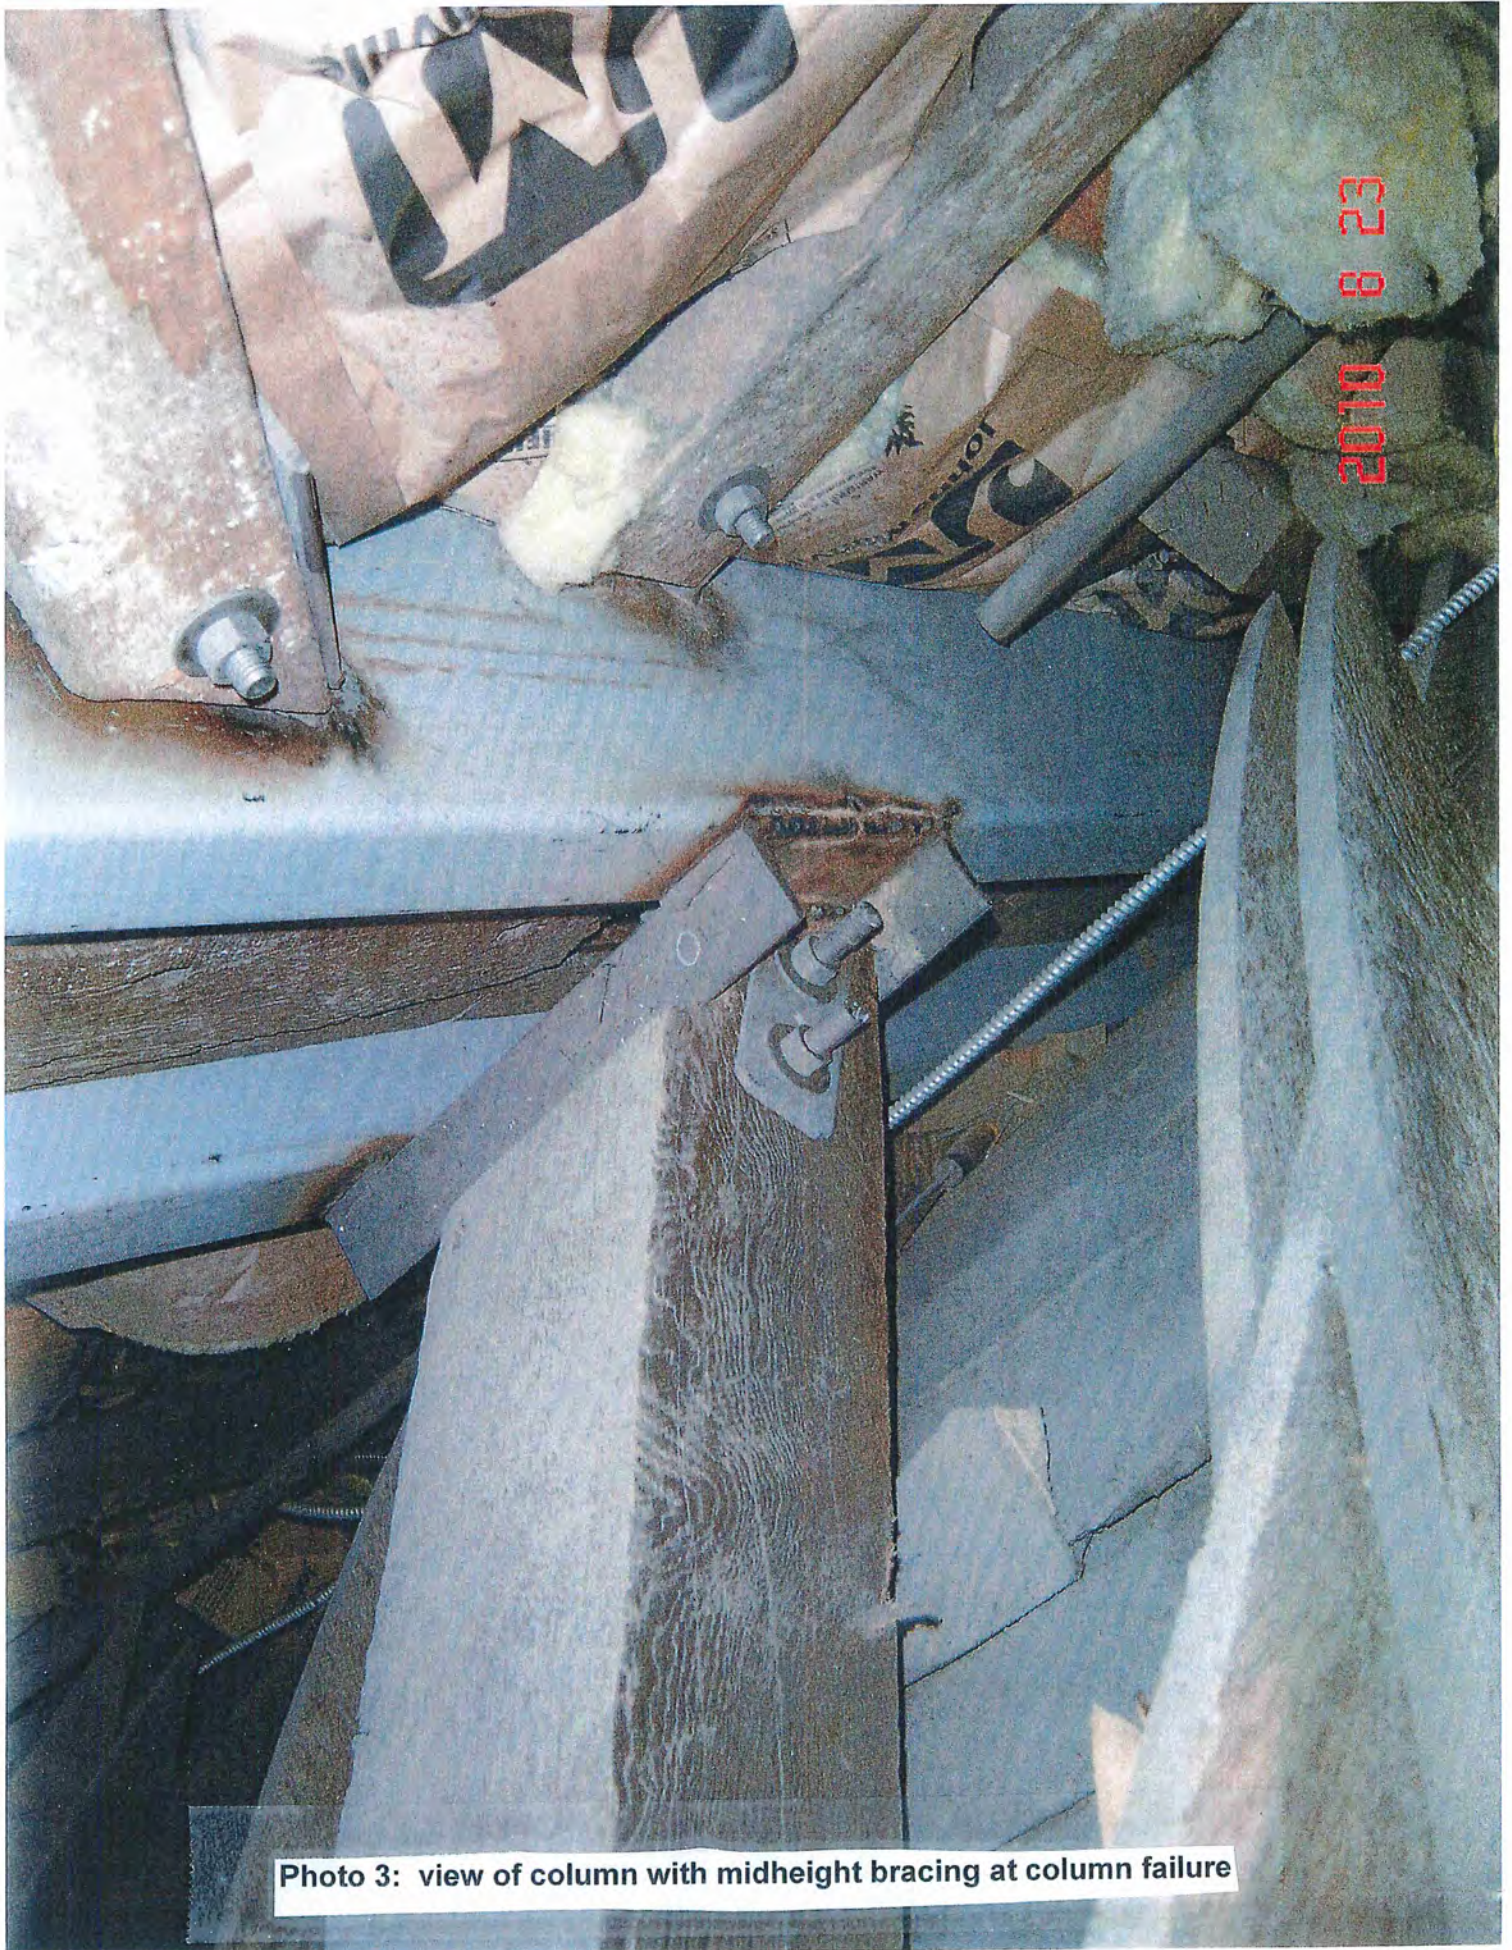
Photo 3: view of column with midheight bracing at column failure
