**NEVADA COMMISSION FOR CULTURAL
CENTERS & HISTORIC PRESERVATION (CCCHP)
GRANT APPLICATION**

Project Title: Carlin School House Rehabilitation
 Project Type: Rehabilitation/Construction Planning/Construction
 Architectural/Engineering Study/Construction

Observations and Recommendations Report – ROUGH DRAFT

Carlin Historical Society Carlin Schoolhouse

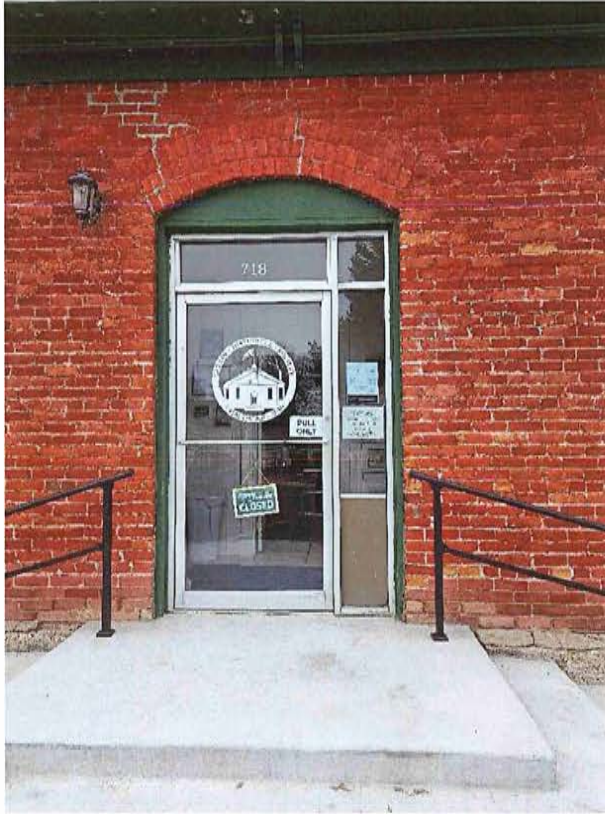
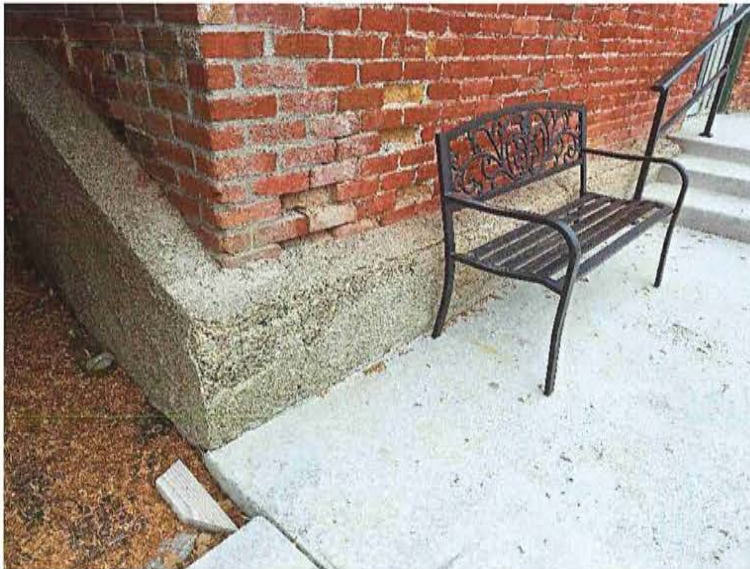
South Elevation

Brick Restoration

- 1.1. Erect scaffold adjacent to the building for safe working access.
- 1.2. Remove up to 300 loose or damaged severely brick from the exterior masonry of the building. Clean off the good brick and set aside to be relaid.
- 1.3 Remove any severely damaged and mismatched mortar joints from the exterior masonry of the building.
- 1.4 Remove damaged mortar associated with up to 7 stair-step cracks around the building. Also remove every third to every fourth horizontal joint associated with these cracked areas for 20" both sides of the point where they intersect the crack.
- 1.5 Install 40" stainless steel helical rods called crack-stitches one in each horizontal preparation with high grade non-shrink grout.
- 1.6 Develop a custom mortar that is compatible with the surrounding masonry and

- reasonably blends with the color and texture of the contiguous mortar.
- 1.7 Find replacement brick that reasonably blends with the original. The brick will be the closest blend of color, size and texture we can find in Salt Lake area brick and salvage yards.
 - 1.8 After properly preparing the mortar joints, repoint the mortar joints with this custom mortar and relay the brick as needed.
 - 1.9 Return once the mortar has sufficiently cured to wash the chimney of any smears and smudges created by these repairs.
 - 1.10 Remove scaffold and properly dispose of any rubble and debris created by these repairs.
Consolidating water repellent.
 - 1.11 After all repairs and paint removal have been completed, apply a silane and siloxane breathable and consolidating water repellent to the exterior masonry of the building.
 - 1.12 Paint, Stain removal.

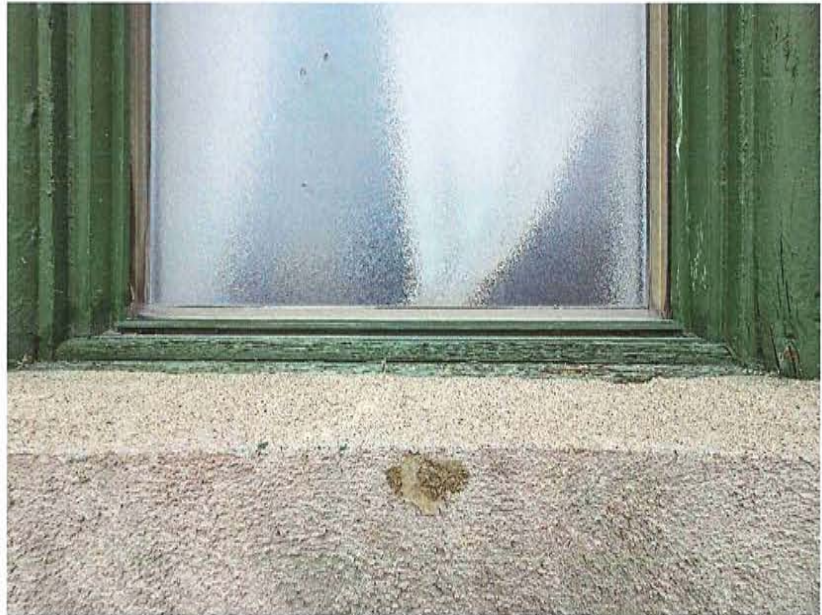
Weathered and Cracking Trim

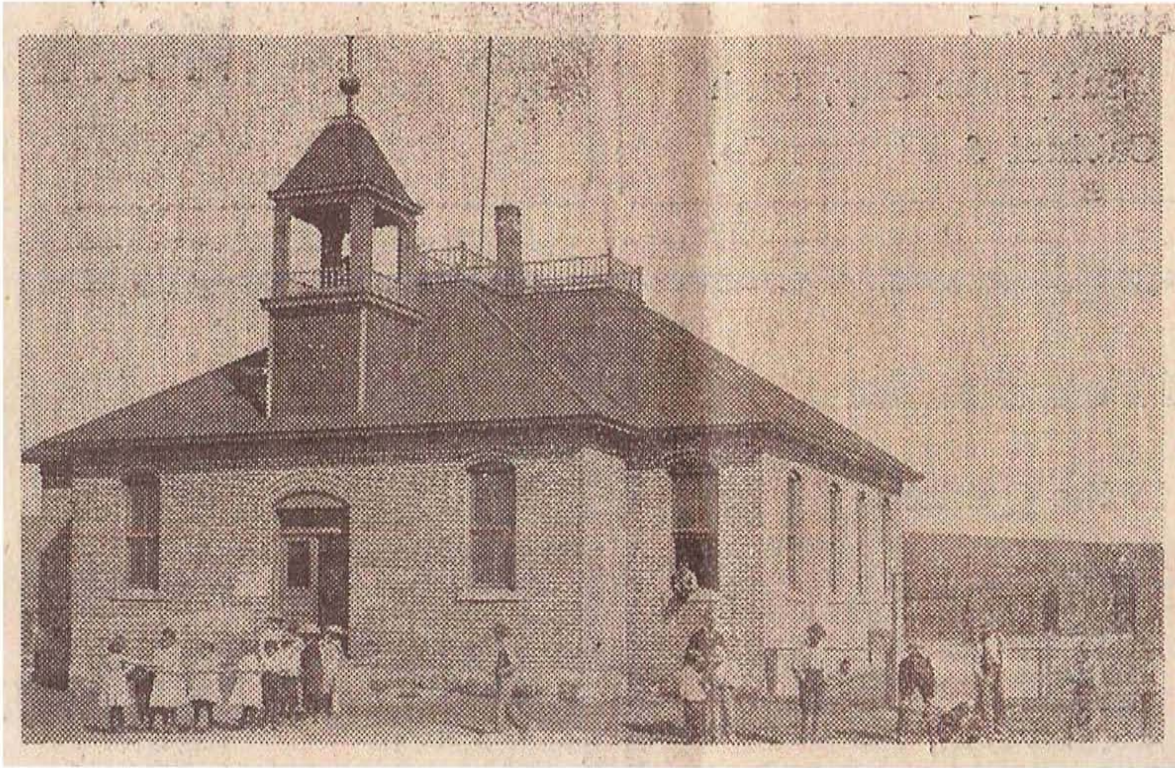
Window Restoration

Showing Original Window Openings and Lites

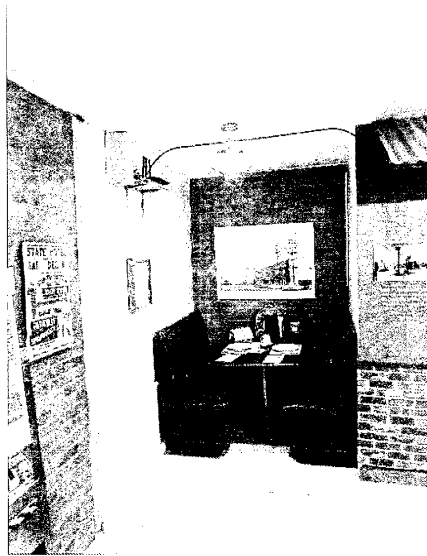
- Some wiring was observed to be attached by non-designed approved and listed for the purpose and routed throughout the space. See figure below.

- Conduit should be provided to route communications/security cabling from all outlets/field devices to the equipment rooms.
- All cabling should be attached and supported by methods approved and listed for the purpose.
- Cabling should be routed through surface using sleeves or other proper methods of supporting and routing wiring through surfaces.
