## NEVADA REGISTER OF HISTORIC PLACES Nomination Form

Historic name: Miners' Union Hall  
Other names: Miners' Union Hall, Eagles Hall, Fraternal Order of Eagles Comstock  
Aerie No. 523 Hall

Street Address: 36 North B Street  
City or Town: Virginia City County: Storey Zip: 89440-0080  
Original Location? ☒ Yes ☐ No. If no, date moved: \_\_\_\_\_

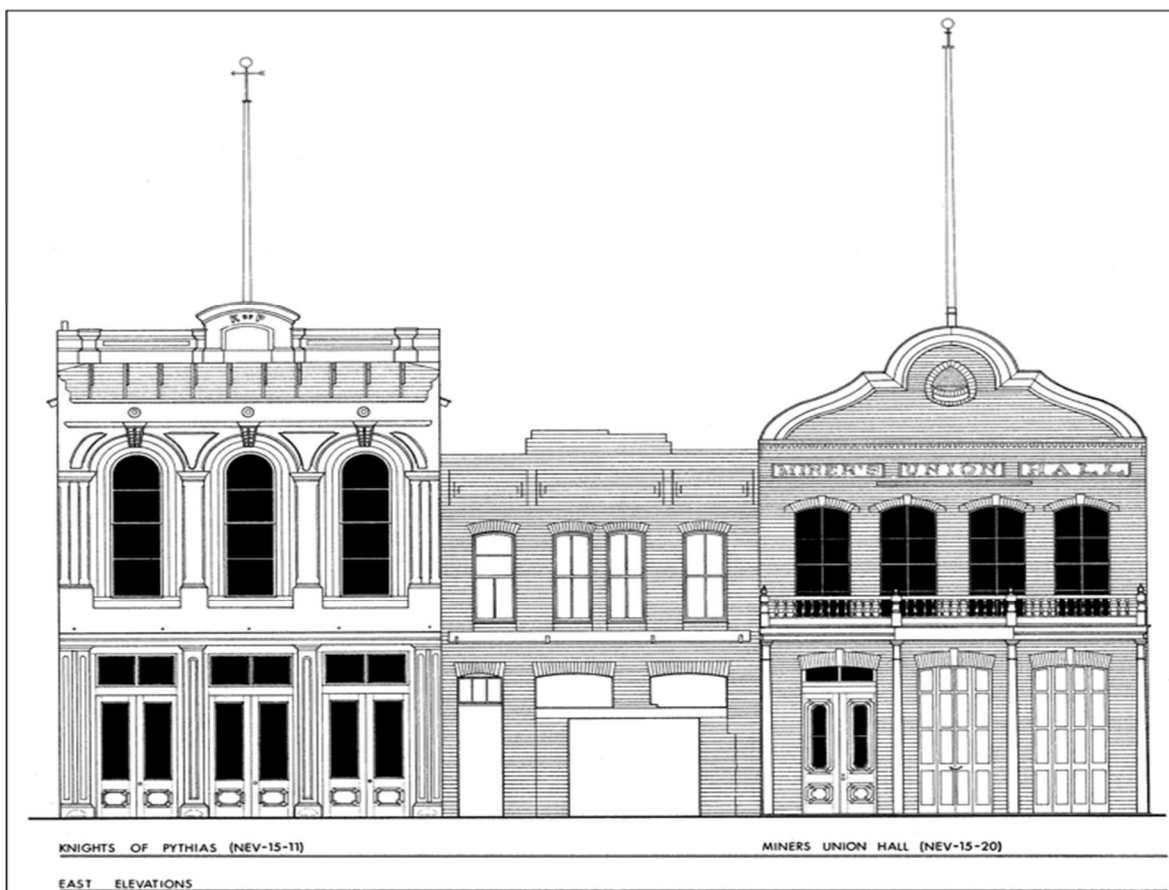
**Figure 8.** Frontal elevation view of the Miners' Union Hall and adjacent Knights of Pythias Building on B Street, Virginia City, Nevada, documented by the Historic American Buildings Survey (HABS), 1937. Courtesy of the Library of Congress.

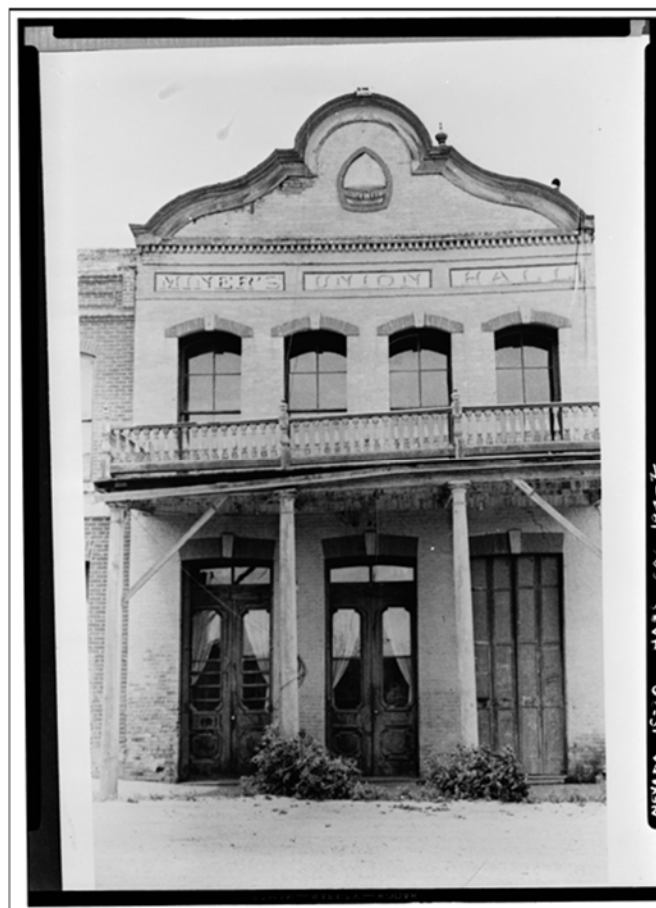
**Figure 10.** Miners' Union Hall, Virginia City, Nevada, east elevations, photographed in 1940 by Robert W. Kerrigan. Courtesy of the Library of Congress.

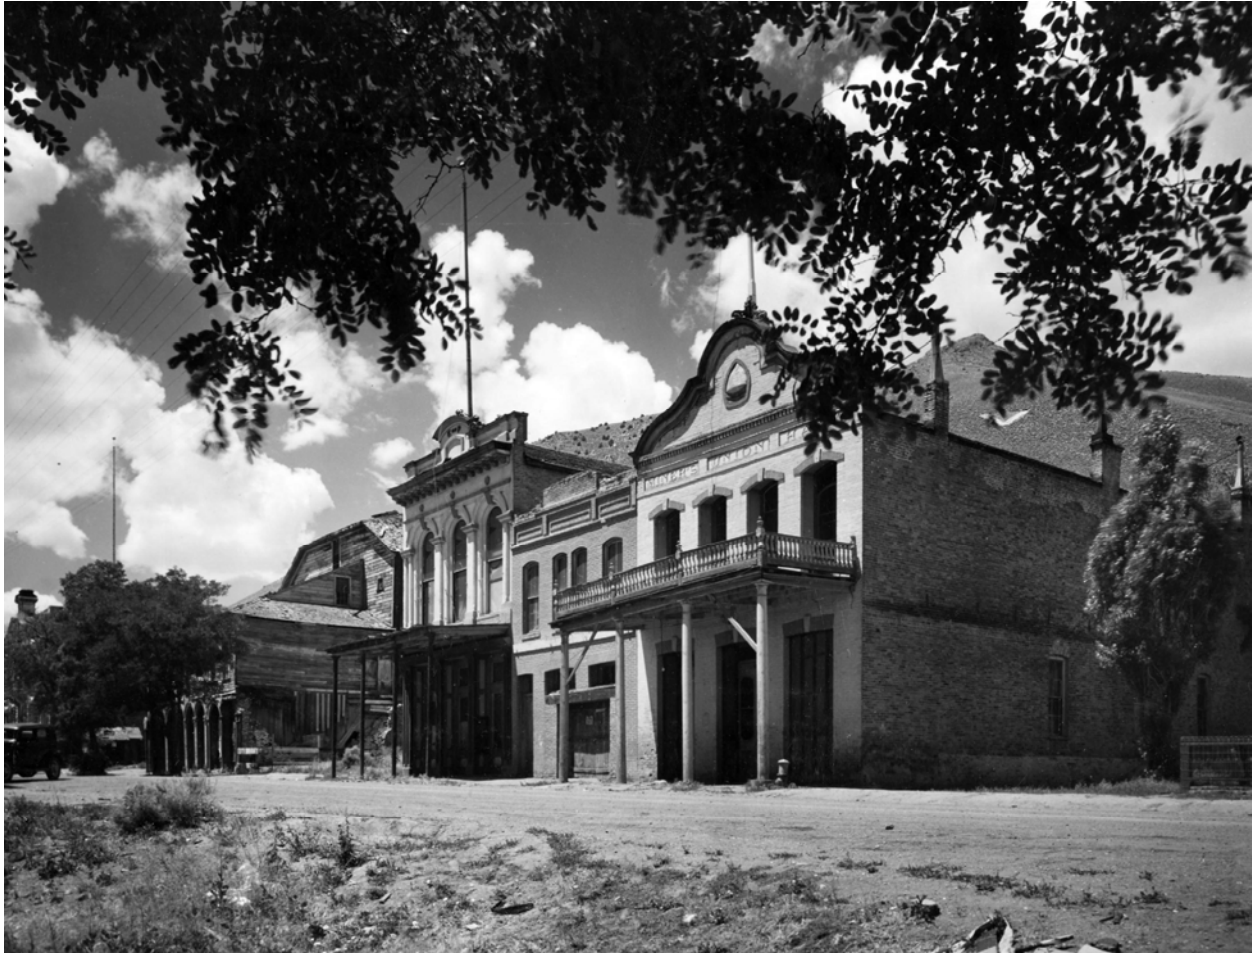
**Figure 11.** *Miners' Union Hall, Virginia City, Nevada, north and east elevations, photographed by Josef Muench in the 1930s. Courtesy of the Utah State Historical Society.*

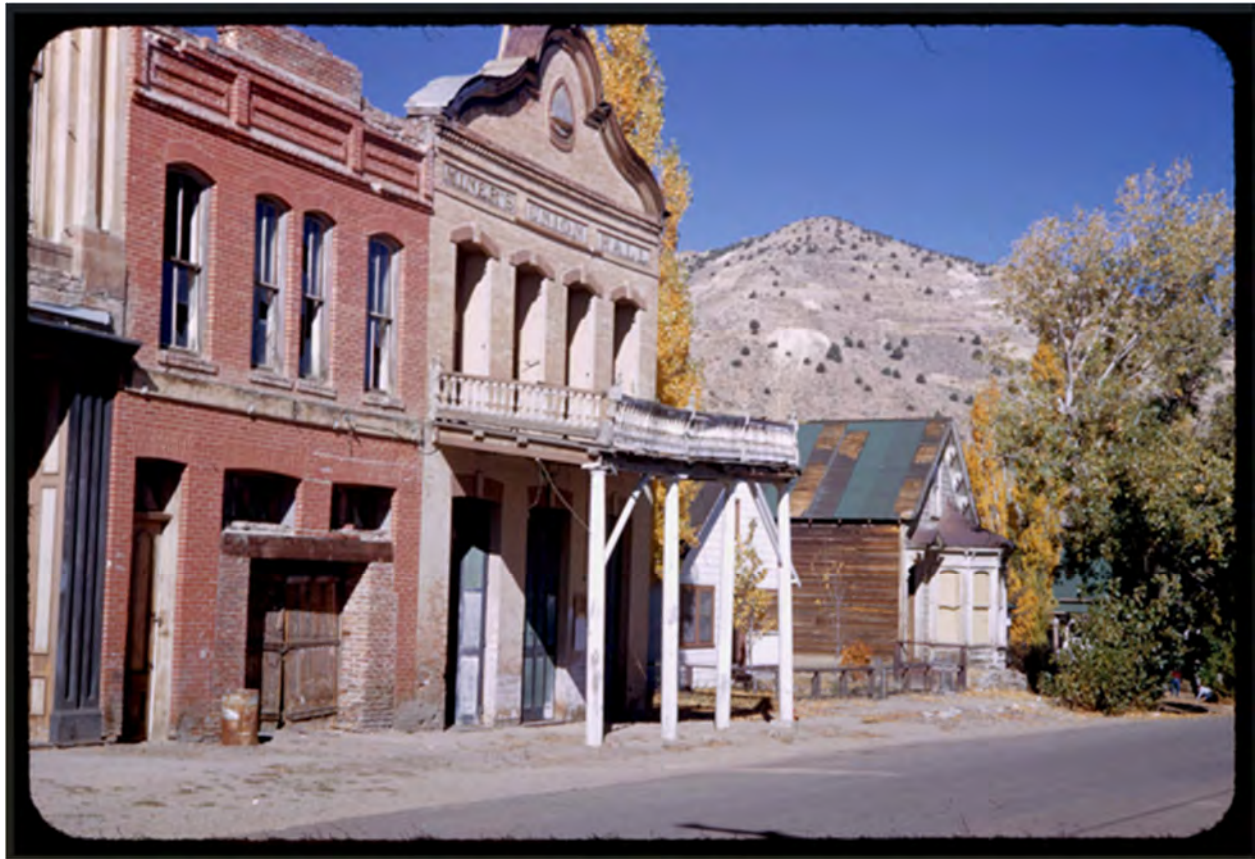
**Figure 12.** *Miners' Union Hall, Virginia City, Nevada, north and east elevations, photographed in 1952 by Charles Cushman. Courtesy Indiana University*

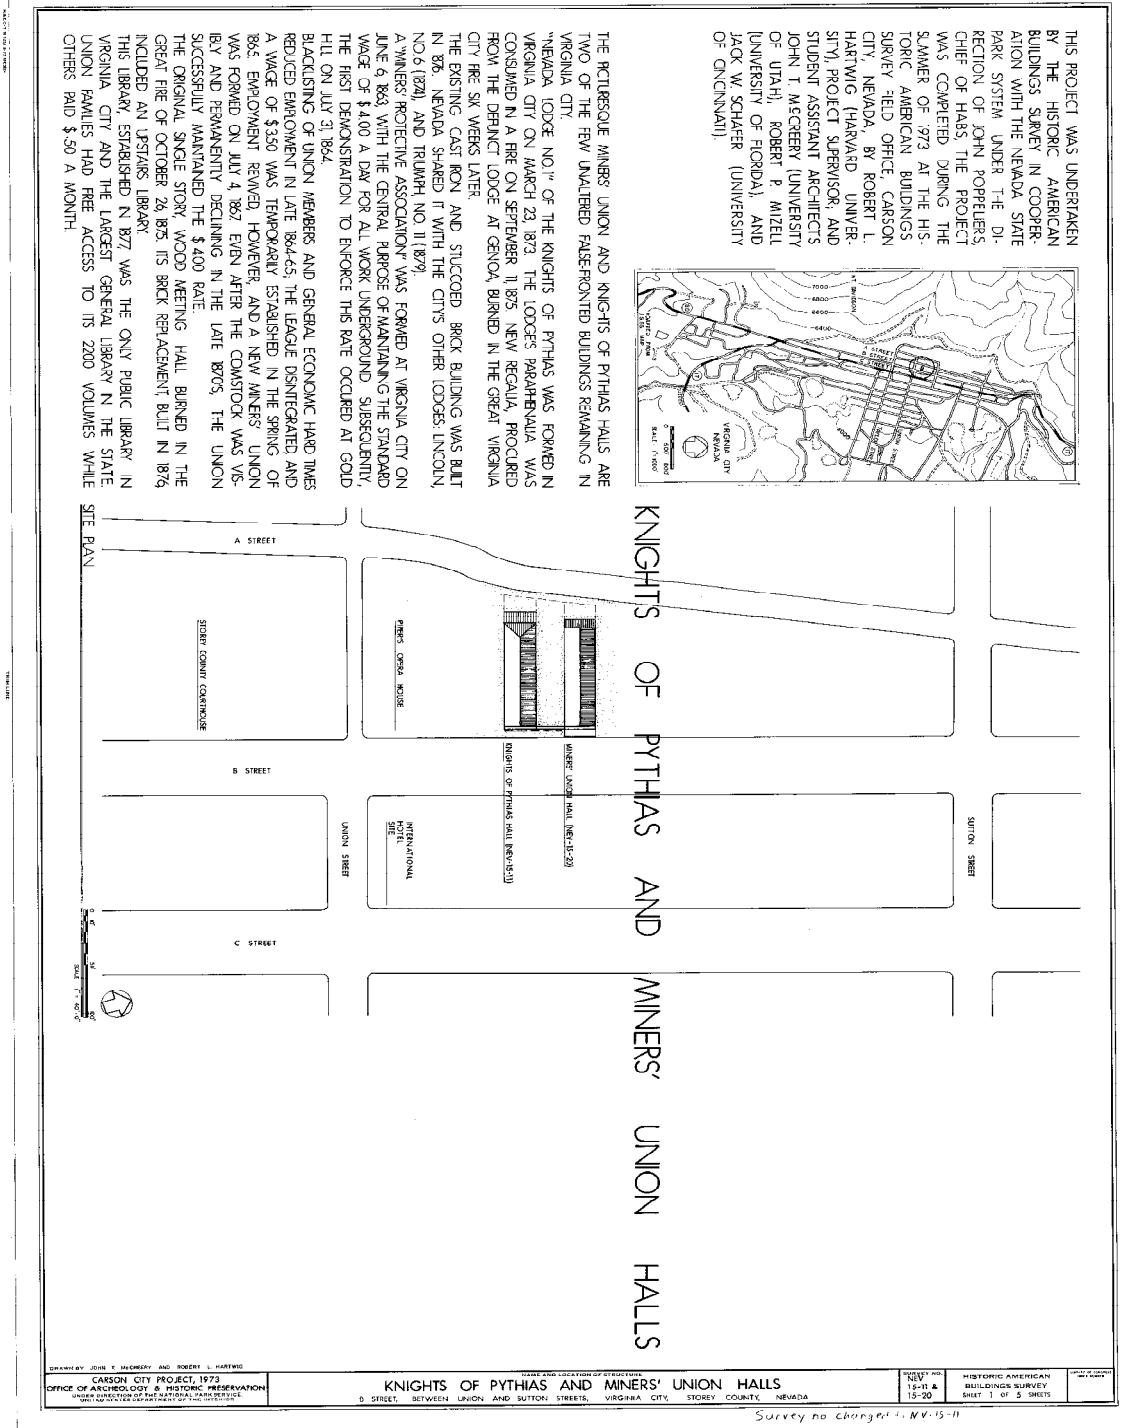
**Figure 14.** Historic American Buildings Survey site plan showing the location of the Miners' Union Hall and adjacent Knights of Pythias Hall within Virginia City's historic commercial district, 1937. Courtesy of the Library of Congress (HABS No. NV-15-11, Sheet 1 of 5).

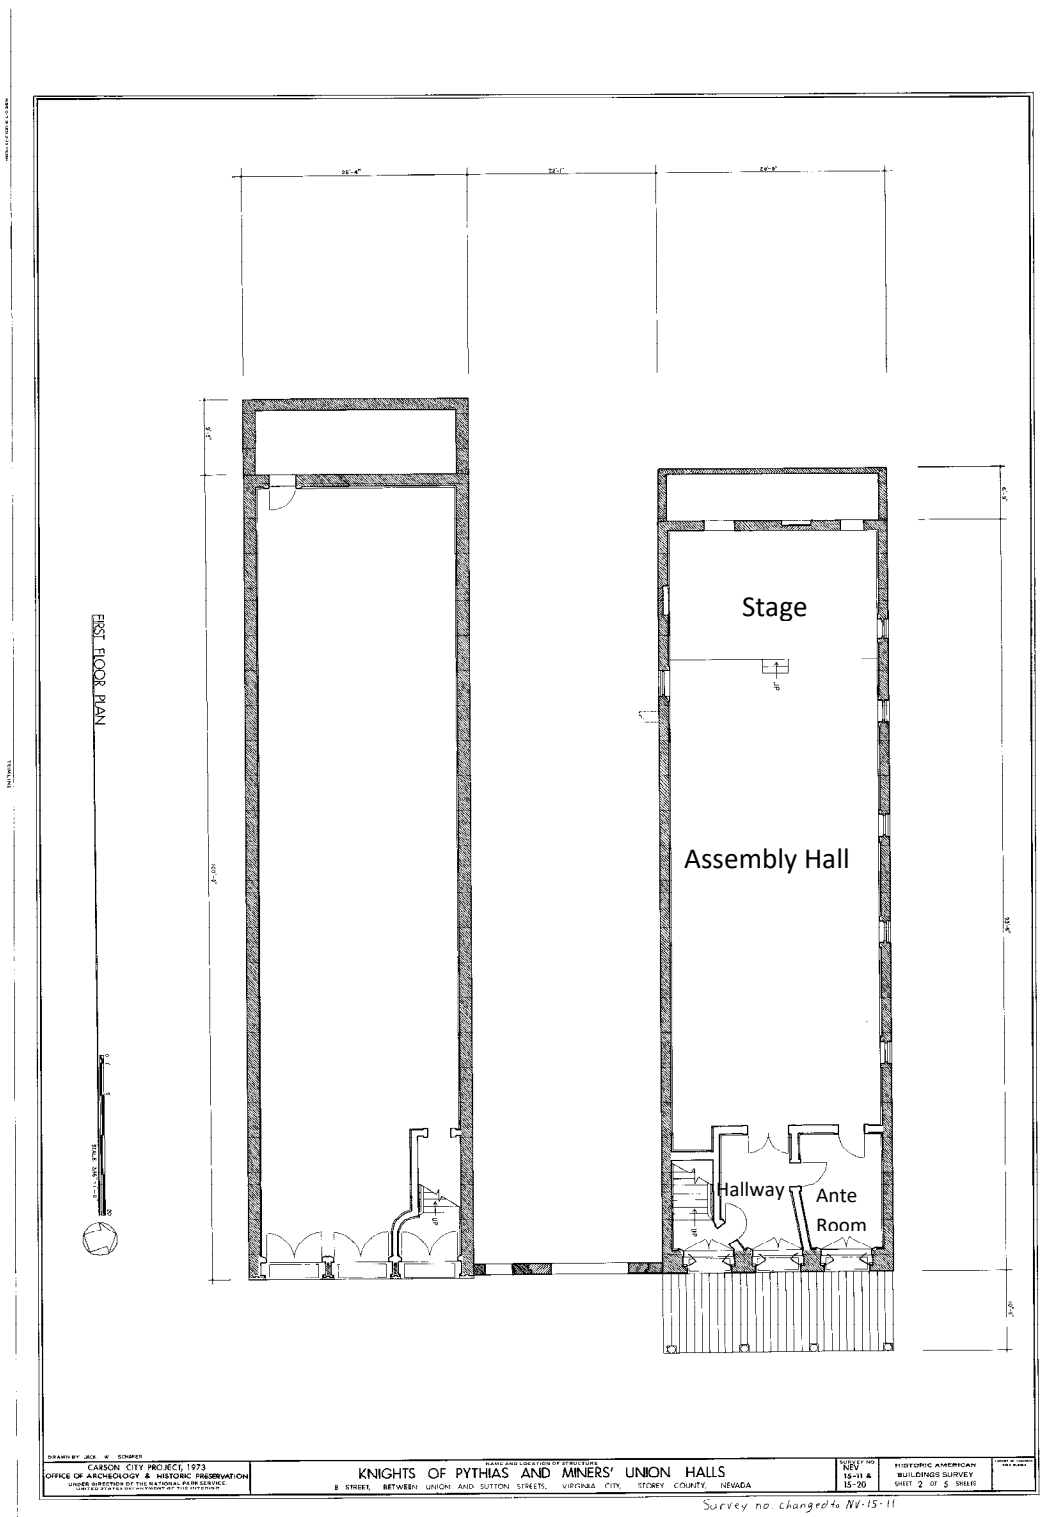
**Figure 15.** First-floor plan of the Miners' Union Hall and adjacent Knights of Pythias Hall prepared for the Historic American Buildings Survey, illustrating the arrangement of the principal assembly spaces, stage area, entrance vestibules, and circulation patterns. Courtesy of the Library of Congress (HABS No. NV-15-11, Sheet 2 of 5).

The Miners' Union Hall was designed to accommodate multiple functions within a single building. The first floor was dominated by a large assembly hall used for union meetings, lectures, public gatherings, and social events. Visitors entered from the covered porch on the east facade into a small entrance lobby at the southeast corner of the building. From the lobby, a vestibule provided direct access to the main assembly hall, while an adjacent staircase led to the second floor (HABS, 1937).

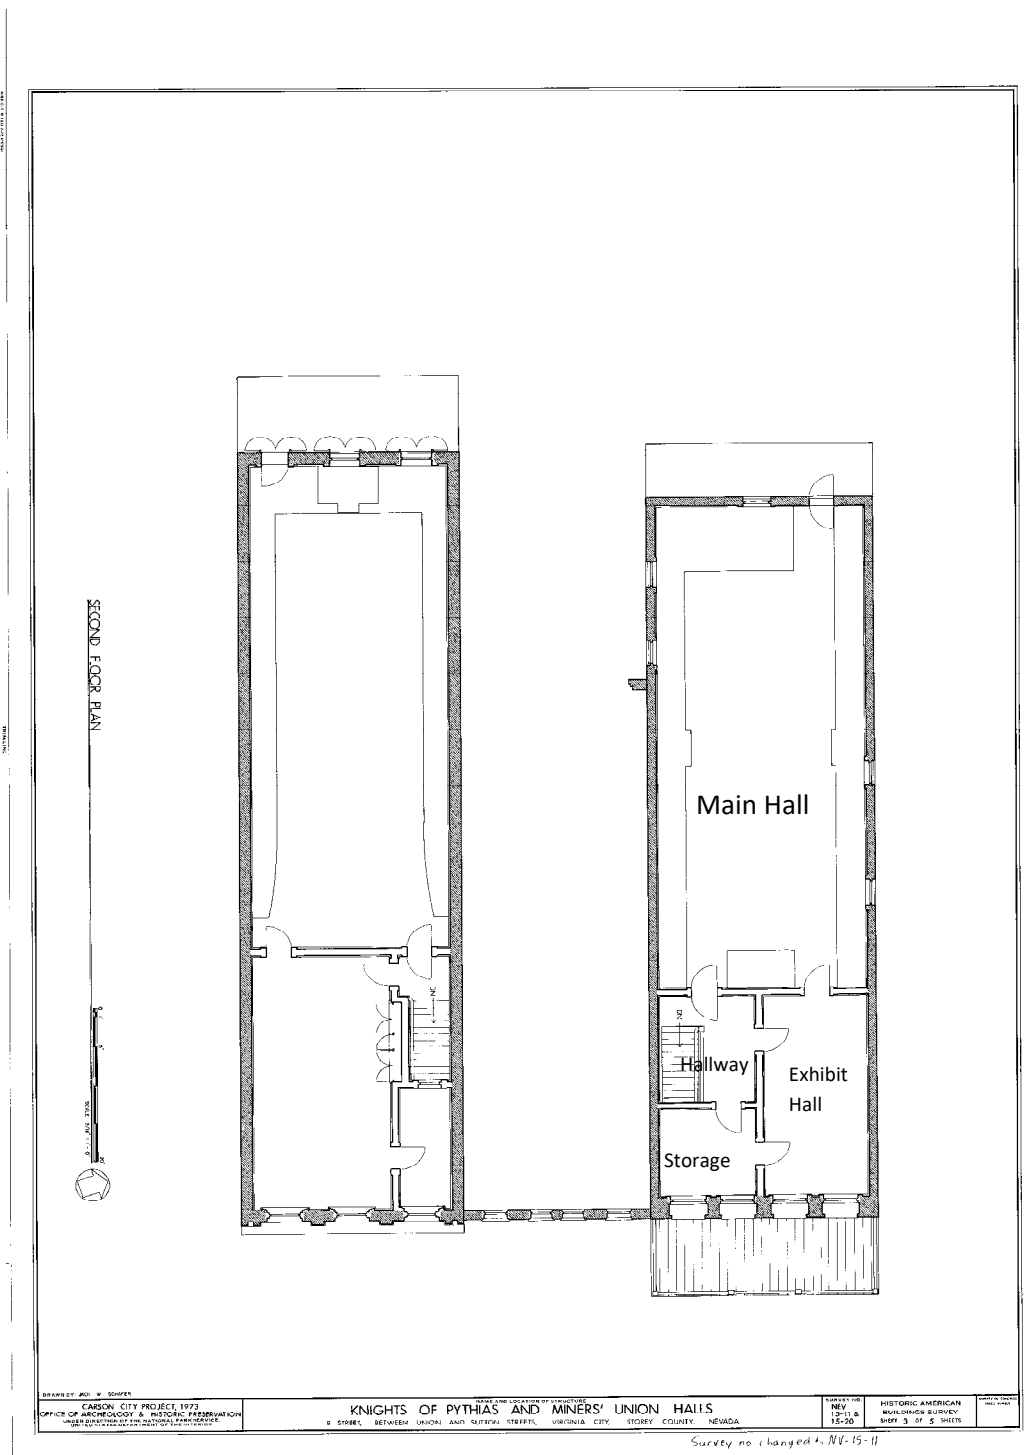
**Figure 16.** Second-floor plan of the Miners' Union Hall and adjacent Knights of Pythias Hall prepared for the Historic American Buildings Survey, illustrating the arrangement of the upper assembly spaces, library and reading room areas, stairways, and circulation patterns. Courtesy of the Library of Congress (HABS No. NV-15-11, Sheet 3 of 5).

The second floor housed the Miners' Union Library, reading room, and chess room. This arrangement physically separated the building's public assembly space from its educational and administrative functions, reflecting the union's commitment to education, recreation, and civic engagement while illustrating how the Miners' Union Hall served as a unified institutional center for organized labor and community life in Virginia City (Thompson & West, 1881).

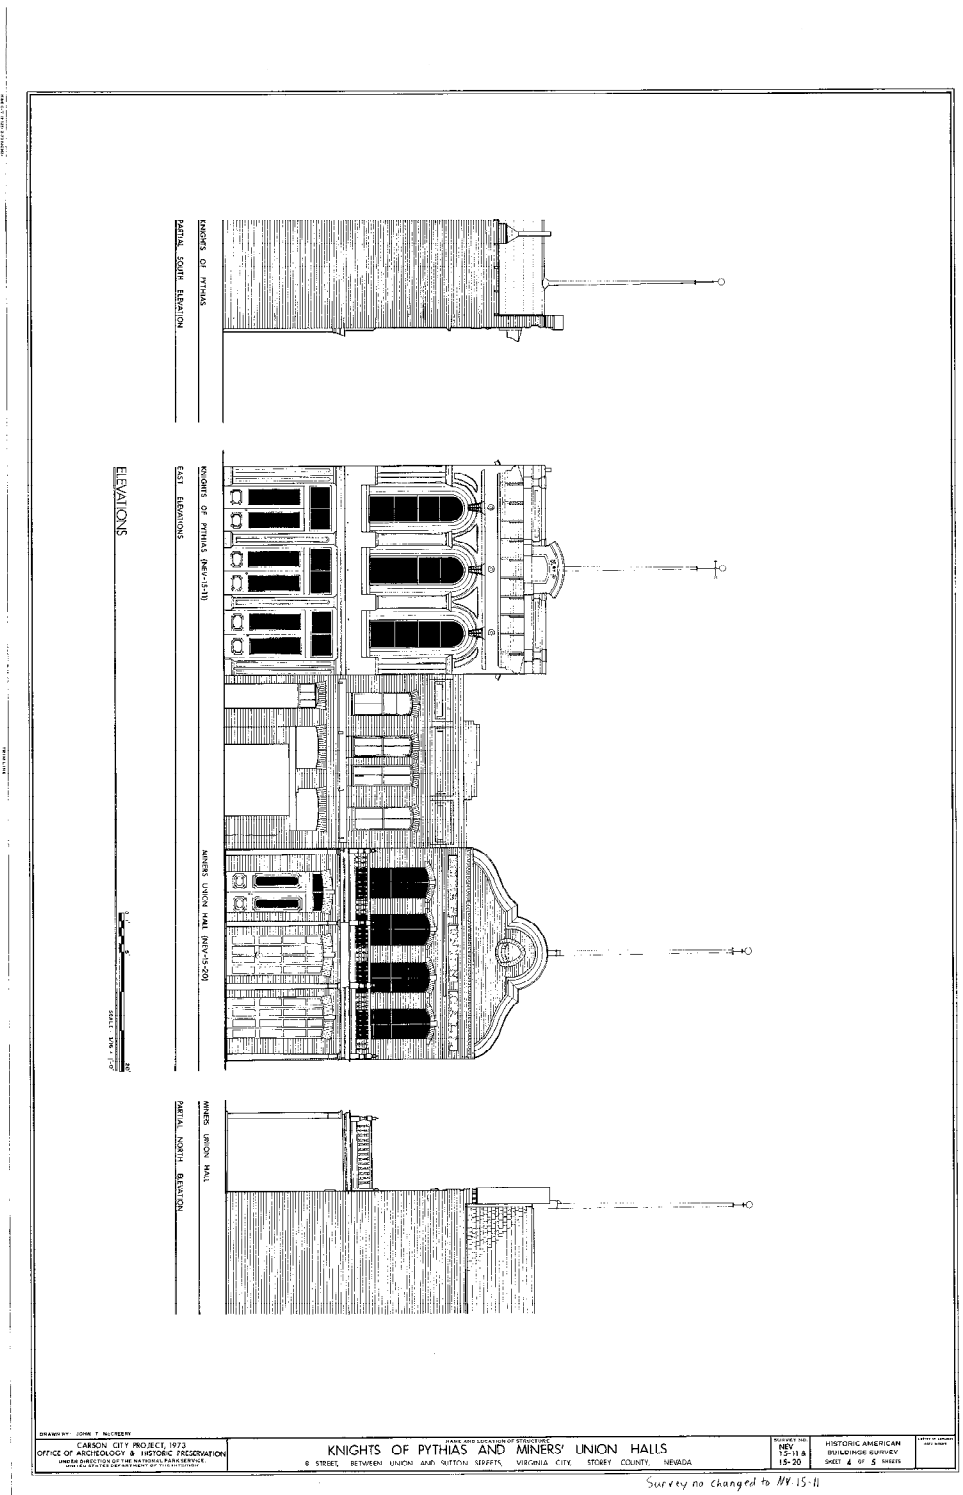
**Figure 17.** Historic American Buildings Survey elevation drawings of the Miners' Union Hall and adjacent Knights of Pythias Hall, depicting the east (primary) and north elevations of the two buildings in Virginia City, Nevada, 1937. Courtesy of the Library of Congress (HABS No. NV-15-11, Sheet 4 of 5).

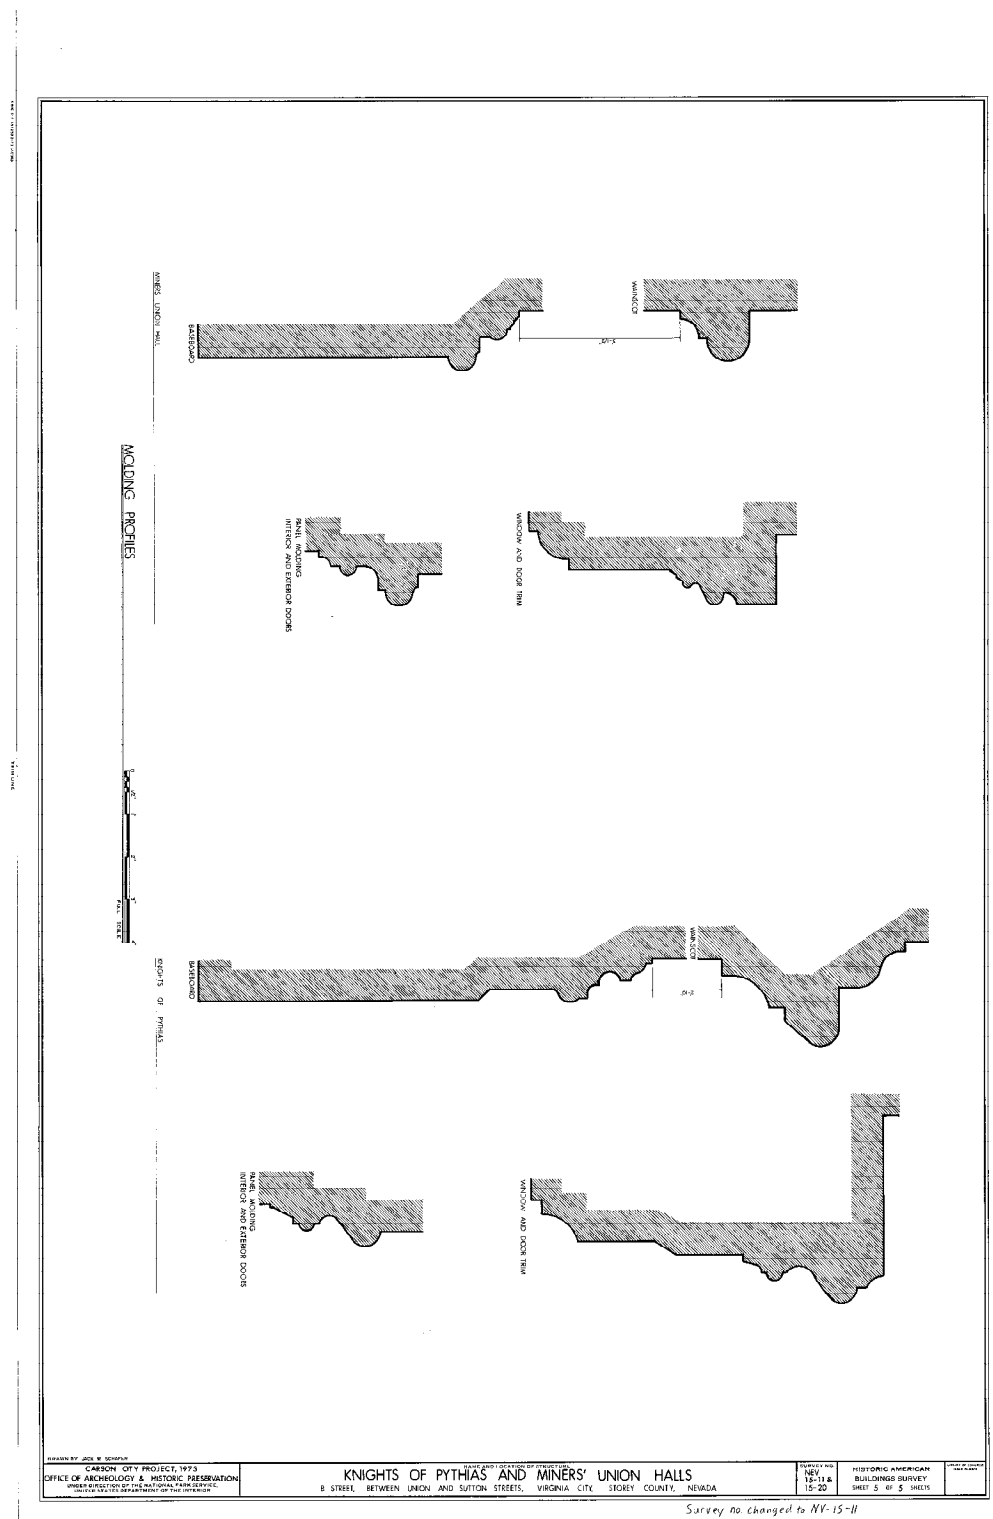
**Figure 18.** Historic American Buildings Survey drawings illustrating representative molding profiles from the Miners' Union Hall and adjacent Knights of Pythias Hall, including baseboards, wainscoting, window and door trim, and interior and exterior door panel moldings. Courtesy of the Library of Congress (HABS No. NV-15-11, Sheet 5 of 5).

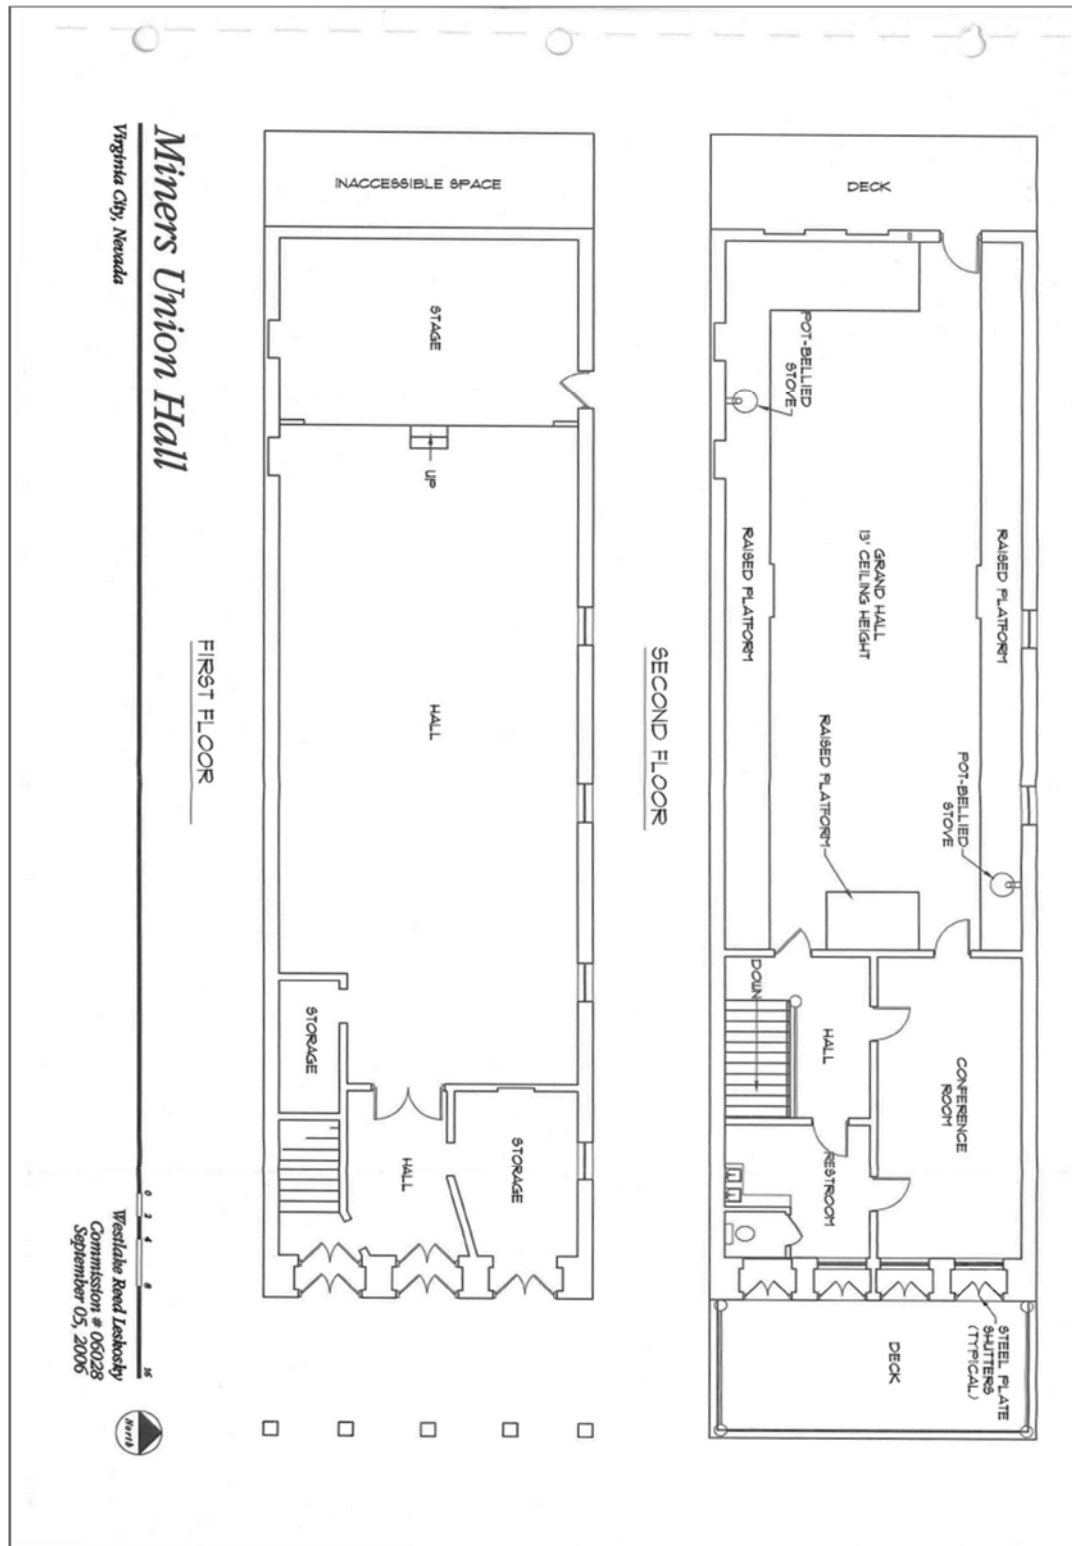
**Figure 19.** Floor plans of the Miners' Union Hall prepared during the 2006 Historic Structure Study, illustrating the first-floor assembly hall and stage area and the second-floor grand hall, conference room, raised platforms, and support spaces. Adapted from Westlake Reed Leskosky, 2006.

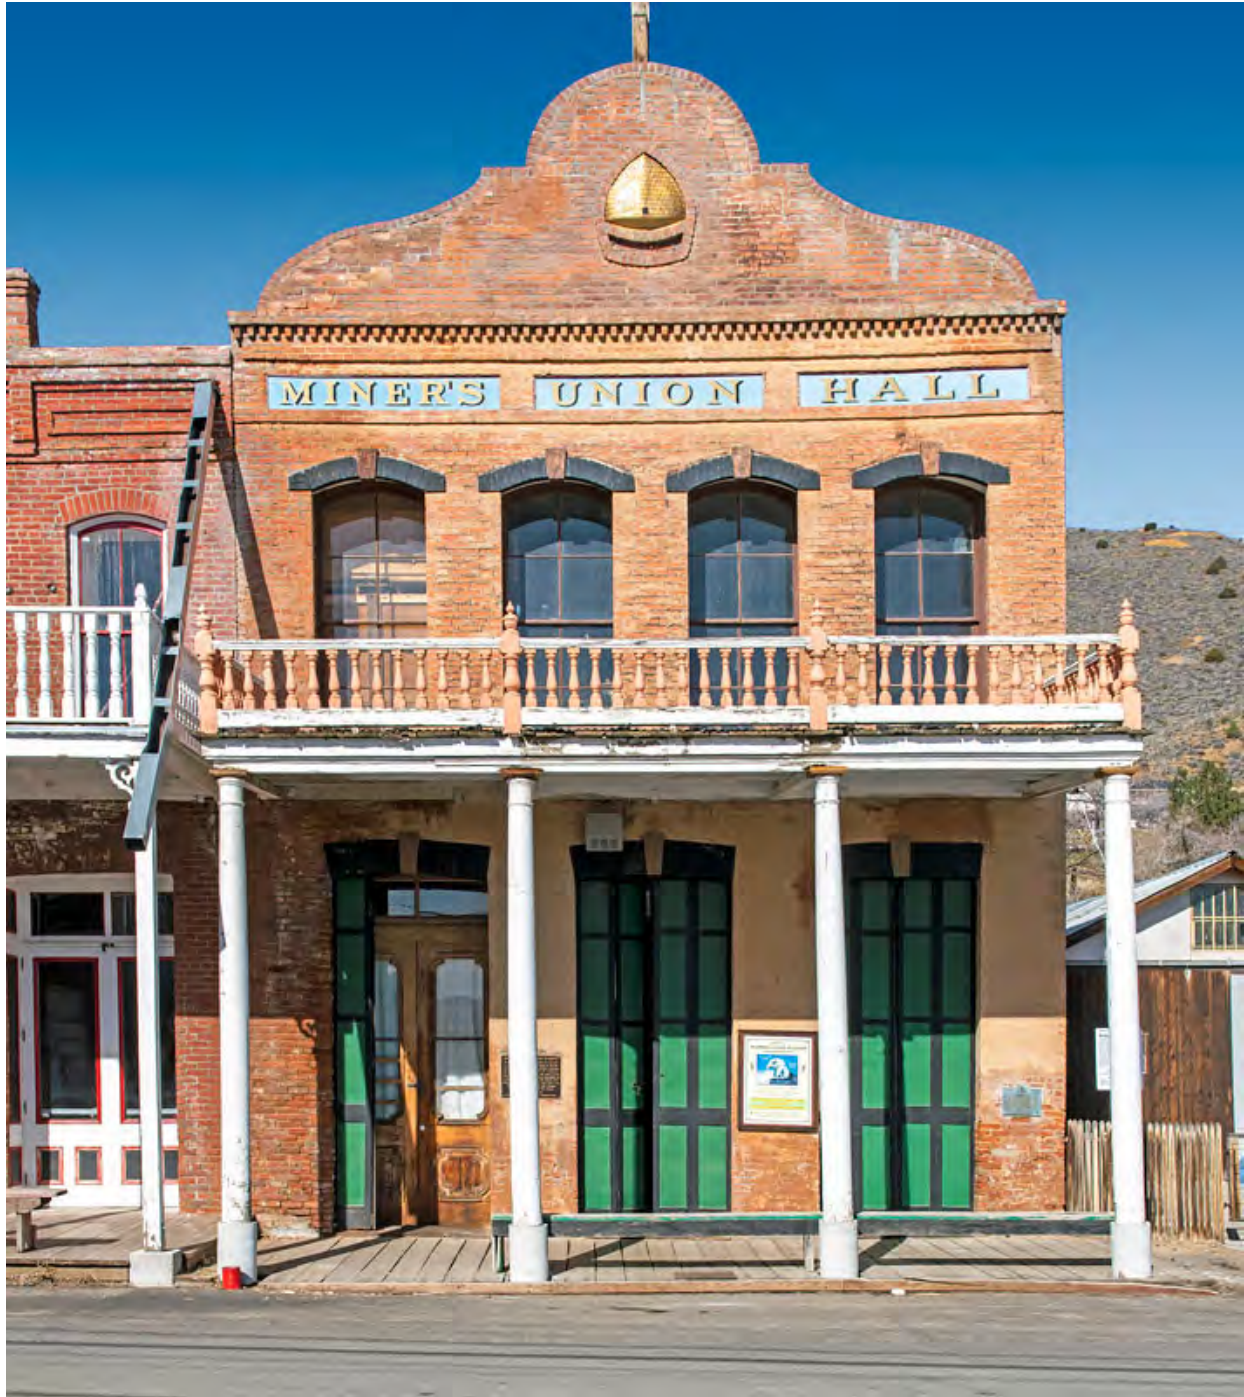
**Photograph 1.** Primary east facade looking west from North B Street. View shows the two-story brick institutional building with curvilinear parapet, painted "MINERS UNION HALL" sign panel, four segmental-arched, two-part commercial second-story window openings, full-width second-story balcony with turned balustrade, one-story porch supported by wood columns, and storefront openings at street level. Photograph by Audie Robinson. Photographed October 18, 2025.

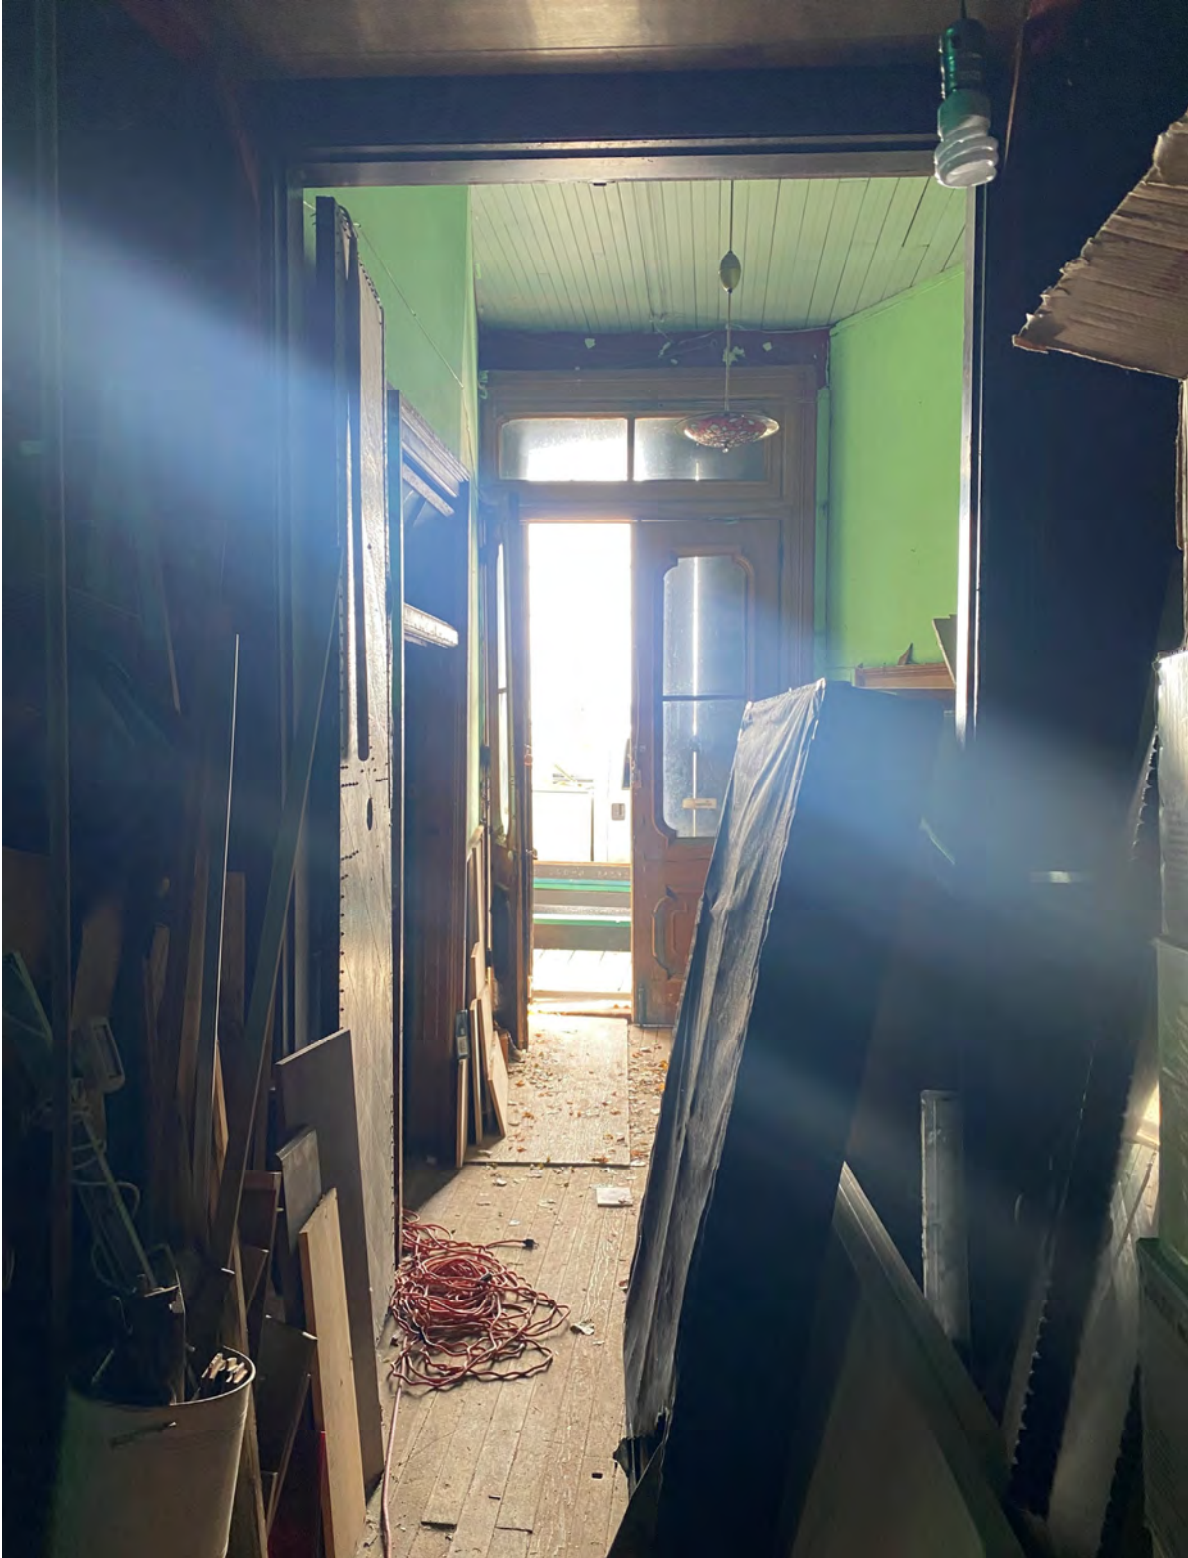
**Photograph 3.** First floor. Entrance vestibule looking east toward North B Street and the primary entrance. Note the historic entry doors, transom windows, wood flooring, and surviving millwork and trim. Photograph by Audie Robinson. Photographed October 18, 2025.

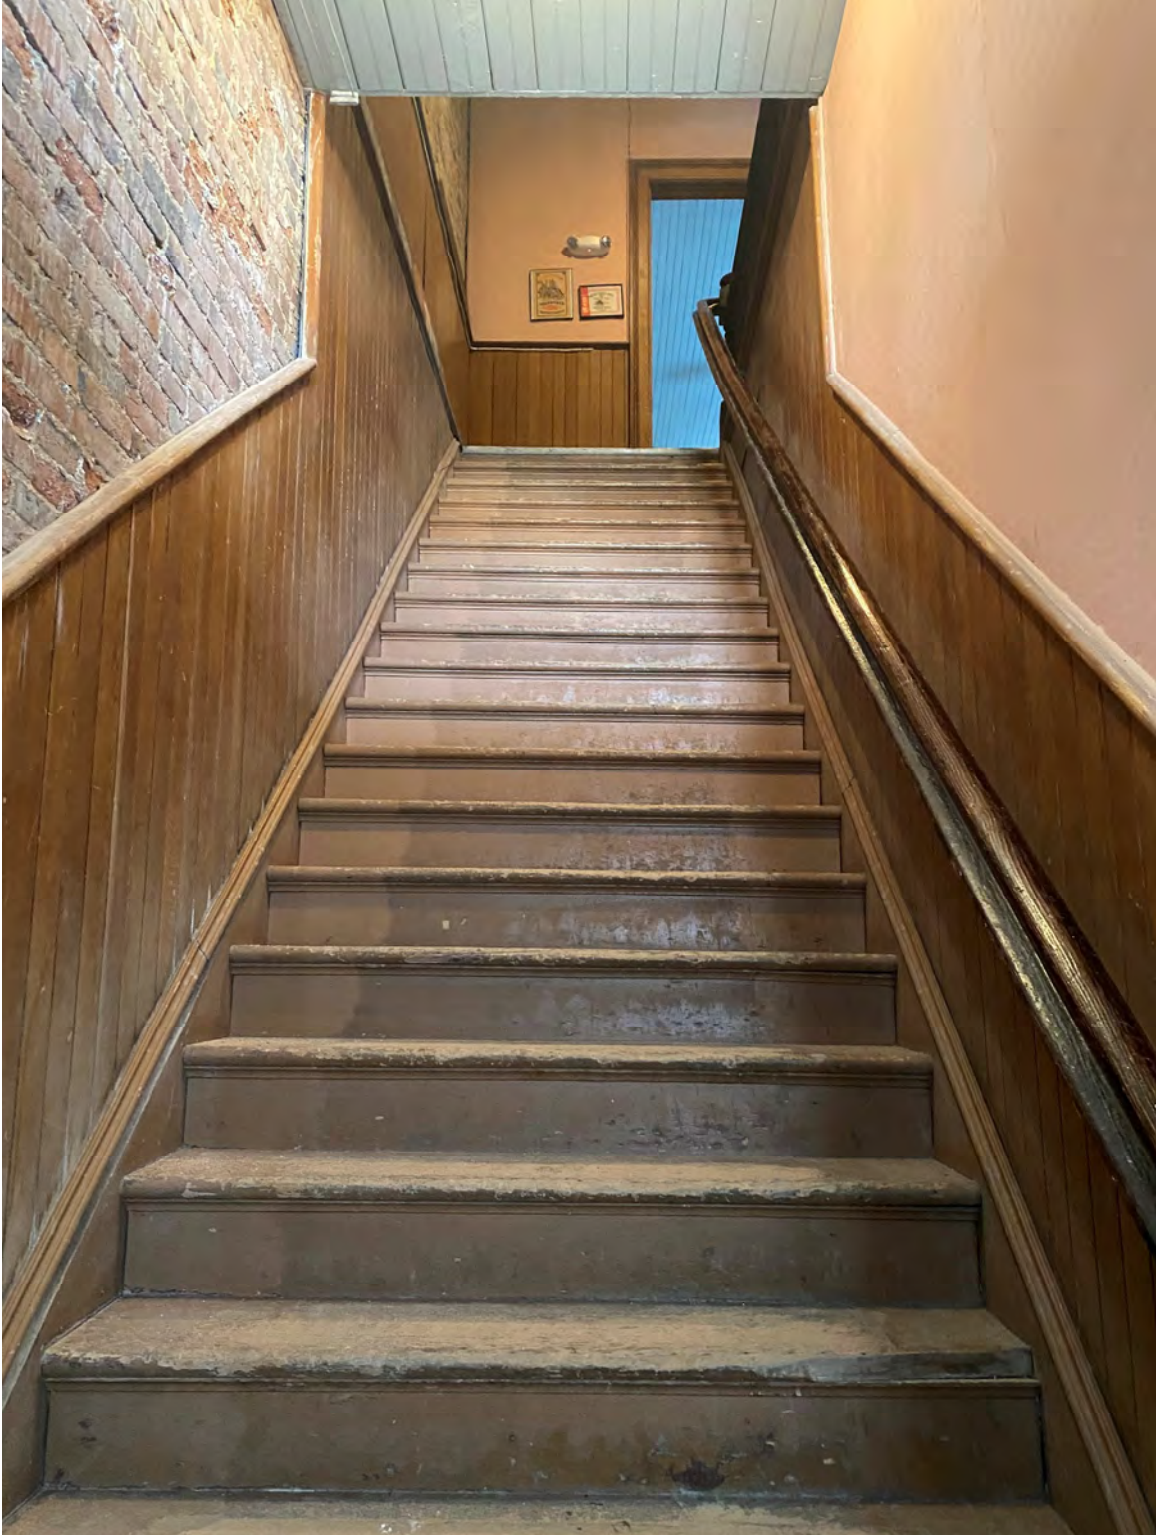
**Photograph 4.** First-floor main stair looking north toward the second-floor landing. View shows original wood stair assembly with wood treads and risers, wood handrail, vertical board wainscoting, plaster walls, exposed brick masonry wall, and tongue-and-groove ceiling above the landing. Photograph by Audie Robinson. Photographed July 14, 2026.

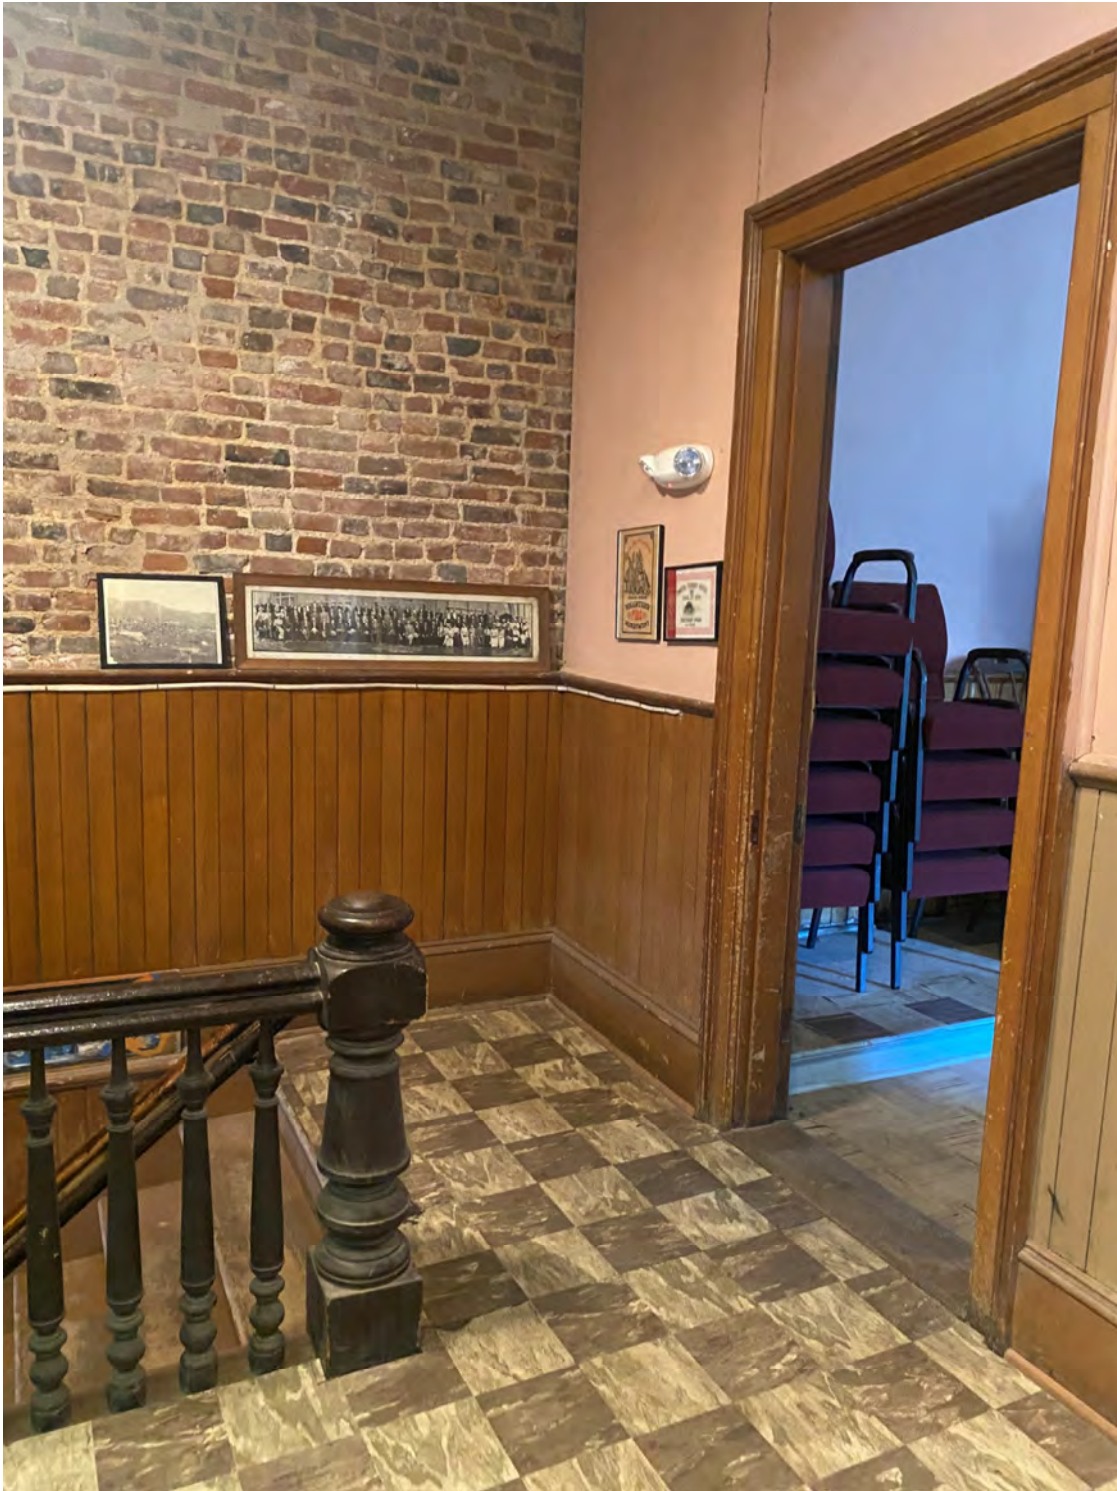
**Photograph 5.** Second-floor landing looking northeast. View shows original stair landing and balustrade, exposed brick masonry wall, vertical board wainscoting, plaster walls, and doorway opening into the adjacent meeting room. Photograph by Audie Robinson. Photographed July 14, 2026.
