## NEVADA REGISTER OF HISTORIC PLACES Nomination Form

Historic name: Miners' Union Hall  
Other names: Miners' Union Hall, Eagles Hall, Fraternal Order of Eagles Comstock  
Aerie No. 523 Hall

Street Address: 36 North B Street  
City or Town: Virginia City County: Storey Zip: 89440-0080  
Original Location? ☒ Yes ☐ No. If no, date moved: \_\_\_\_\_

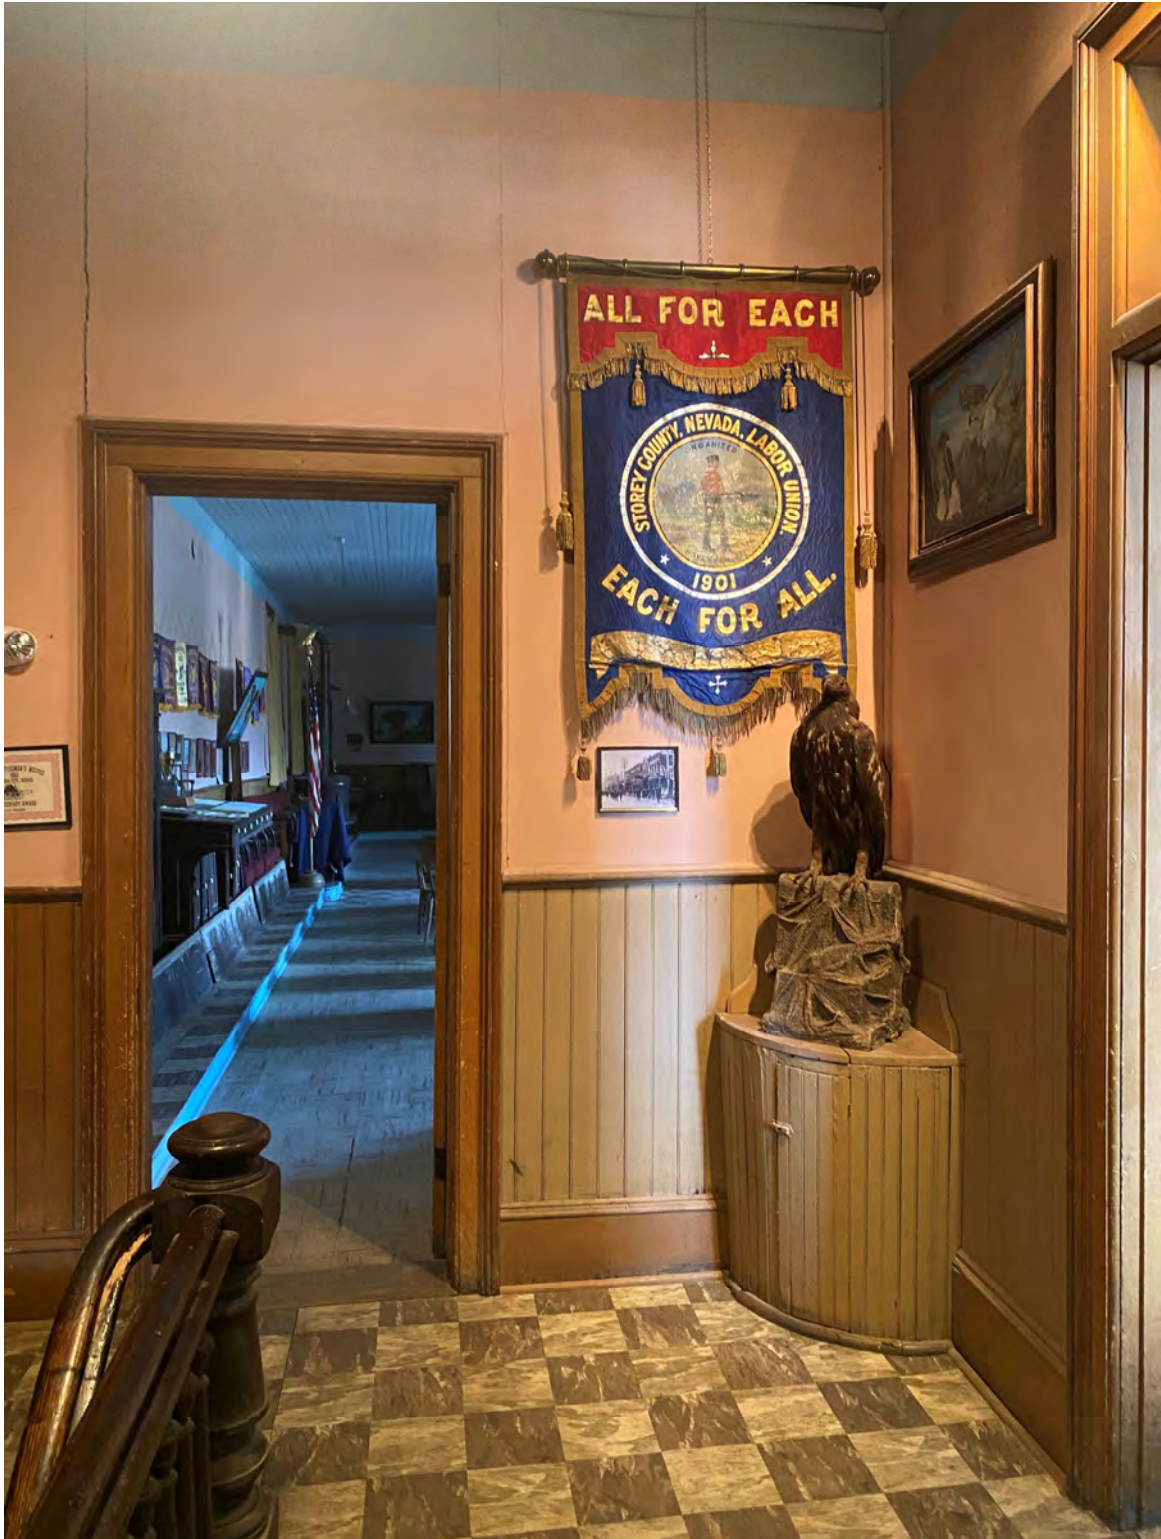
**Photograph 6.** Second-floor entry hall looking west into the Main Hall. View shows wood wainscoting, plaster walls, transomed doorway opening, and circulation between the stair landing and Main Hall assembly space. Photograph by Audie Robinson. Photographed July 14, 2026.

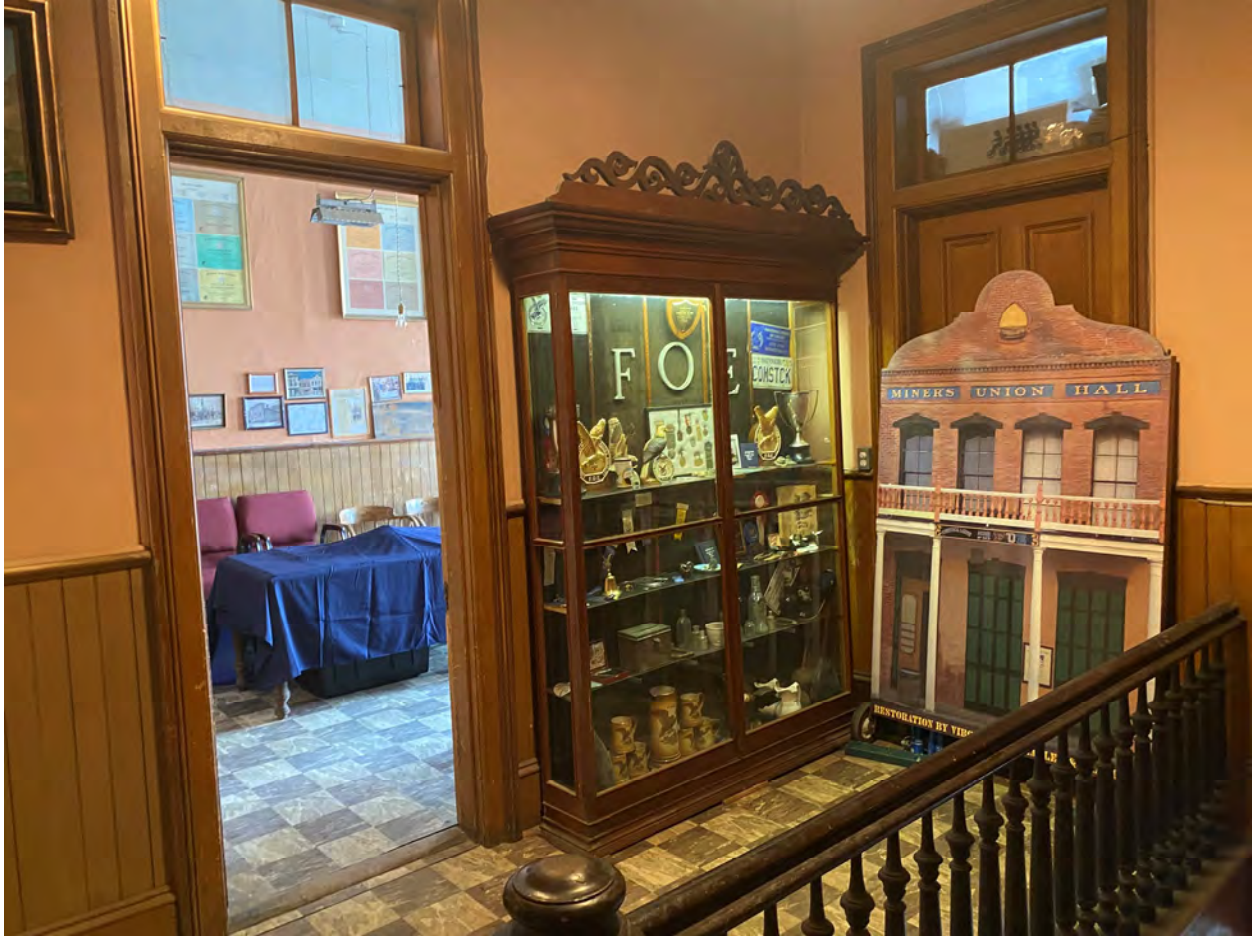
**Photograph 7.** Second-floor stair landing looking northeast toward the exhibit room. View shows wood wainscoting, plaster walls, transomed doorway openings, and circulation between the stair landing, exhibit room, and Main Hall assembly space. Photograph by Audie Robinson. Photographed July 14, 2026.

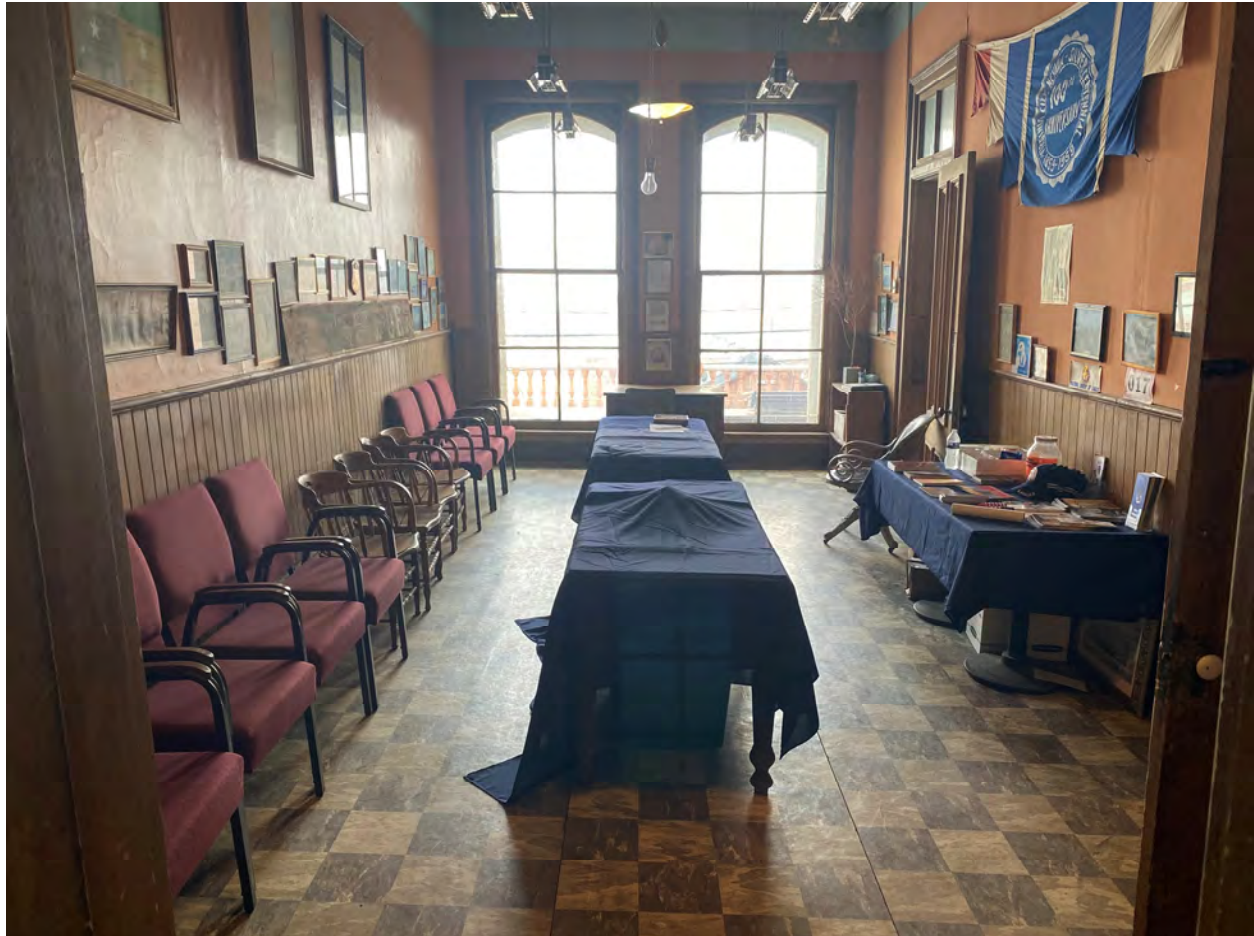
**Photograph 8.** Second-floor exhibit room looking east toward the balcony windows overlooking B Street. View shows wood wainscoting, plaster walls, wood flooring, historic window openings, and exhibit space adjacent to the Main Hall assembly room. Photograph by Audie Robinson. Photographed July 14, 2026.

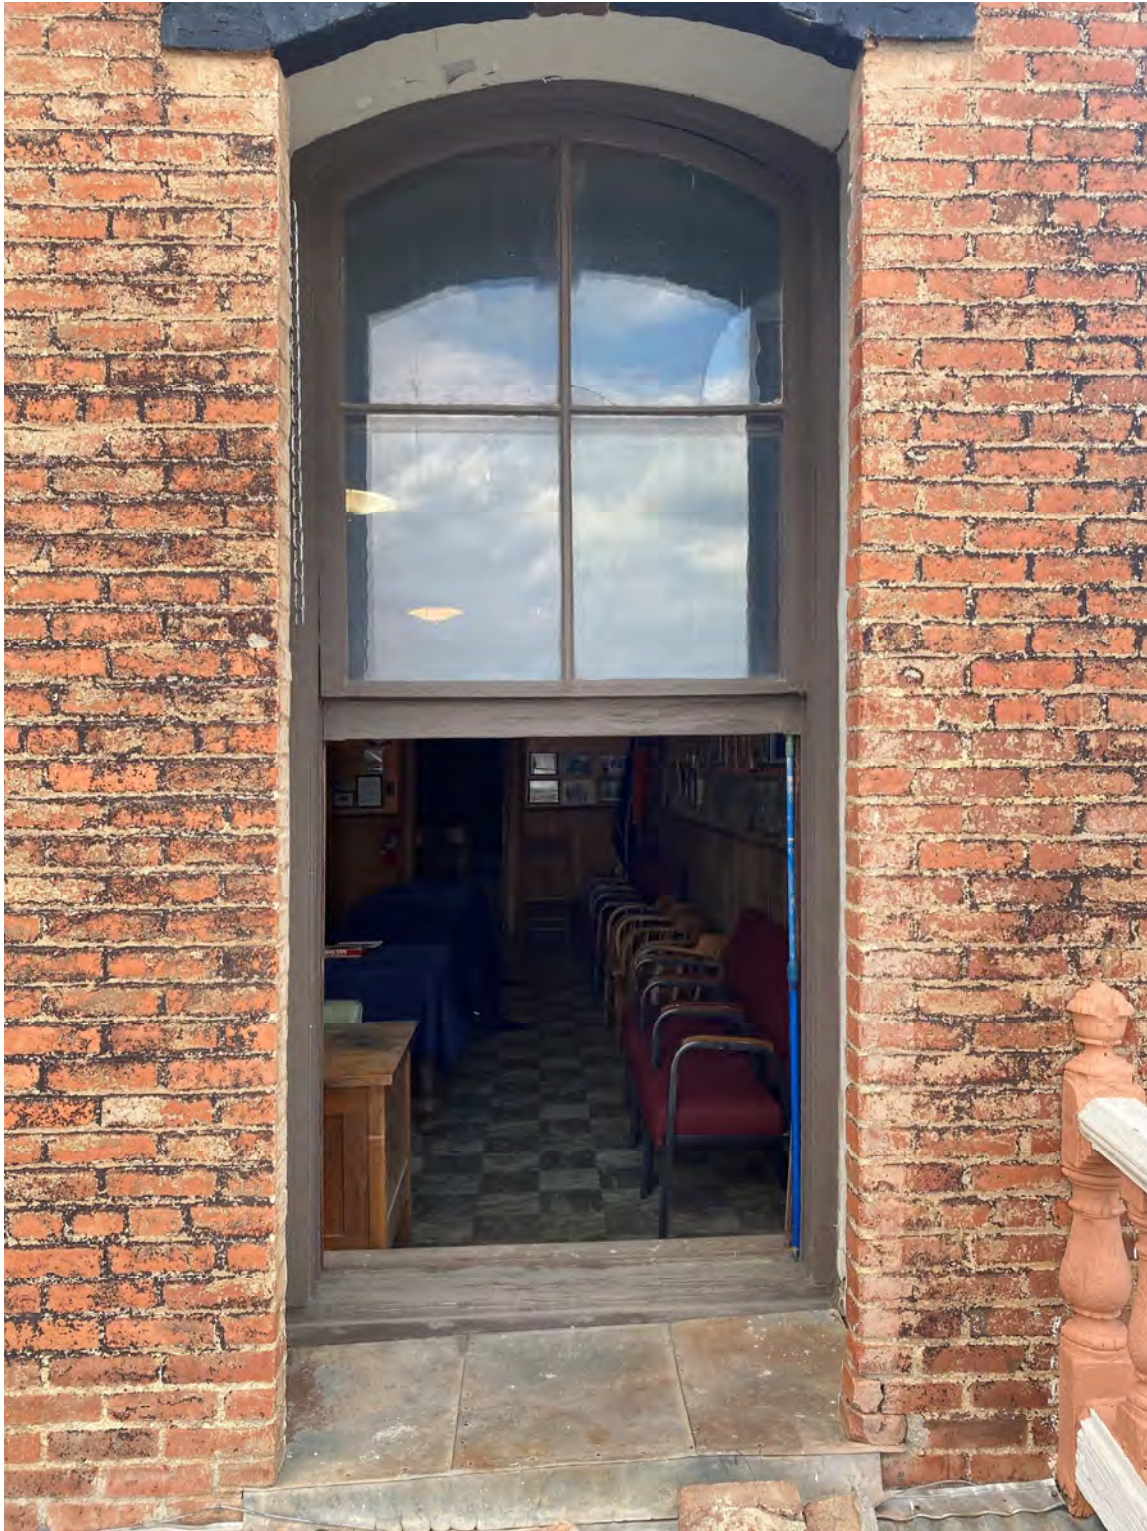
**Photograph 9.** Second-floor front elevation window looking west into the second-floor exhibit room from the exterior balcony. View shows the segmental arched masonry opening, wood window frame and sash, and relationship between the exterior balcony and second-floor exhibit room. Photograph by Audie Robinson. Photographed July 14, 2026.

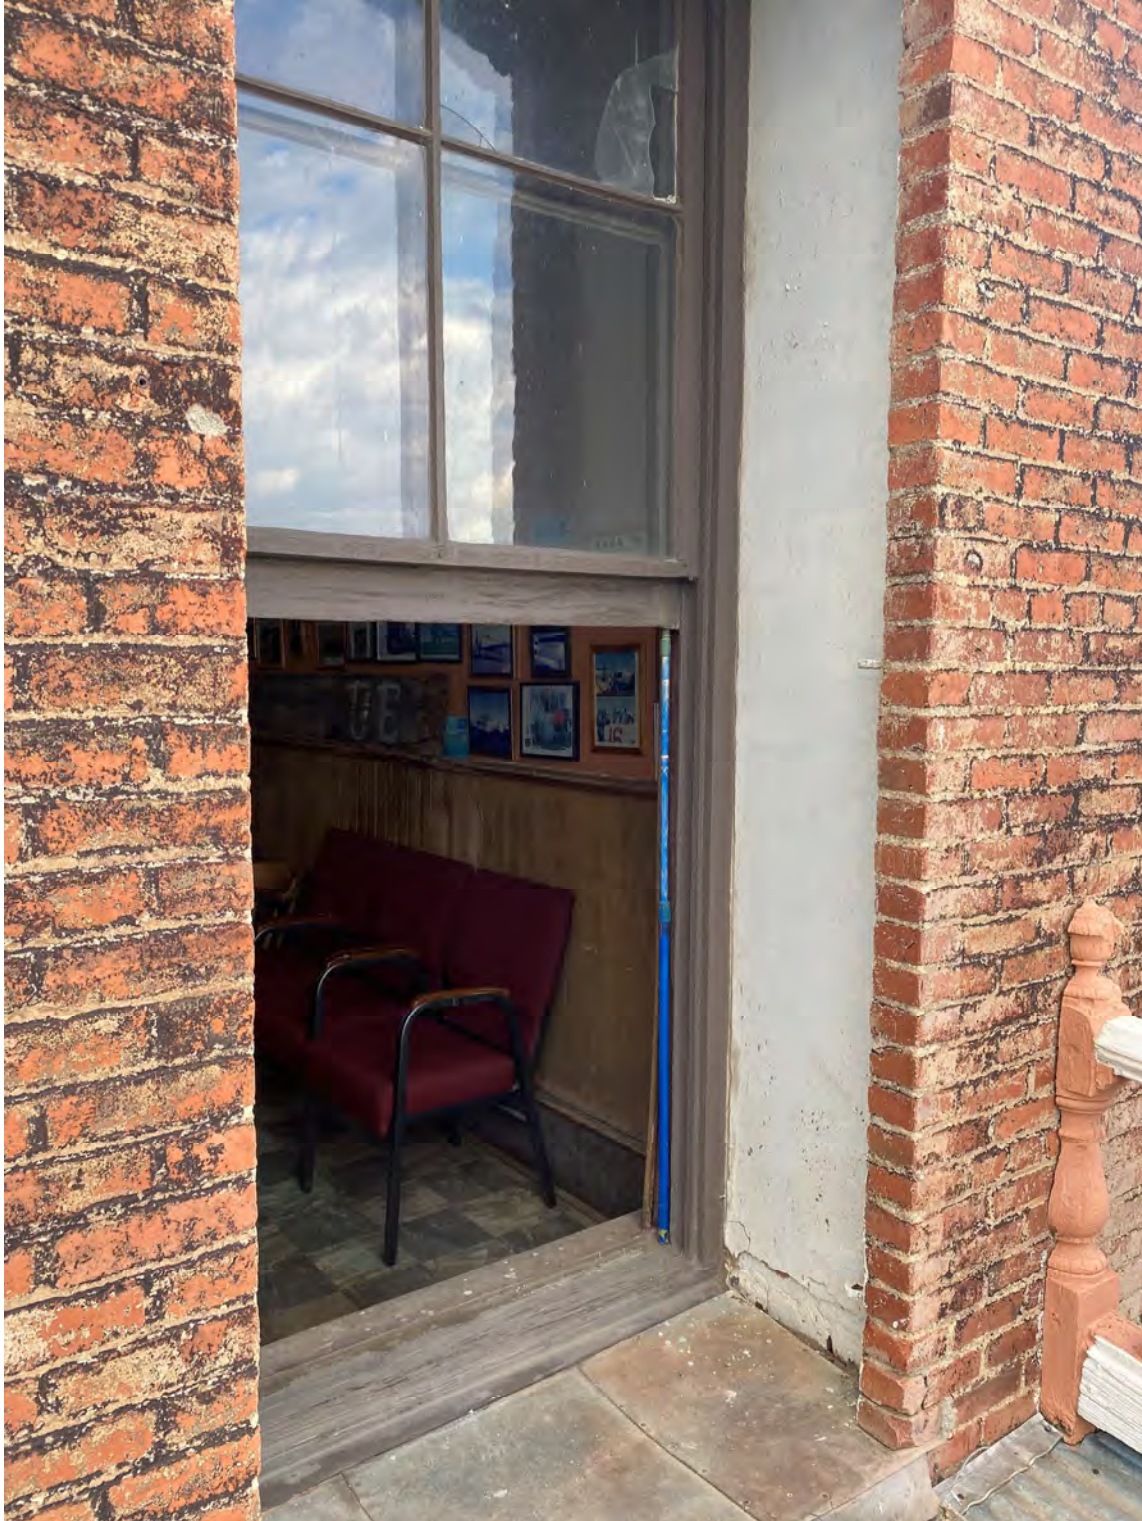
**Photograph 10.** Oblique view of the north second-floor front elevation window looking northwest from the exterior balcony. View shows the relationship between the exterior balcony, masonry wall, wood window frame and sash, and second-floor exhibit room. Photograph by Audie Robinson. Photographed July 14, 2026.

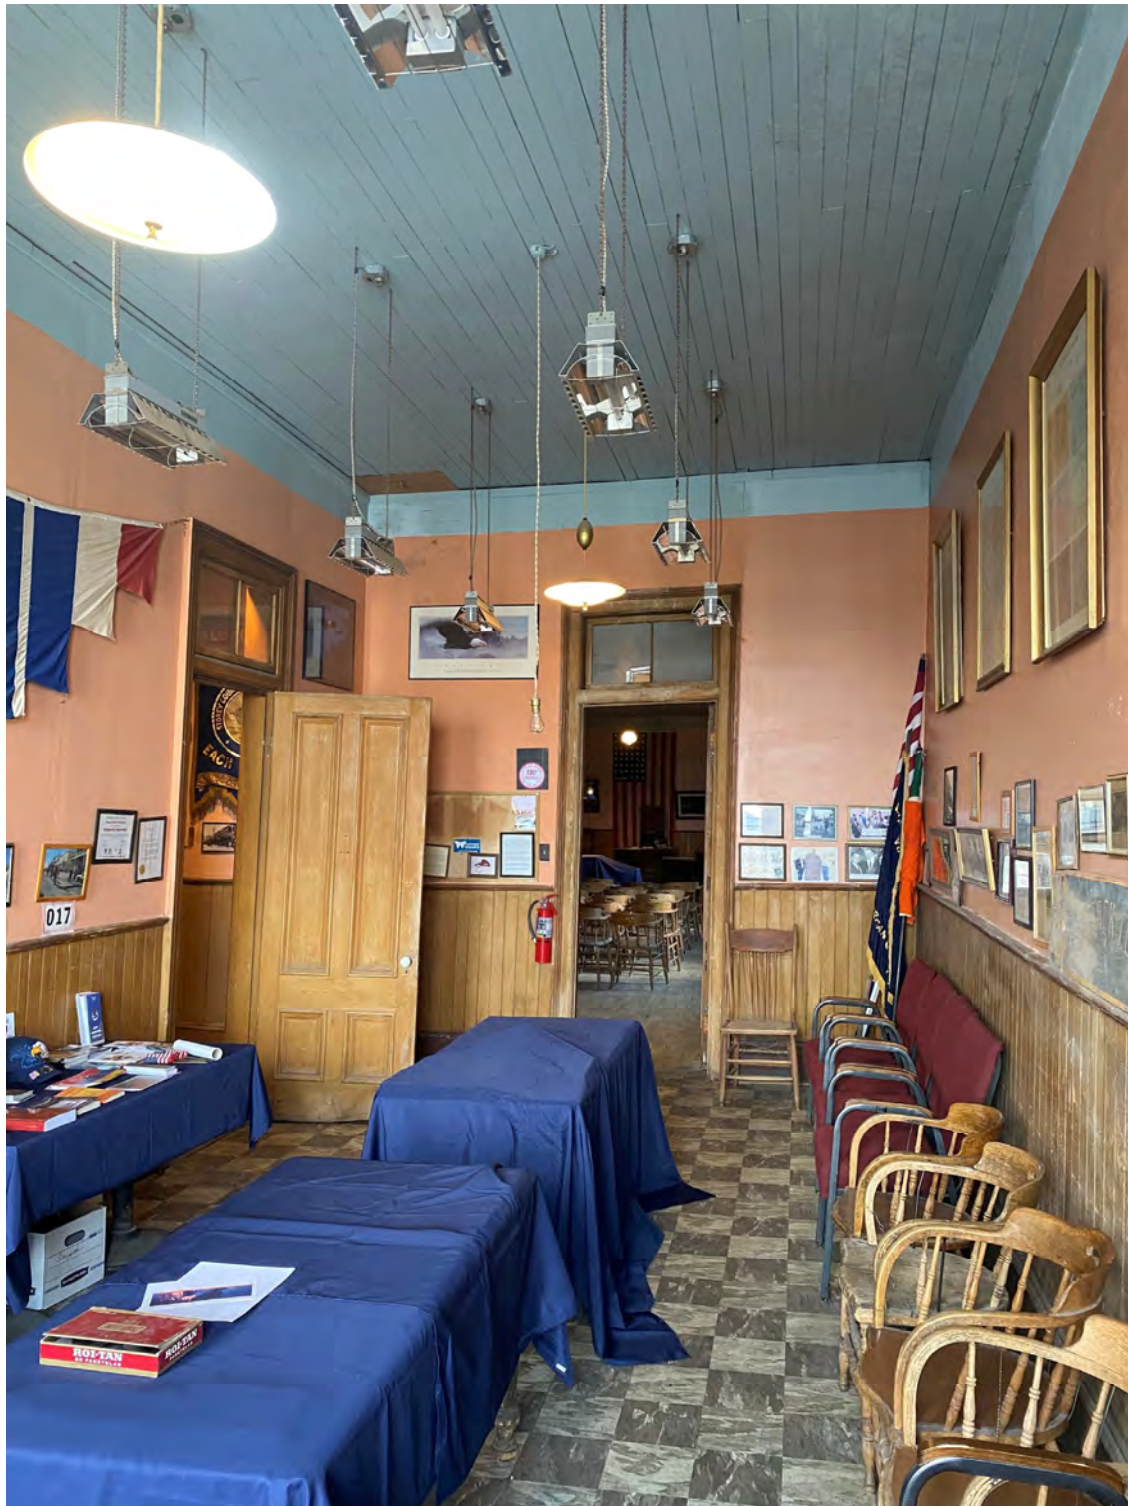
**Photograph 12.** Second-floor exhibit room looking west toward the Main Hall. View shows wood wainscoting, plaster walls, wood ceiling, transomed doorway openings, historic light fixtures, and circulation between the exhibit room and Main Hall assembly space. Photograph by Audie Robinson. Photographed July 14, 2026.

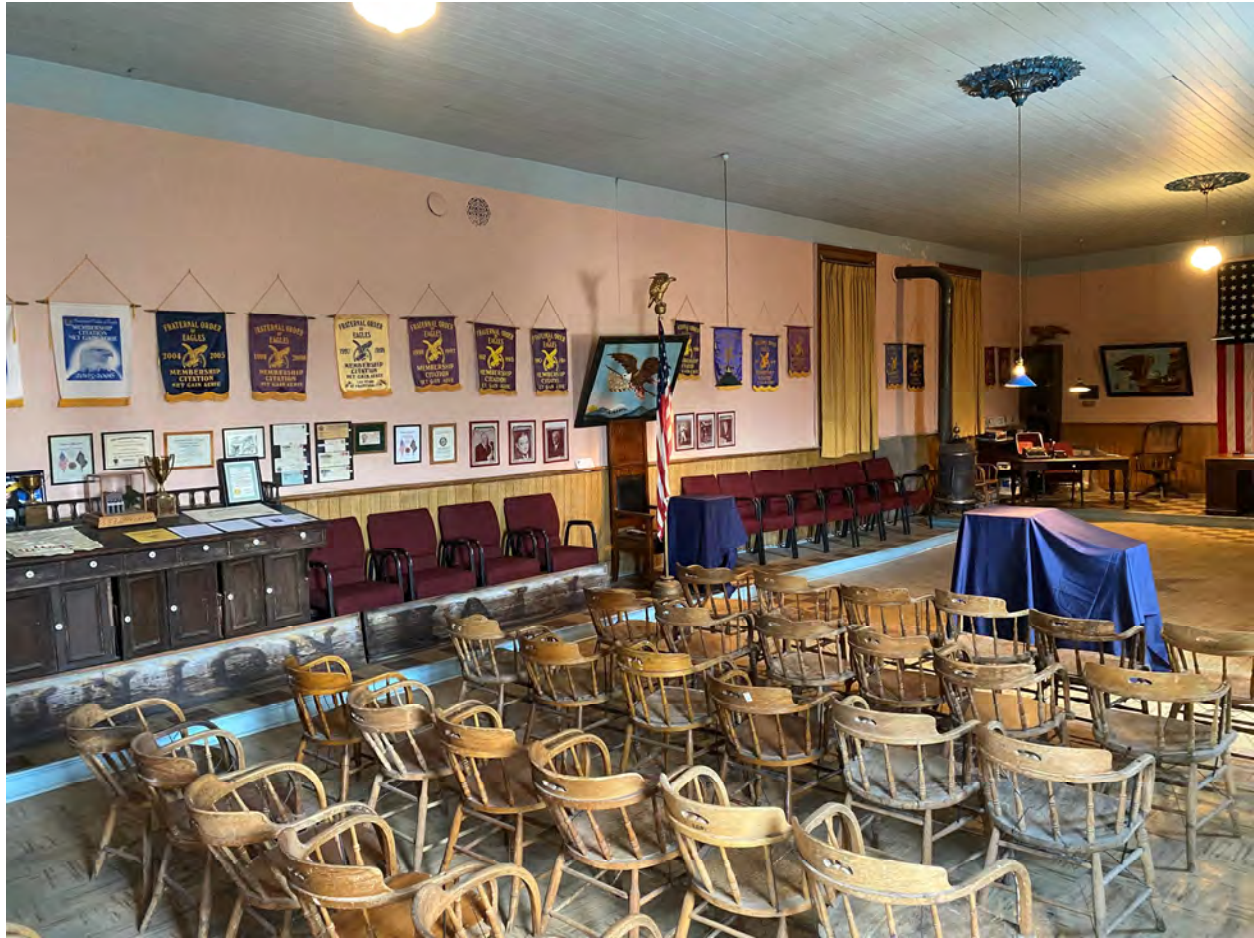
**Photograph 12.** Main Hall looking southwest from the northeast corner of the assembly space toward the interior south wall. View shows wood wainscoting, plaster walls, wood ceiling, two tall windows near the west end of the room, historic furnishings, and audience seating arrangement within the Main Hall. Photograph by Audie Robinson. Photographed July 14, 2026.

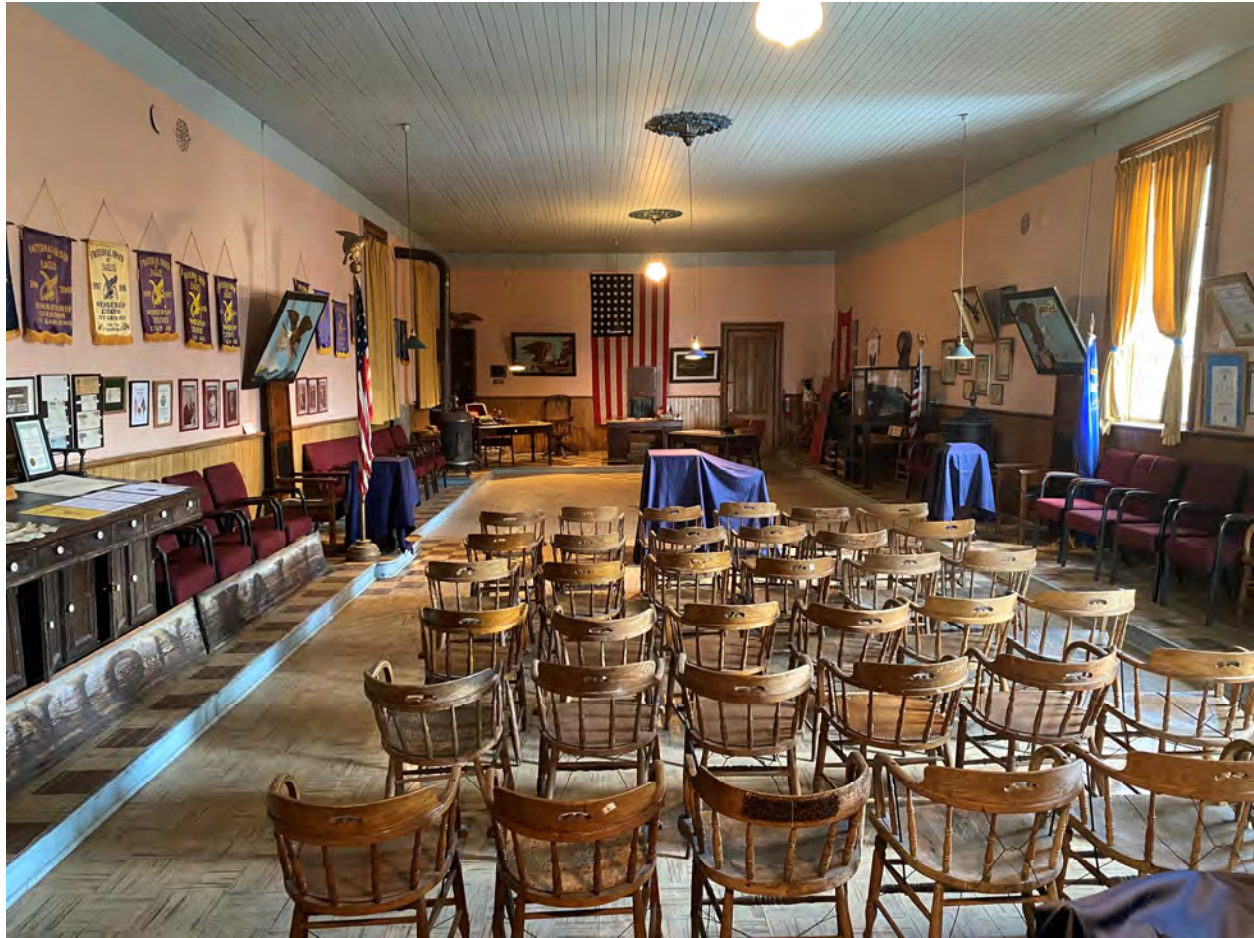
**Photograph 13.** Main Hall looking west from the east end of the assembly space. View shows audience seating arrangement, raised perimeter platforms along the north and south walls, wood wainscoting, plaster walls, wood ceiling, historic furnishings, and the ceremonial area at the west end of the room with the American flag and dais. Photograph by Audie Robinson. Photographed July 14, 2026.

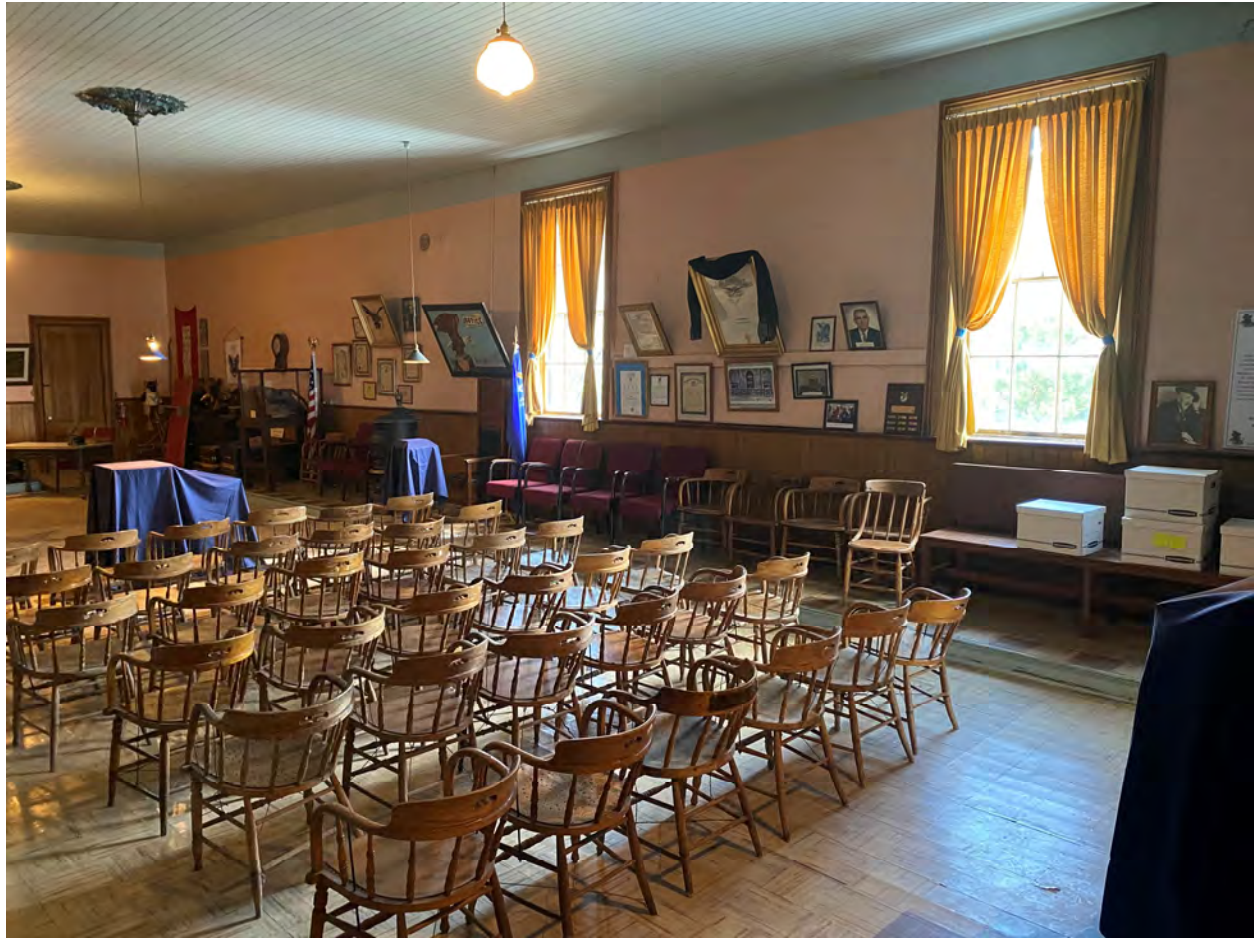
**Photograph 14.** Main Hall looking northwest toward the interior north wall from the southeast portion of the assembly space. View shows wood wainscoting, plaster walls, wood ceiling, two tall windows near the east end of the room, historic furnishings, wall displays, and audience seating arrangement along the raised perimeter platform. Photograph by Audie Robinson. Photographed July 14, 2026.

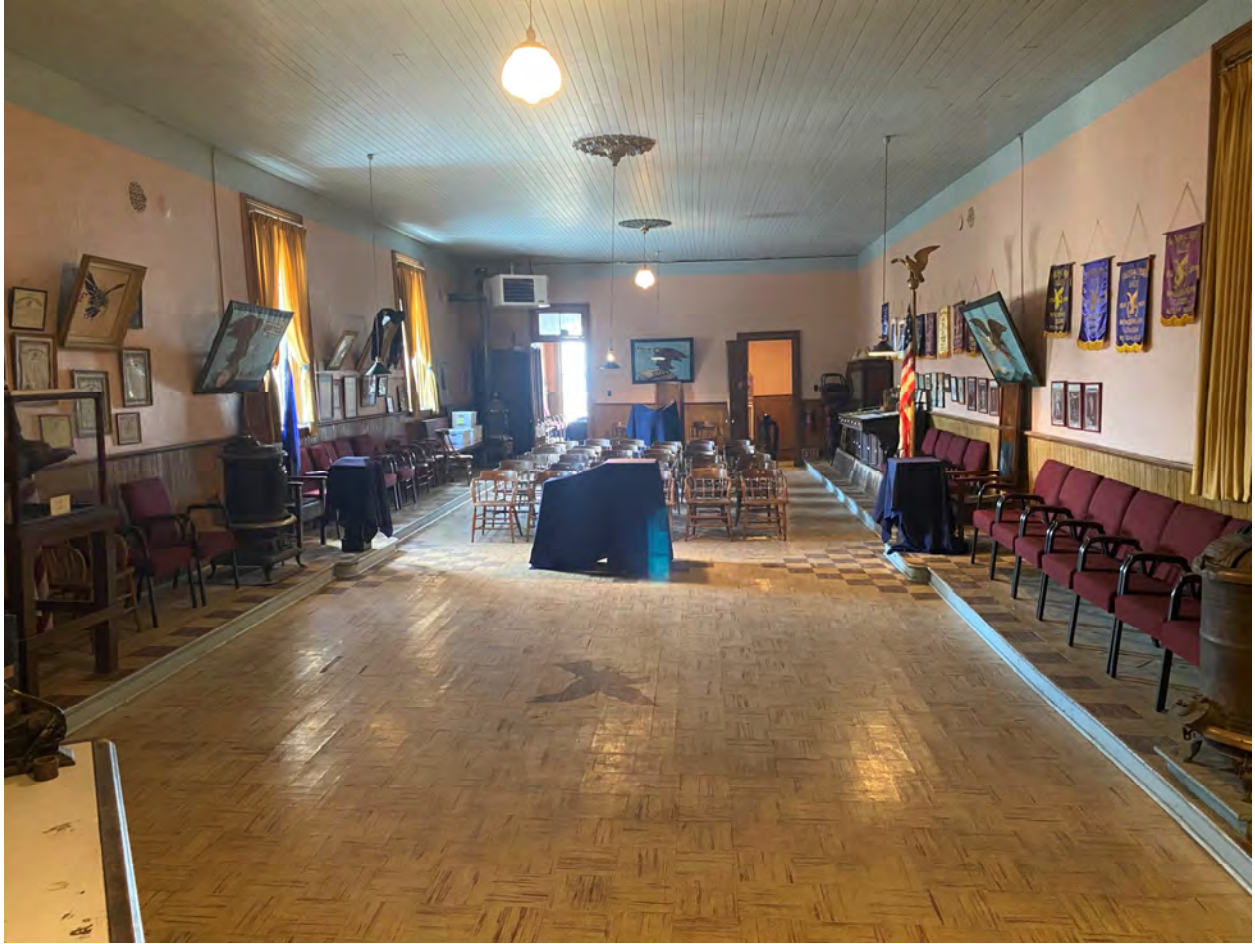
**Photograph 15.** Main Hall looking east from the west end of the assembly space. View shows the assembly floor, raised perimeter platforms along the north and south walls, wood wainscoting, plaster walls, wood ceiling, historic furnishings, audience seating arrangement, and the east end circulation opening to the front exhibit room and stair hall. Photograph by Audie Robinson. Photographed July 14, 2026.

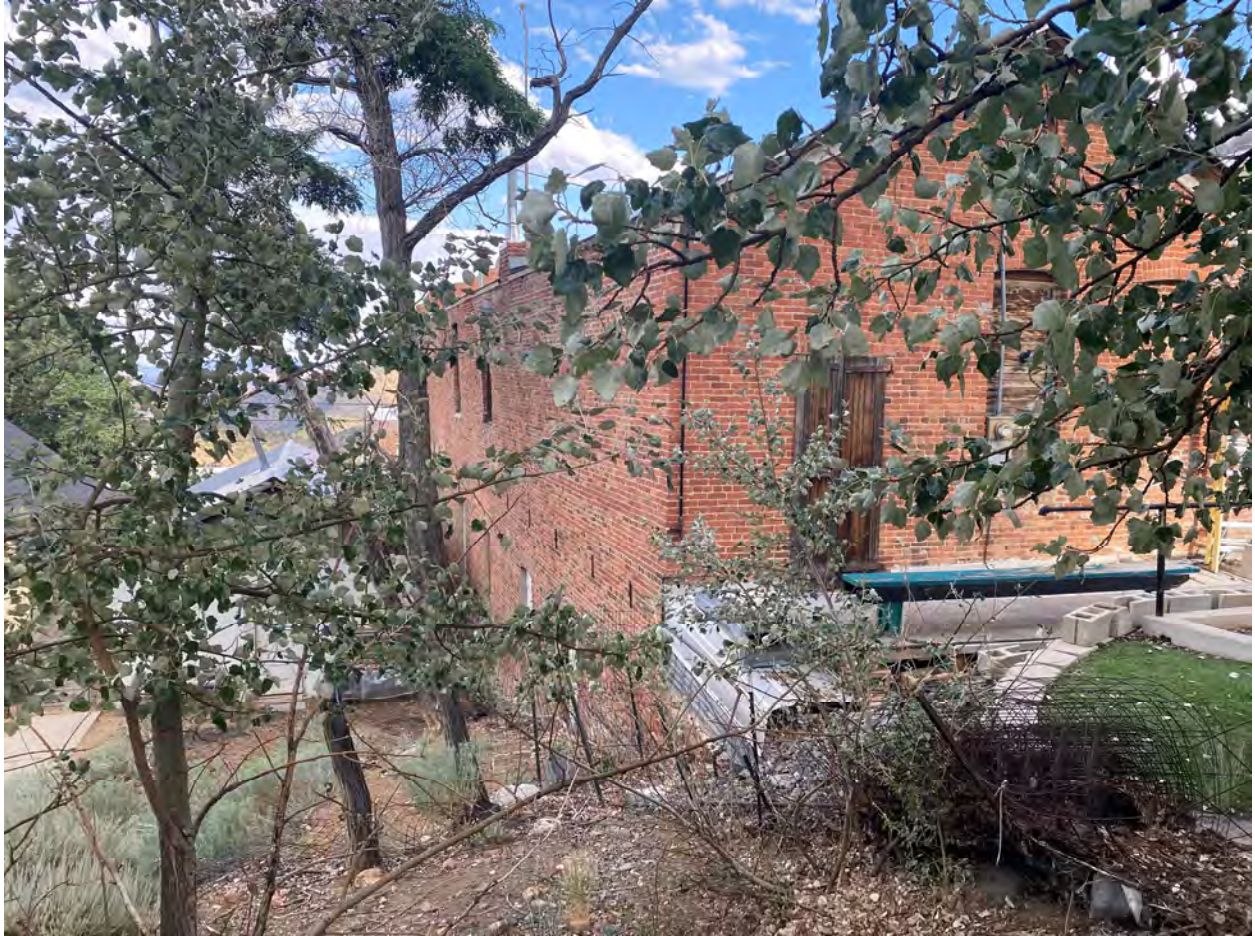
**Photograph 16.** North and west elevations looking southeast from the sloping ground north of the building. View shows brick masonry construction, gable roof form, wood-shuttered second-story doorway providing access to the upper level from the rear of the building, segmental-arched window openings, and the relationship of the building to the sloping topography surrounding Virginia City. Photograph by Audie Robinson. Photographed July 14, 2026.

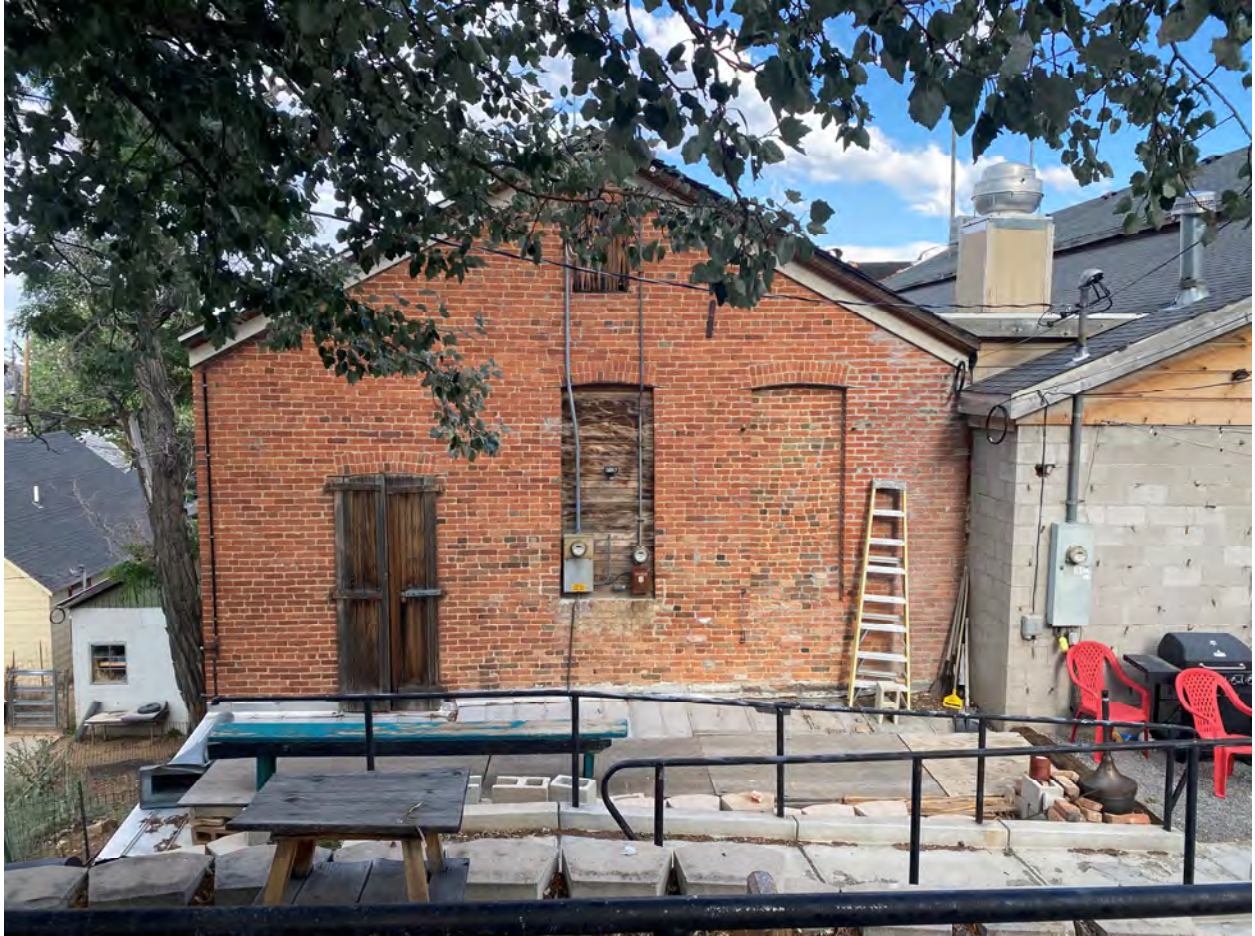
**Photograph 17.** Rear (west) elevation gable end looking east from the rear of the property. View shows brick masonry construction, gable end roof form, shuttered second-story doorway providing access to the upper level from the rear of the building, infilled opening with segmental brick arch, and utility service installations associated with the historic rear elevation. Photograph by Audie Robinson. Photographed July 14, 2026.

The west elevation historically functioned as the service and operational end of the building and exhibits a simpler architectural treatment than the principal east facade. At the west end of the building, the adjacent grade rises to the second-story level, burying the rear of the first story into the abutting hillside, a condition characteristic of many nineteenth-century commercial and institutional buildings constructed on the steep terrain of Virginia City. This relationship between the building and the natural topography reflects the adaptation of nineteenth-century builders to the steep hillsides of the Comstock and distinguishes the rear elevation from the more formal street-facing facade (Photo 17).
