**STEWART OLD GYM – BUILDING 20  
GYM FLOOR DEBRIS REMOVAL  
5500 SYNDER  
CARSON CITY, NEVADA  
SPWD PROJECT NO. 17-C09**

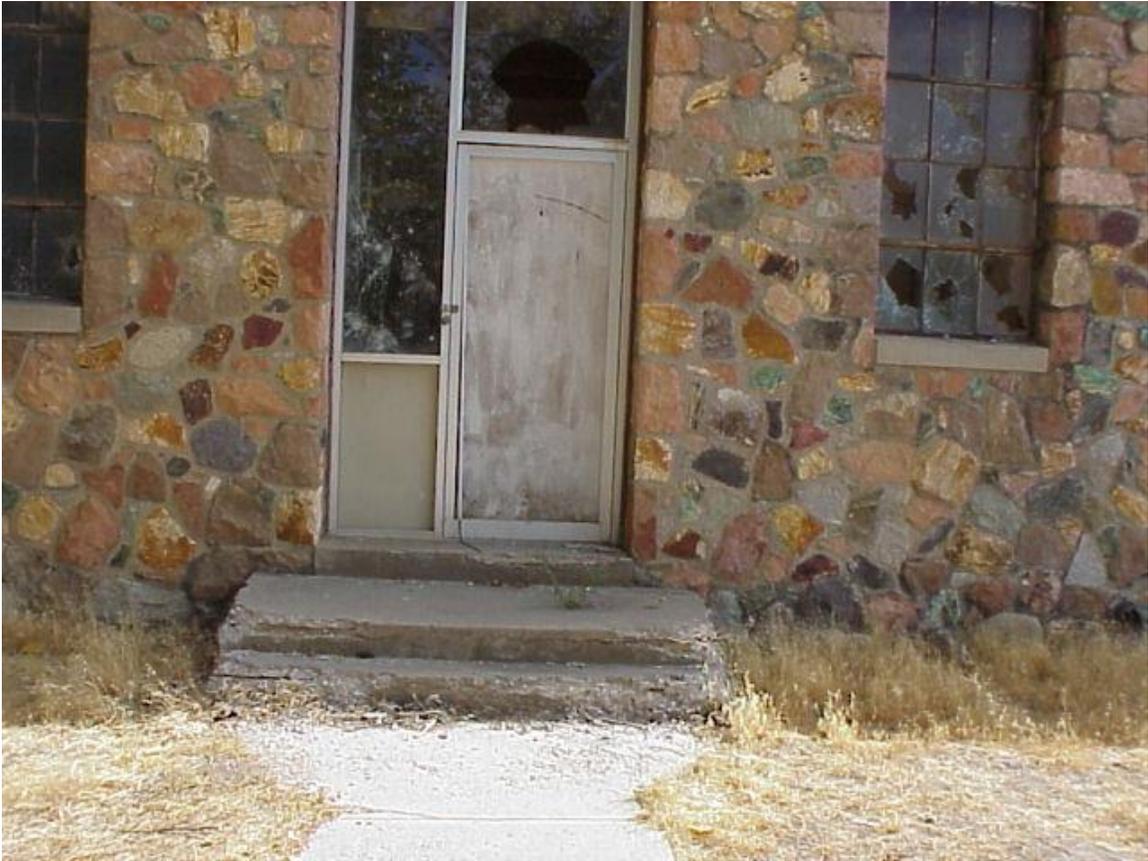
**Figure 1: Front store front to be removed and replaced. The width once removed is 5'1".**

The Contractor is permitted to remove the store front door in the center of the gym to allow equipment and personnel to enter the building. Once the store front is removed, the opening will be approximately 5' 1".

- The north facing door system is to be reinstalled or a wood insert with a door is to be installed to secure the building and allow access to the building.

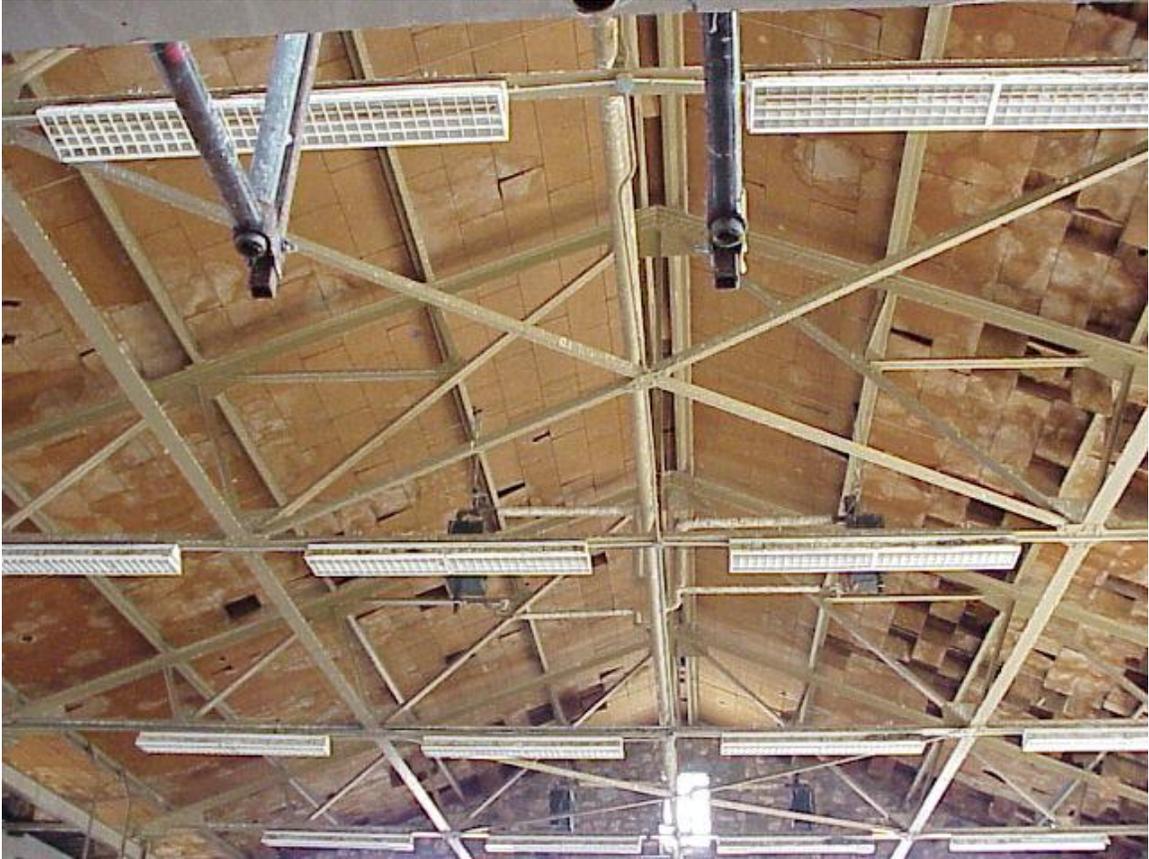
**Figure 2: Ceiling tiles to be removed. This picture is 15 years old and 90% of the tiles have already fallen.**

The Contractor is to remove the loose ceiling tiles located at the bottom of the roof deck. The roof deck is a pitched roof with the center line approximately 30 feet above finished floor.

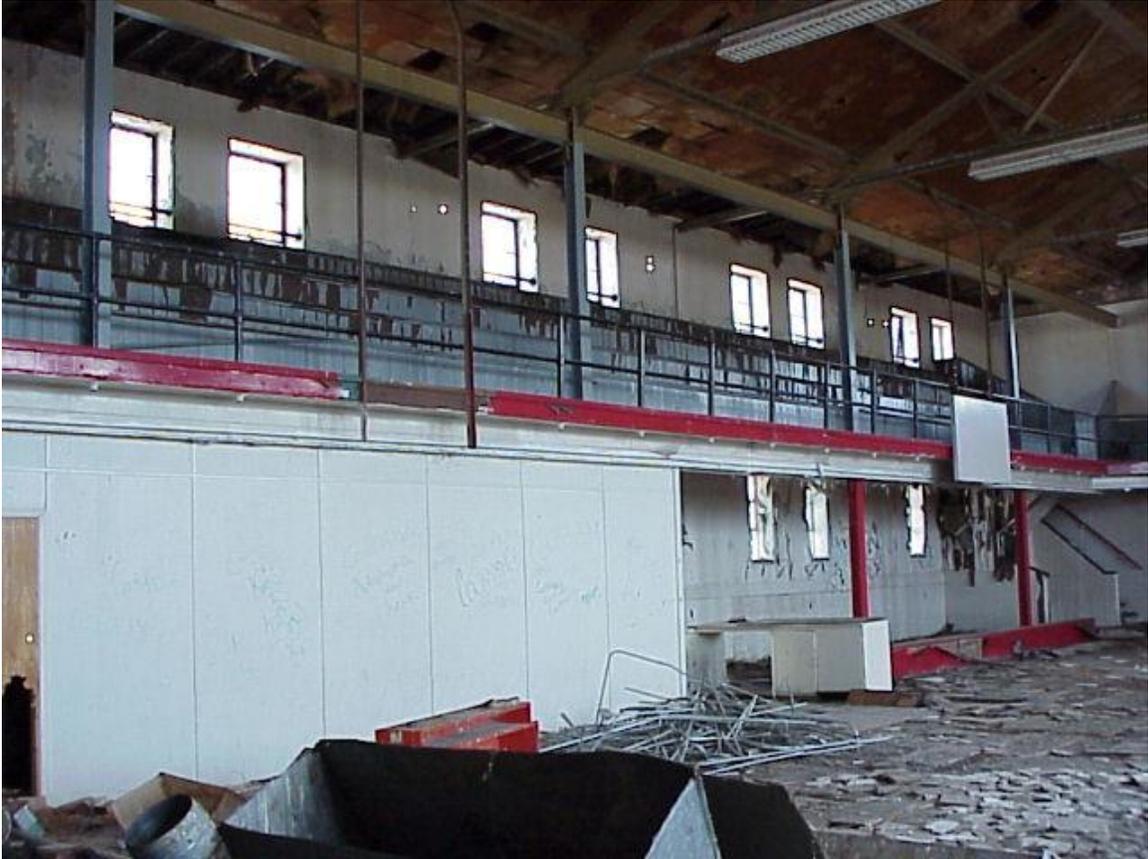
**Figure 3: Front door is located just behind the white wood paneling in the center of the room. The hand removal areas are located behind the wood paneling and then behind the red bleacher with the two vertical red supports on the right of the picture**

The Contractor is to remove the miscellaneous wood and debris located under the bleachers located east and west of the north facing exit door way. It should be noted that these areas are not on a concrete floor. The supporting flooring system is constructed of floor joist with plywood flooring. This material is to be hand removed. This area will not support equipment.

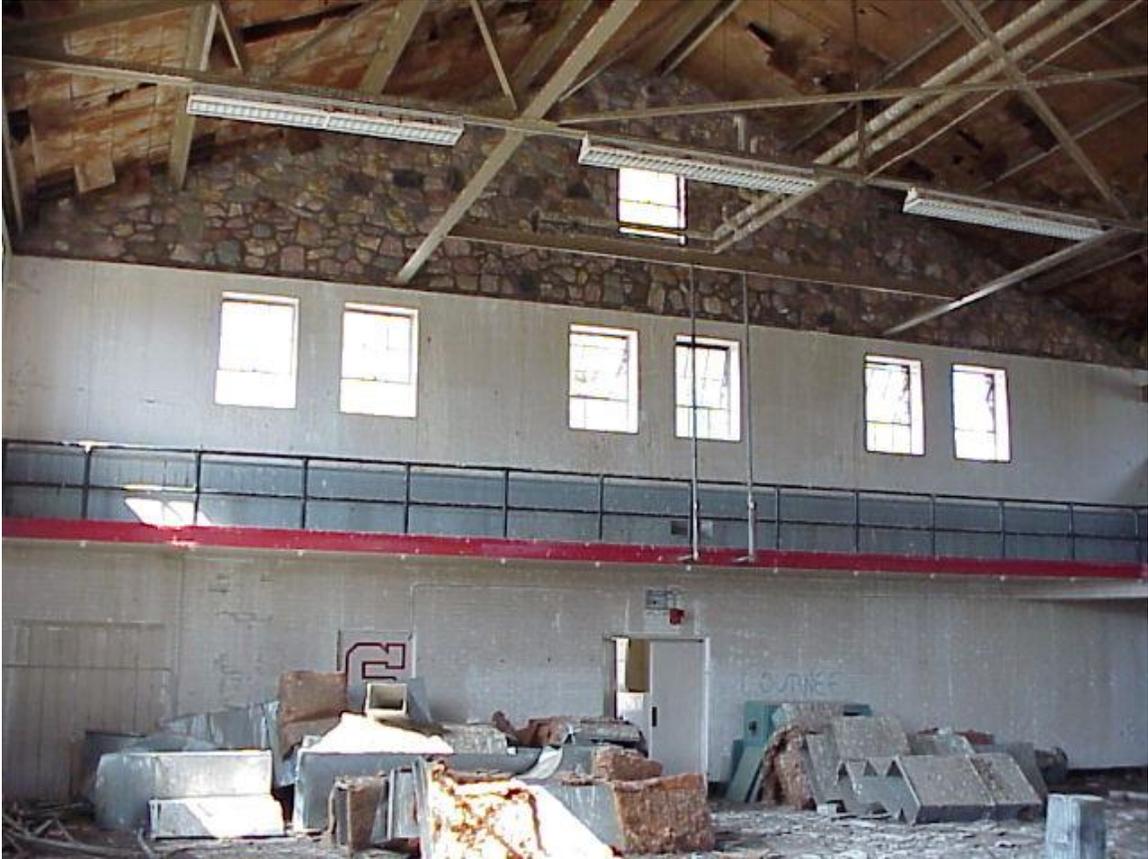
**Figure 4: Miscellaneous debris. This is a 2001 picture, but the material is still in place covered with fallen ceiling tiles.**

The Contractor is to remove and properly dispose of the flooring and other debris located on the gym floor. These include metal cabinets, HVAC ducting, and miscellaneous wood structures.
