**Request for Permission to Undertake Structural or Visual Alterations**

**Building Number and Name:** Building 19, Bakery and Post Office

## 19-C16 Renovation of Collection Storage

Building 19, Stewart Facility  
Carson City, NV 89701

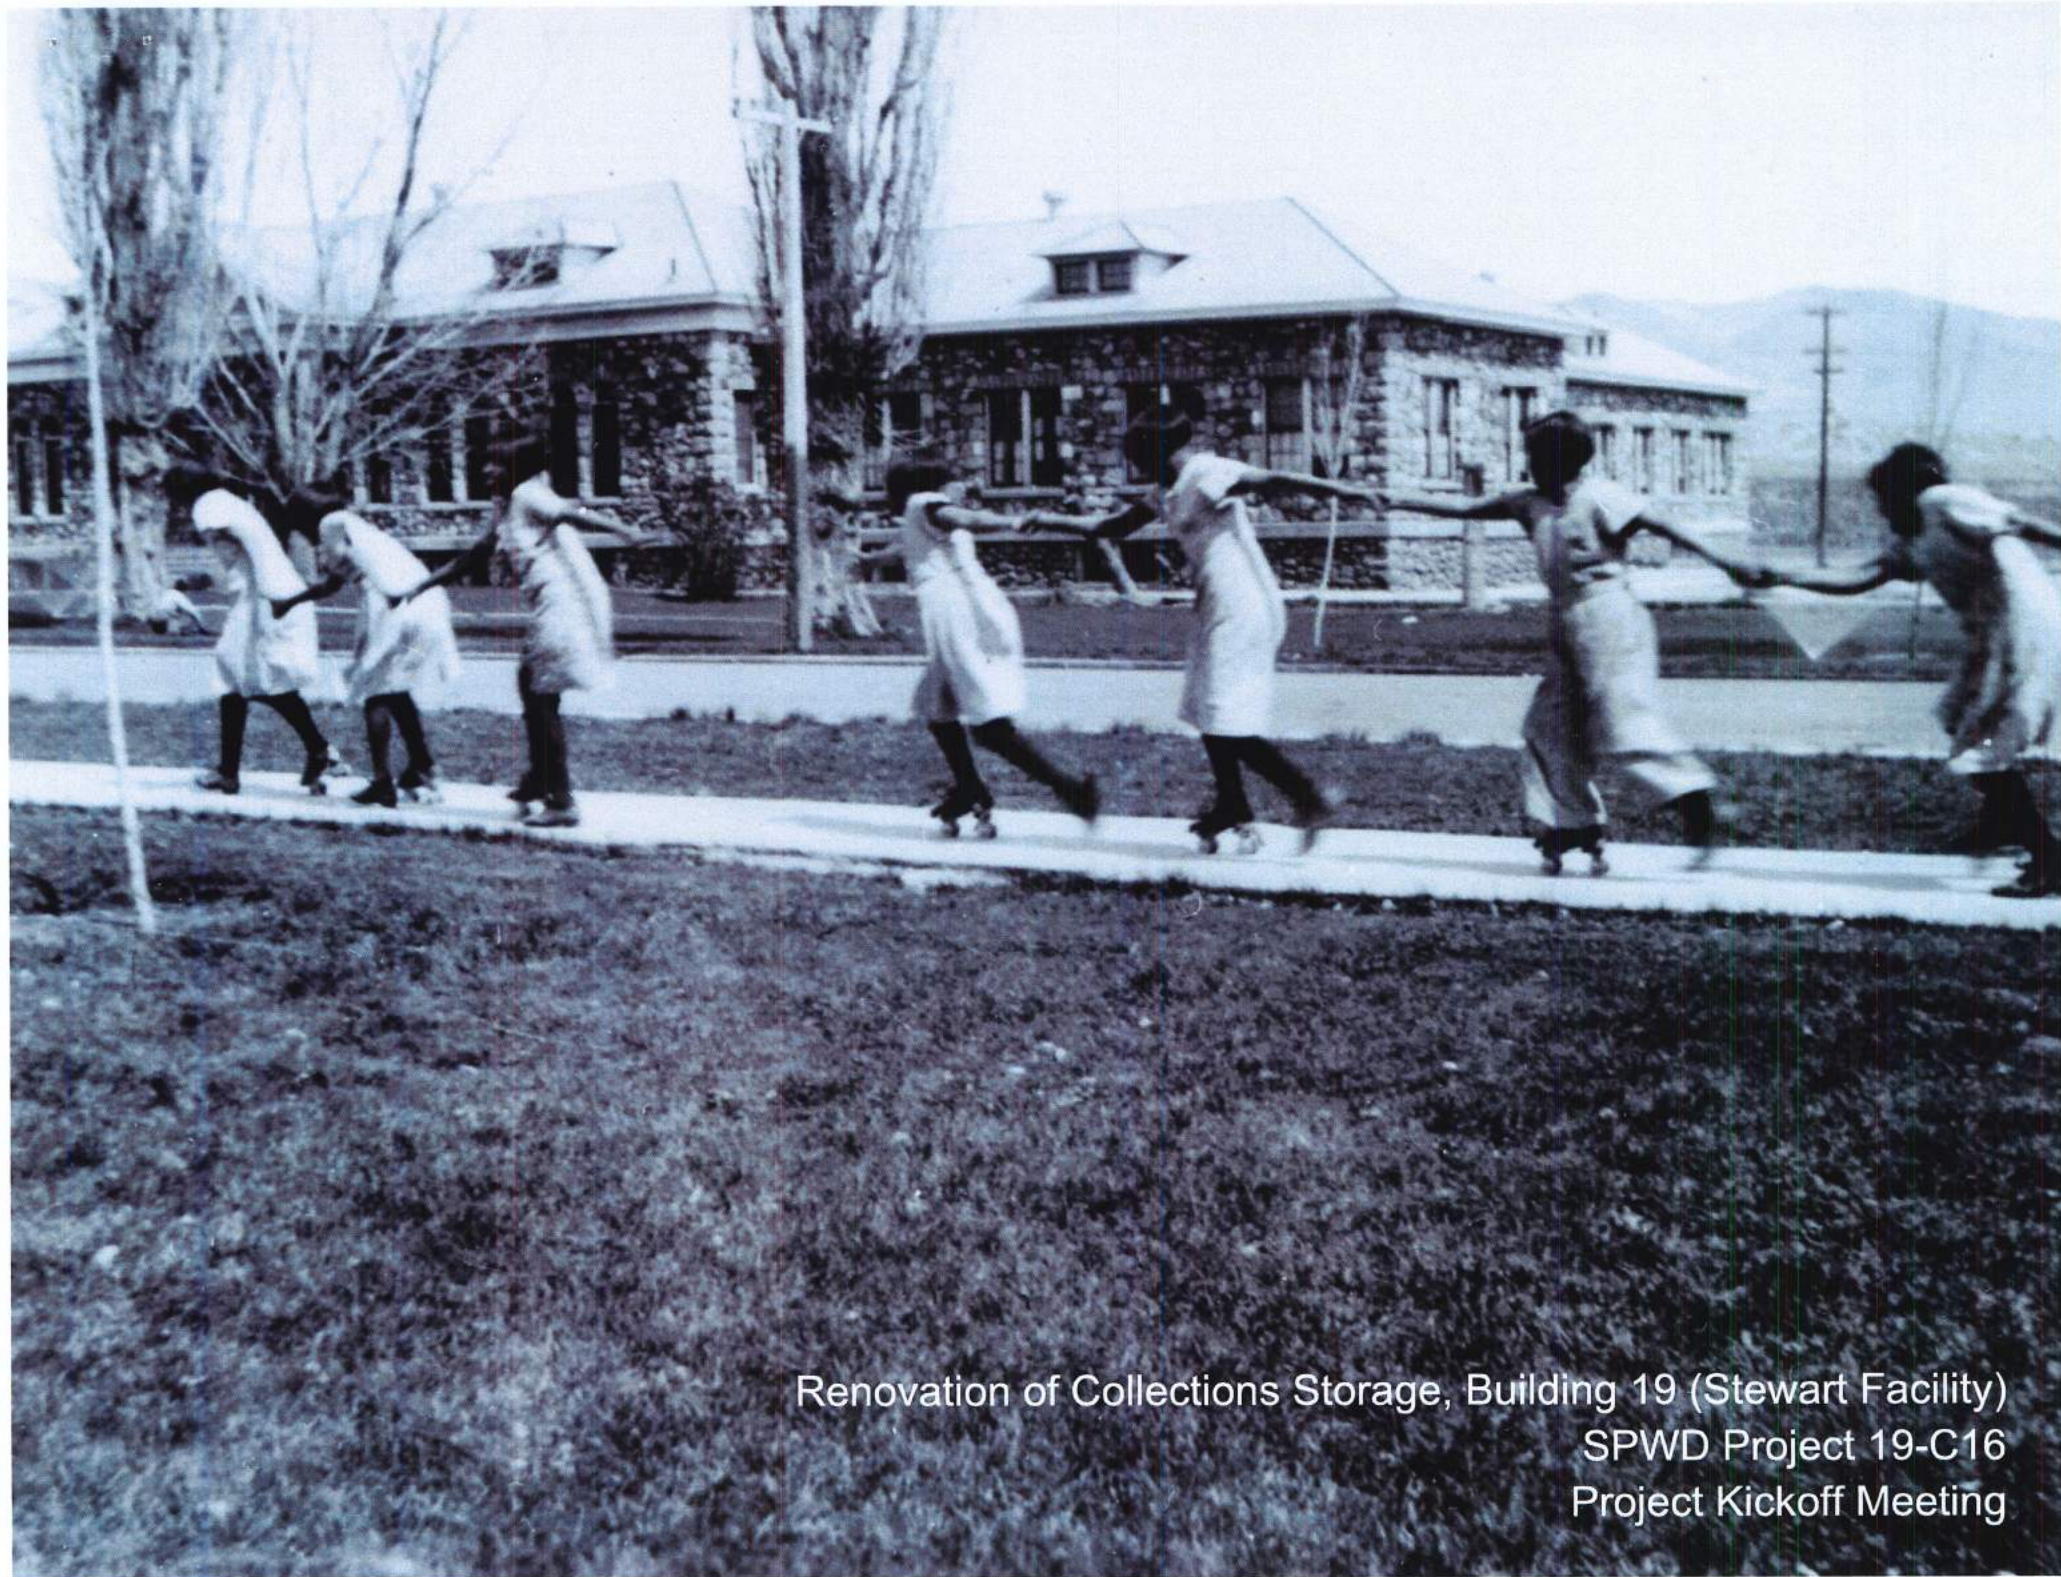
Renovation of Collections Storage, Building 19 (Stewart Facility)  
SPWD Project 19-C16  
Project Kickoff Meeting

Renovation of Collections Storage Building 19 (Stewart Facility), Project 19-C16  
Scope Site Plan  
6/9/22
