CHDC Meeting Date: August 4, 2026

**Agenda Item # Two**

| <b>Address</b> | 1 Sutro Tunnel Road: Sutro Townsite – Tank House |

Executive Summary: The Tank House building at the Sutro Tunnel requires preservation to enhance safety, stop degradation and to help further the historic activities at the tunnel site. The building needs a new foundation, wall repair, a new roof and the riveted tank cradle is to be rebuilt. All activities shall be done with a mind towards conservation, safety and fidelity to the historic nature of the site. The Tank House is not present in the 1890's photos but is present as an established building in a 1962 photo. Estimated year built 1902.

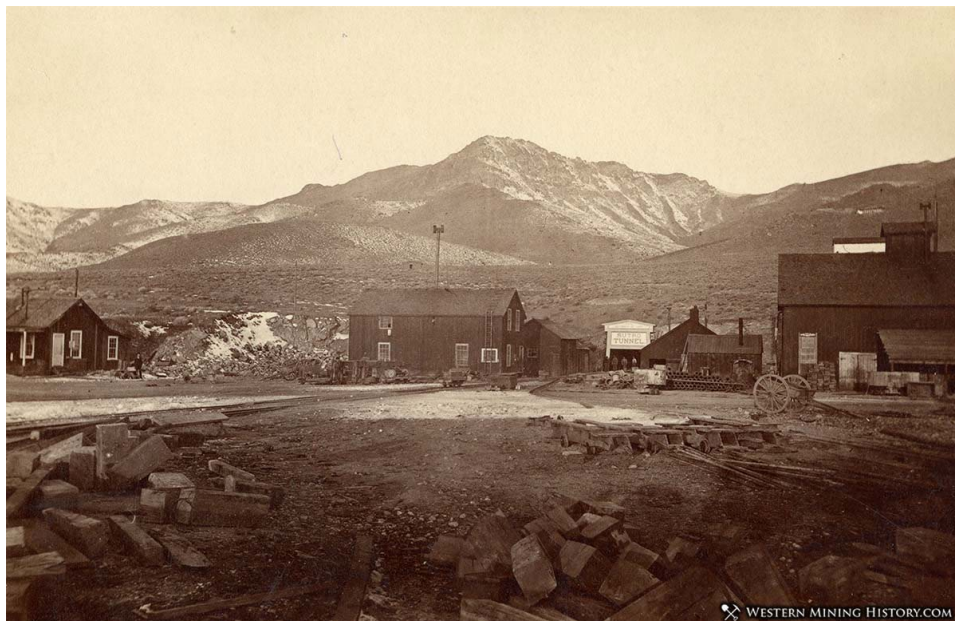
<https://westernmininghistory.com/gallery-image/39653/>

A photograph taken in 1890 entitled “Sutro Tunnel and surface buildings ca. 1890” preserved by the UNR Digital Archives and hosted by Western Mining History.com does not show the Tank House as we see it today. There is however a very similar building closer to the tunnel portal which may be the same structure at a different location. The construction methods for the 1890 building and the existing Tank House are similar.

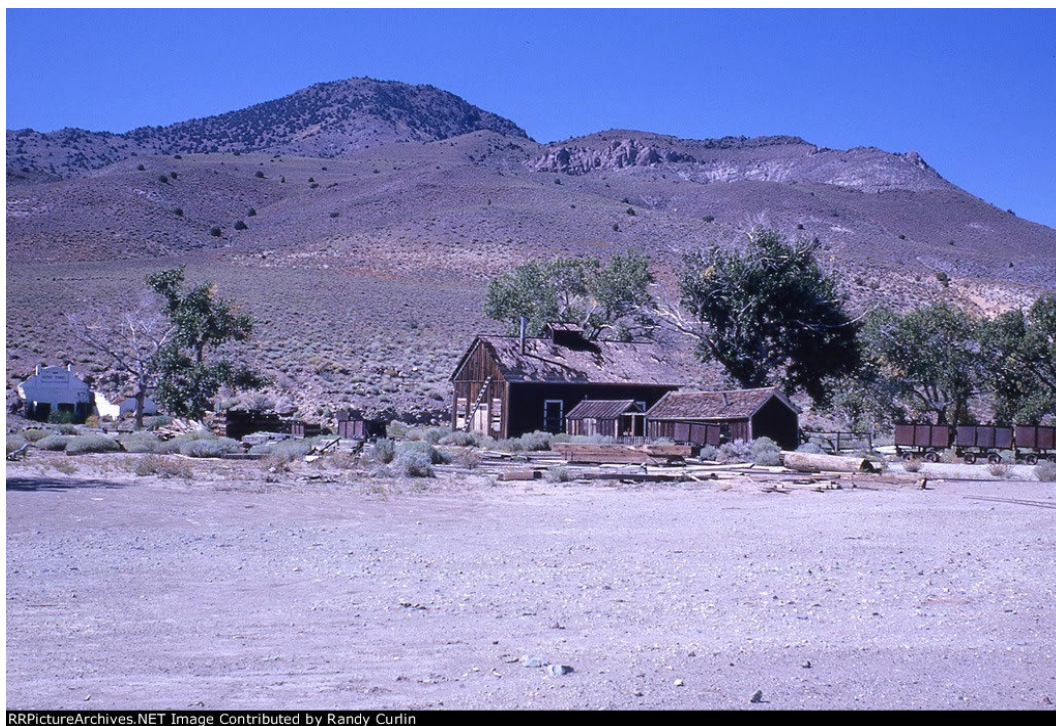
RRPictureArchives.NET Image Contributed by Randy Curlin

The roof is mostly missing with only rafters and a long center beam remaining. In recent years (circa 2020) scrap plywood and tarps were temporarily placed to protect the structure (since removed). The 1962 photo (see below) seems to show board and bat used for the roof.

Randy Curlin is given credit for this photo reportedly taken September 1962.

The original rafters have been labeled and preserved, and may be used and returned to their original positions. Overall, the roof is visible in the 1962 Curlin photo. The photo seems to show board and bat for the walls and the roof. This construction may be replicated.

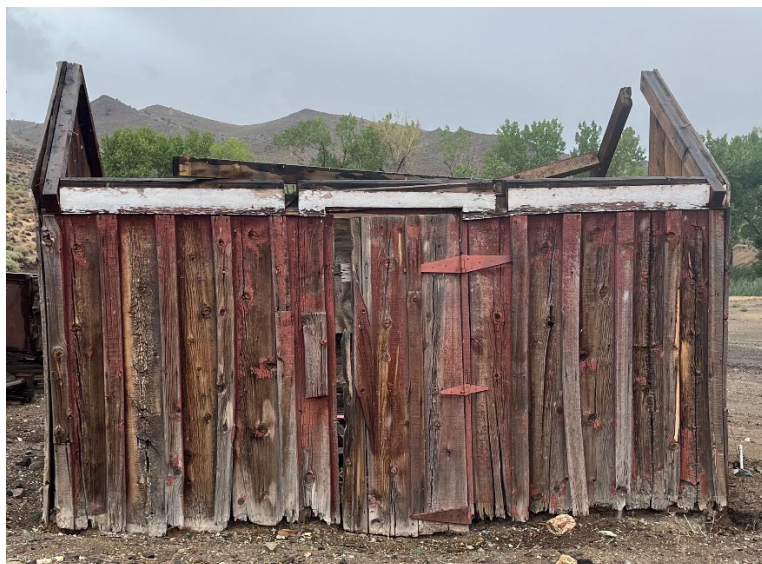
Tank House Current Condition – historic tank has been temporarily removed to locations about 10' to the right.

The tank and cradle have been removed for the safety of the public, the staff and the Tank House itself. The north end of the cradle had failed, and the outflow pipes and north wall of the Tank House were supporting the tank.

The tank's cradle will need to be rebuilt and any wood damaged by earth contact repaired or removed. When the cradle is back in place the tank itself may be returned to position. The original pipes may be "dummy" mounted to the cement foundation to tell the story of the tank's use. There is no expectation that the original tank will be plumbed back into service.

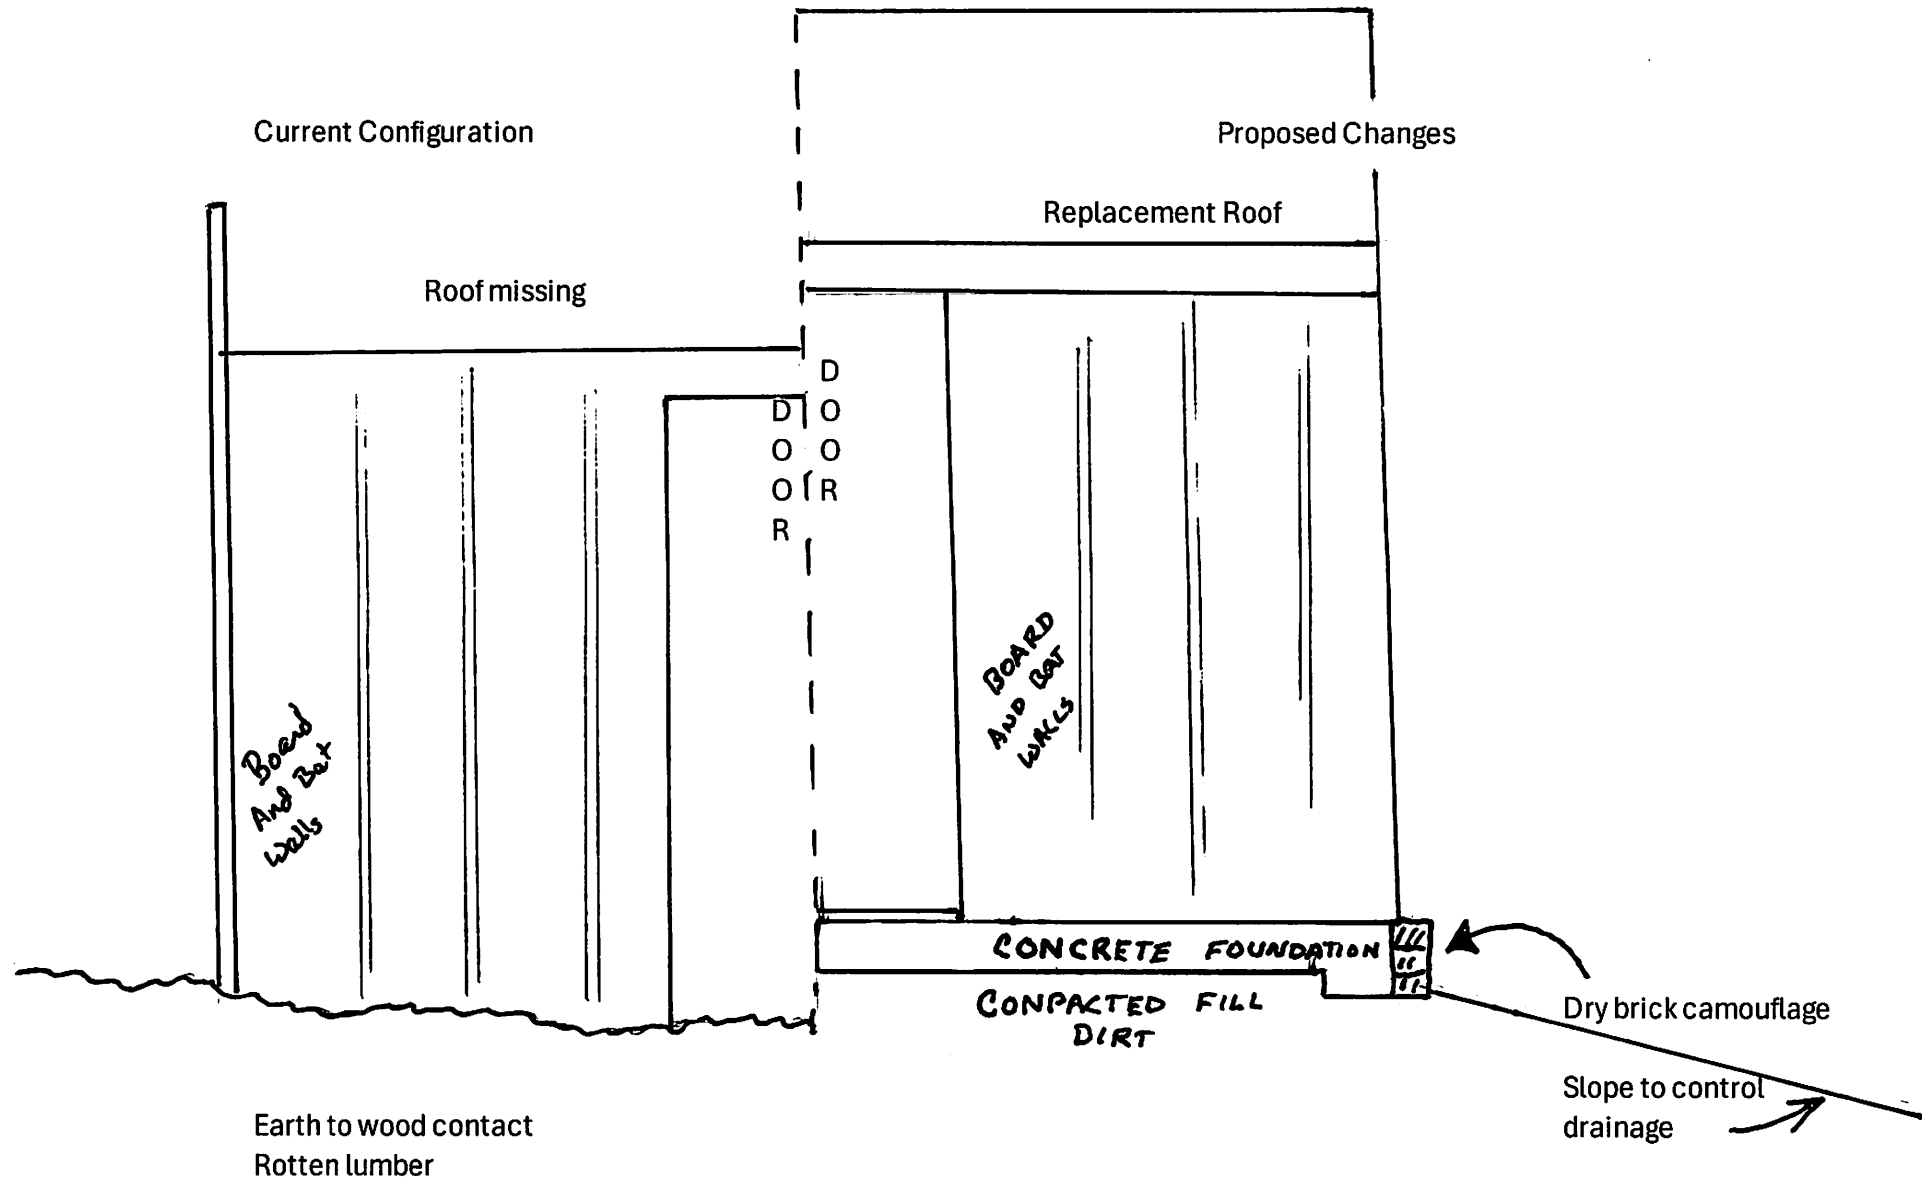
Sketch of the "Tank House" - Sutro Tunnel

Description: The existing building is central to the Sutro Tunnel campus, south-west of the Machine Shop (Museum) building. The Tank House structure is oriented true to the compass points. The building is of heavy wooden plank construction with a length of 13 feet by a width of 8 feet 3 inches and a single-story height of 9 feet to the peak of the simple A-Frame roof. There is a single door on the West facing wall.

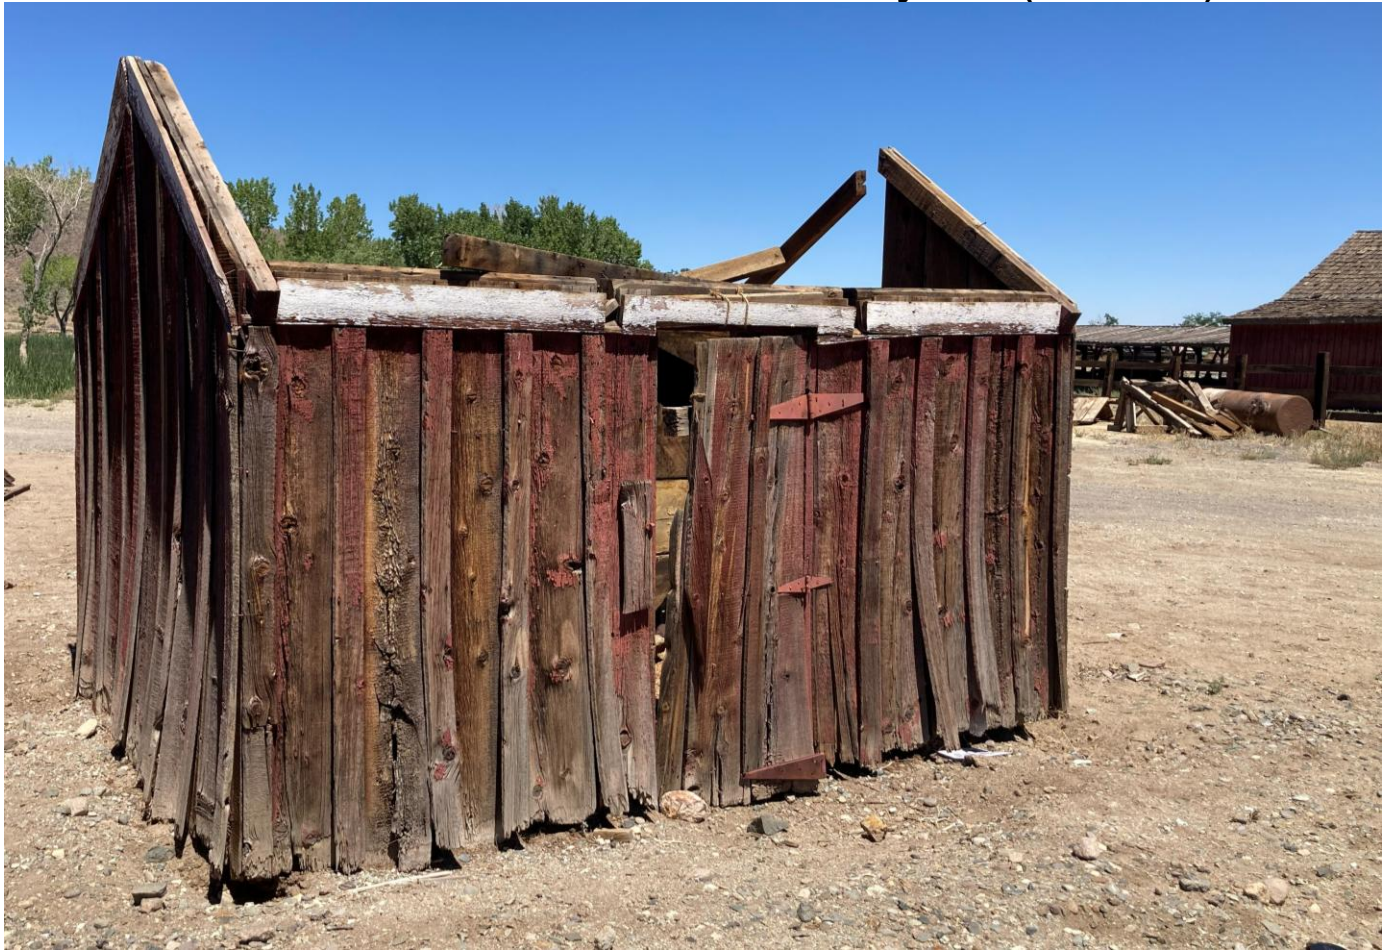
South Elevation

The original foundation construction of the building was composed of corner beams set directly into the ground with connecting planks in direct earth contact. The soil in the site is silt taken from the excavation activities of the tunnel. Currently the building is sinking into the ground and lumber in contact with the ground is highly compromised. Repair of the building would necessitate removing a portion of the rotten wood of the vertical corner beams and full replacement of the horizontal connecting planks. To ensure preservation a concrete foundation would be cast in the current location of the building after the grade of the ground level is increased to allow adequate drainage. Site preparation would require bringing in fill dirt and grading drainage away from the foundation of the building. Moving the building on wooden skids about 50 feet to the south will be practical and should not present any damage to the structure.

When the new foundation is completed, the building may be moved back into position. With a new foundation the building may be placed back into position. This will require the damaged wood to be removed from the corner posts. The building should be anchored to the foundation to reduce the possibility of the building moving with the heavy wind experienced at the site.

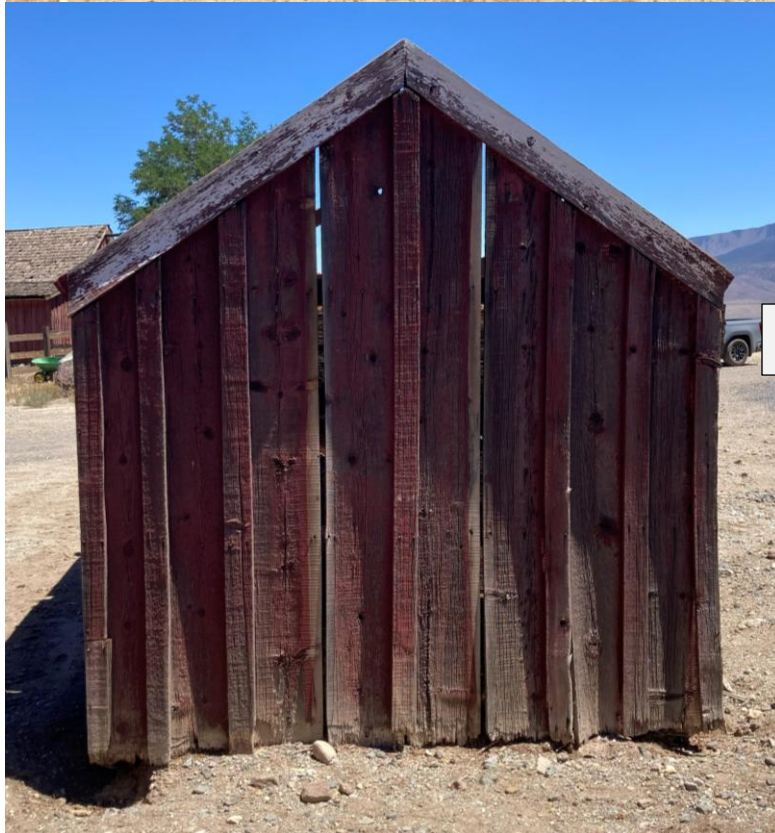
West Elevation

The walls of the building are in adequate condition with the exception of the west facing wall and door. Failed planks can be replaced on a case-by-case basis using resawn lumber bespoke to the needed dimensions.

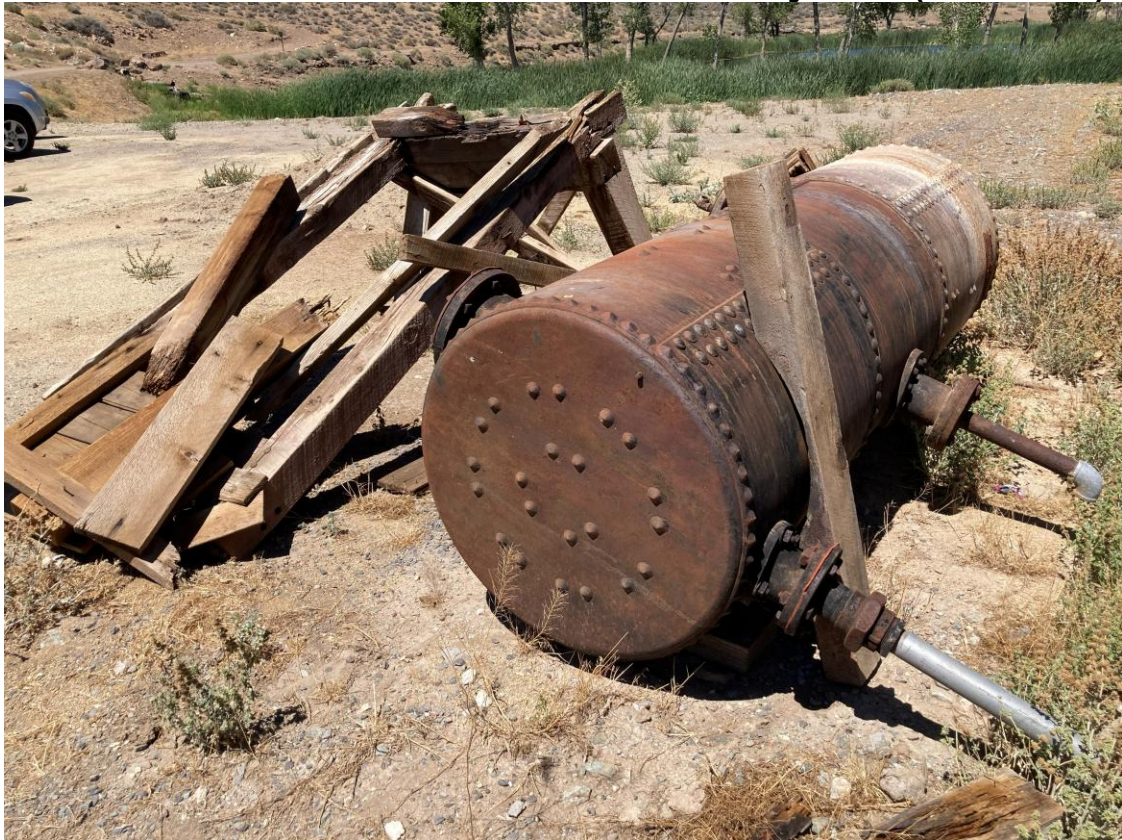
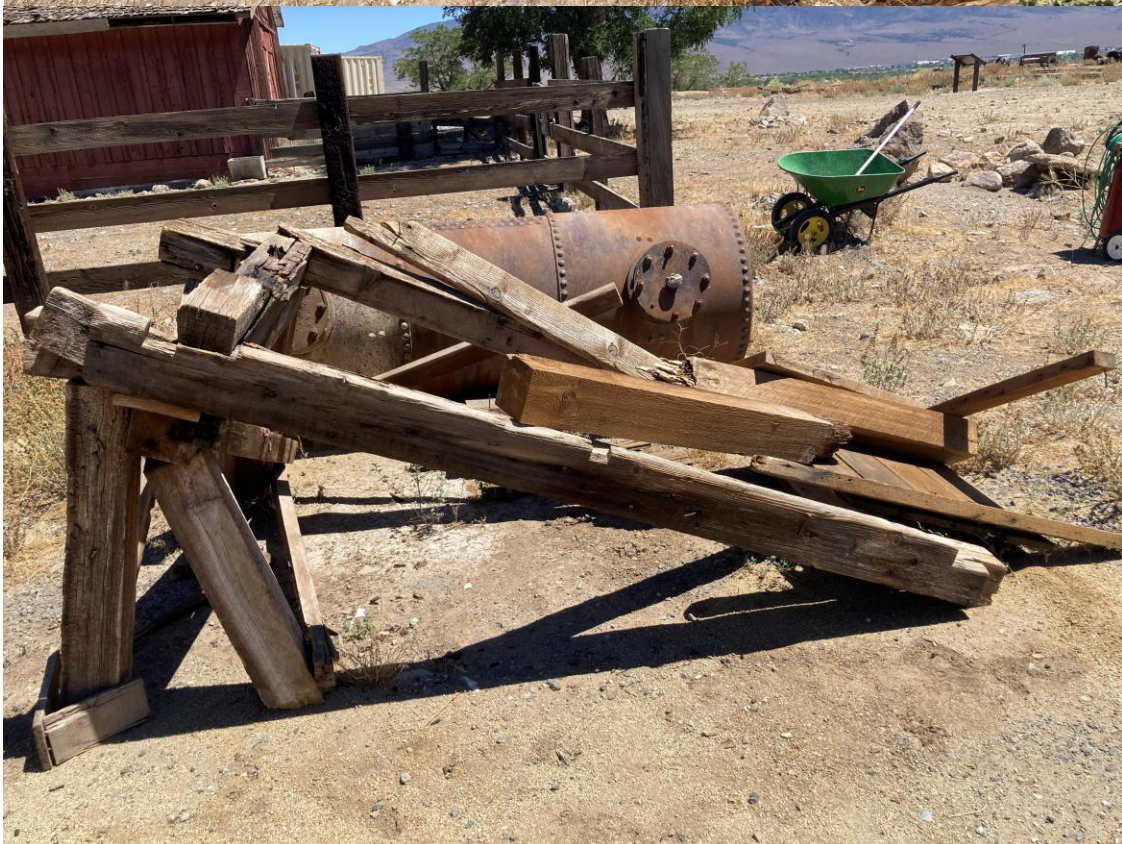
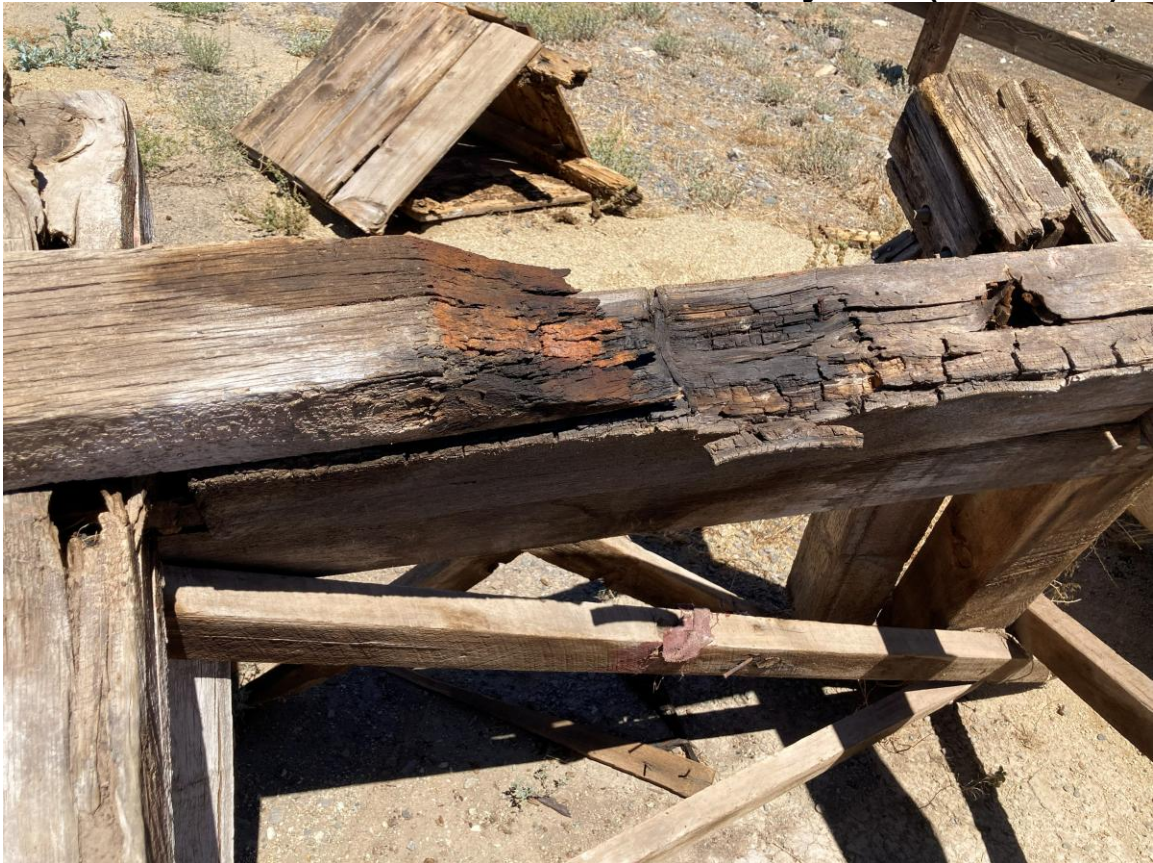
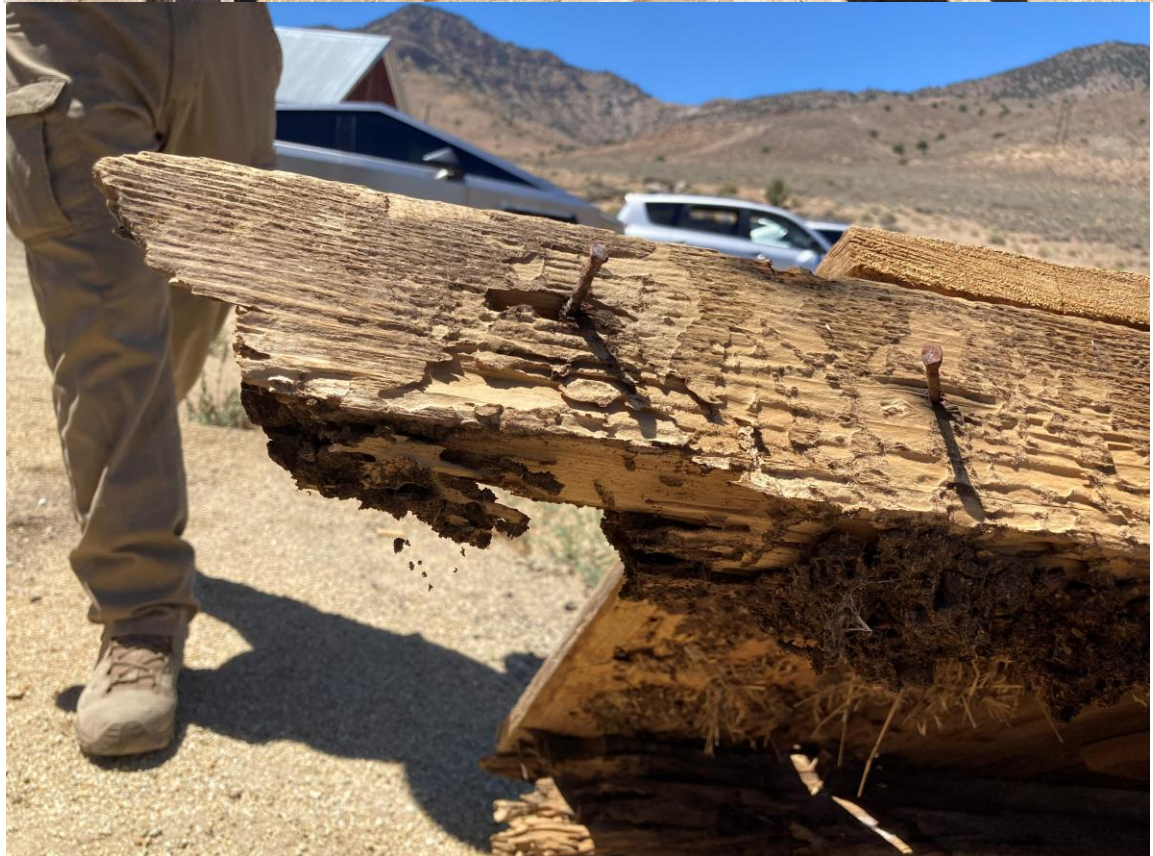
**Current Photos of Tank & Cradle – Taken By Staff (7-28-2026)**

Filling the structure to the exclusion of other activities is a large riveted steel tank. The tank is cylindrical in shape and mounted horizontally on a heavy wooden cradle. The dimensions are 9 feet long by 3 feet in diameter. Two raised features are on the top center line of the tank (fill points) and there is one raised feature in the center bottom of the cylinder. Heavy steel pipe both enter and exit the tank with gate valve(s) installed.

The tank is mounted on a heavy plank and beam cradle fashioned with both large round shank nails and wooden dowel pegs. The cradle is highly compromised and presented a hazard to both guests, Sutro Tunnel staff and the north wall of the Tank House. Safety mitigation was essential. As a critical safety measure the remaining roof rafters were labeled, photographed and removed to allow the tank and cradle to be moved and placed directly on the ground and further from the visiting public.

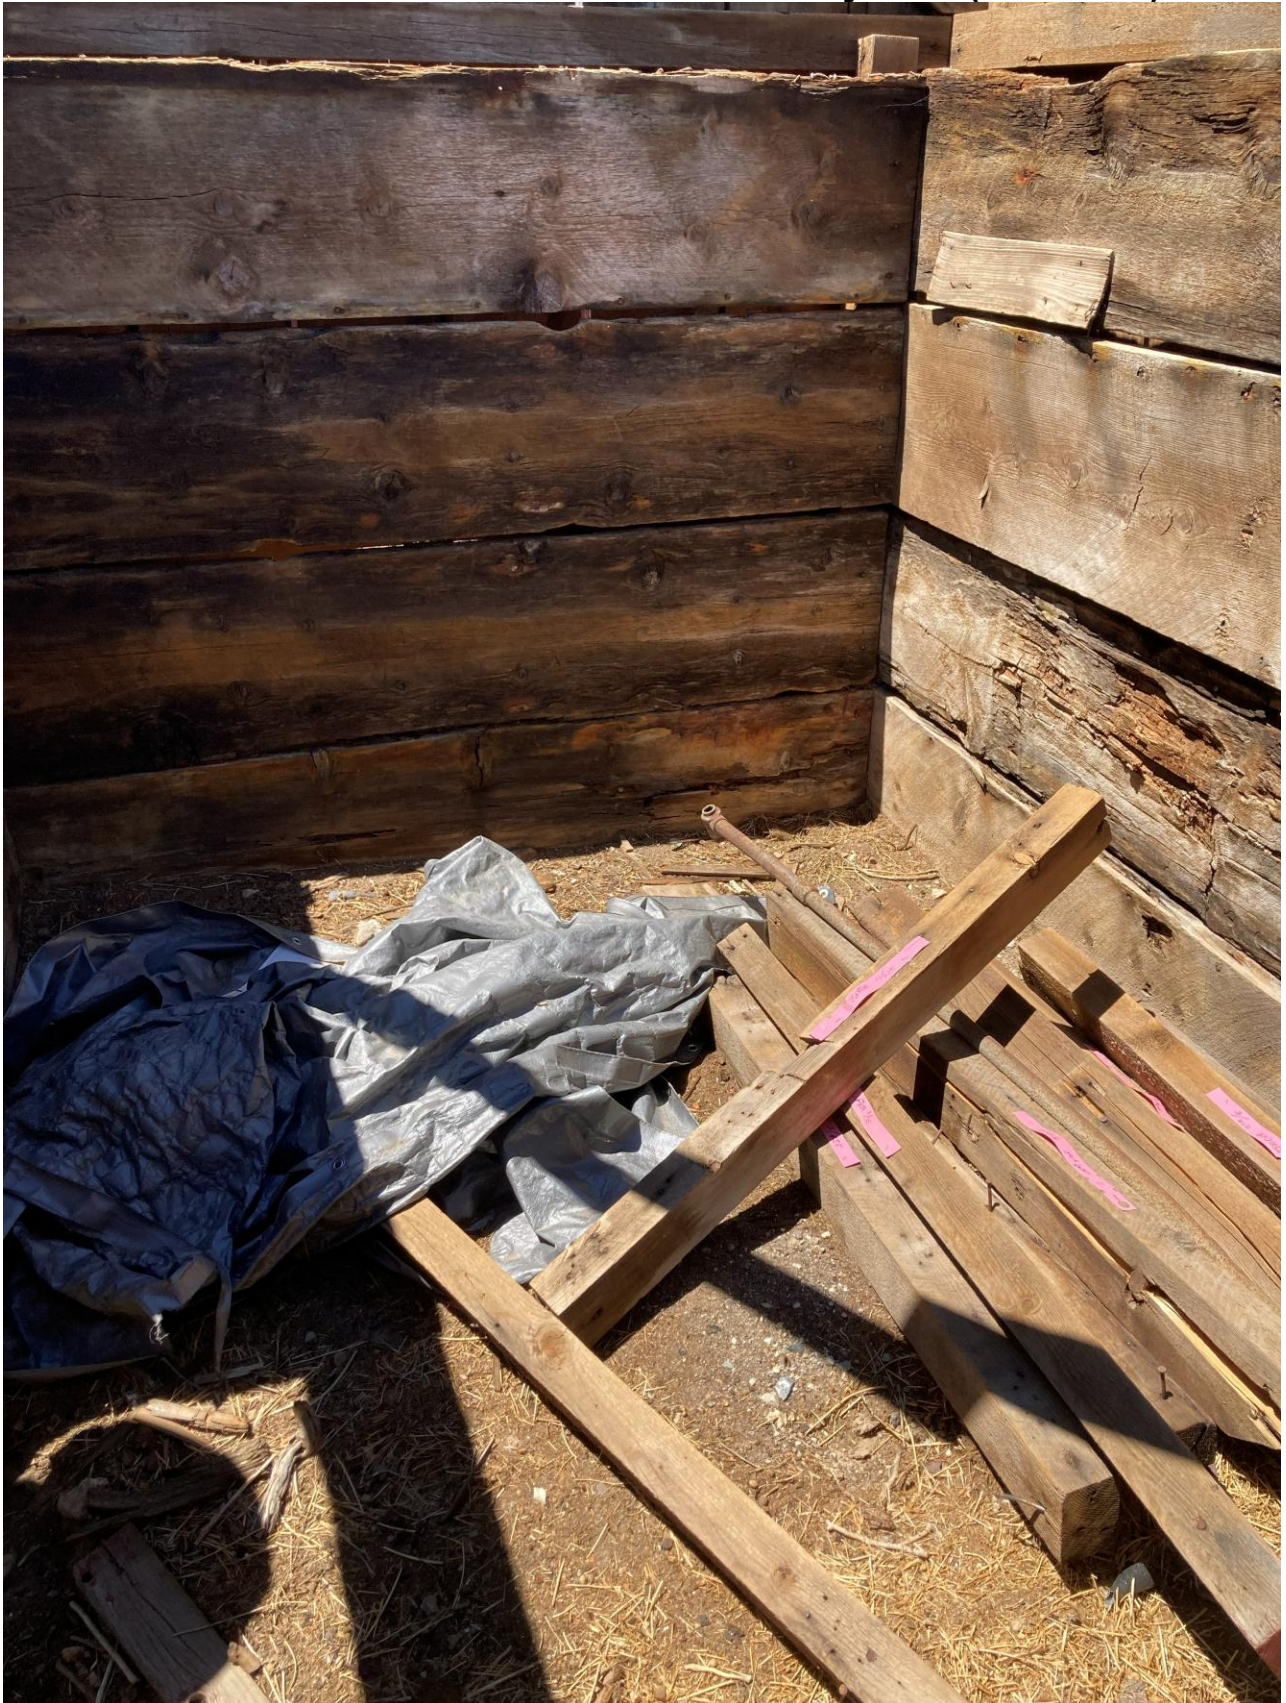
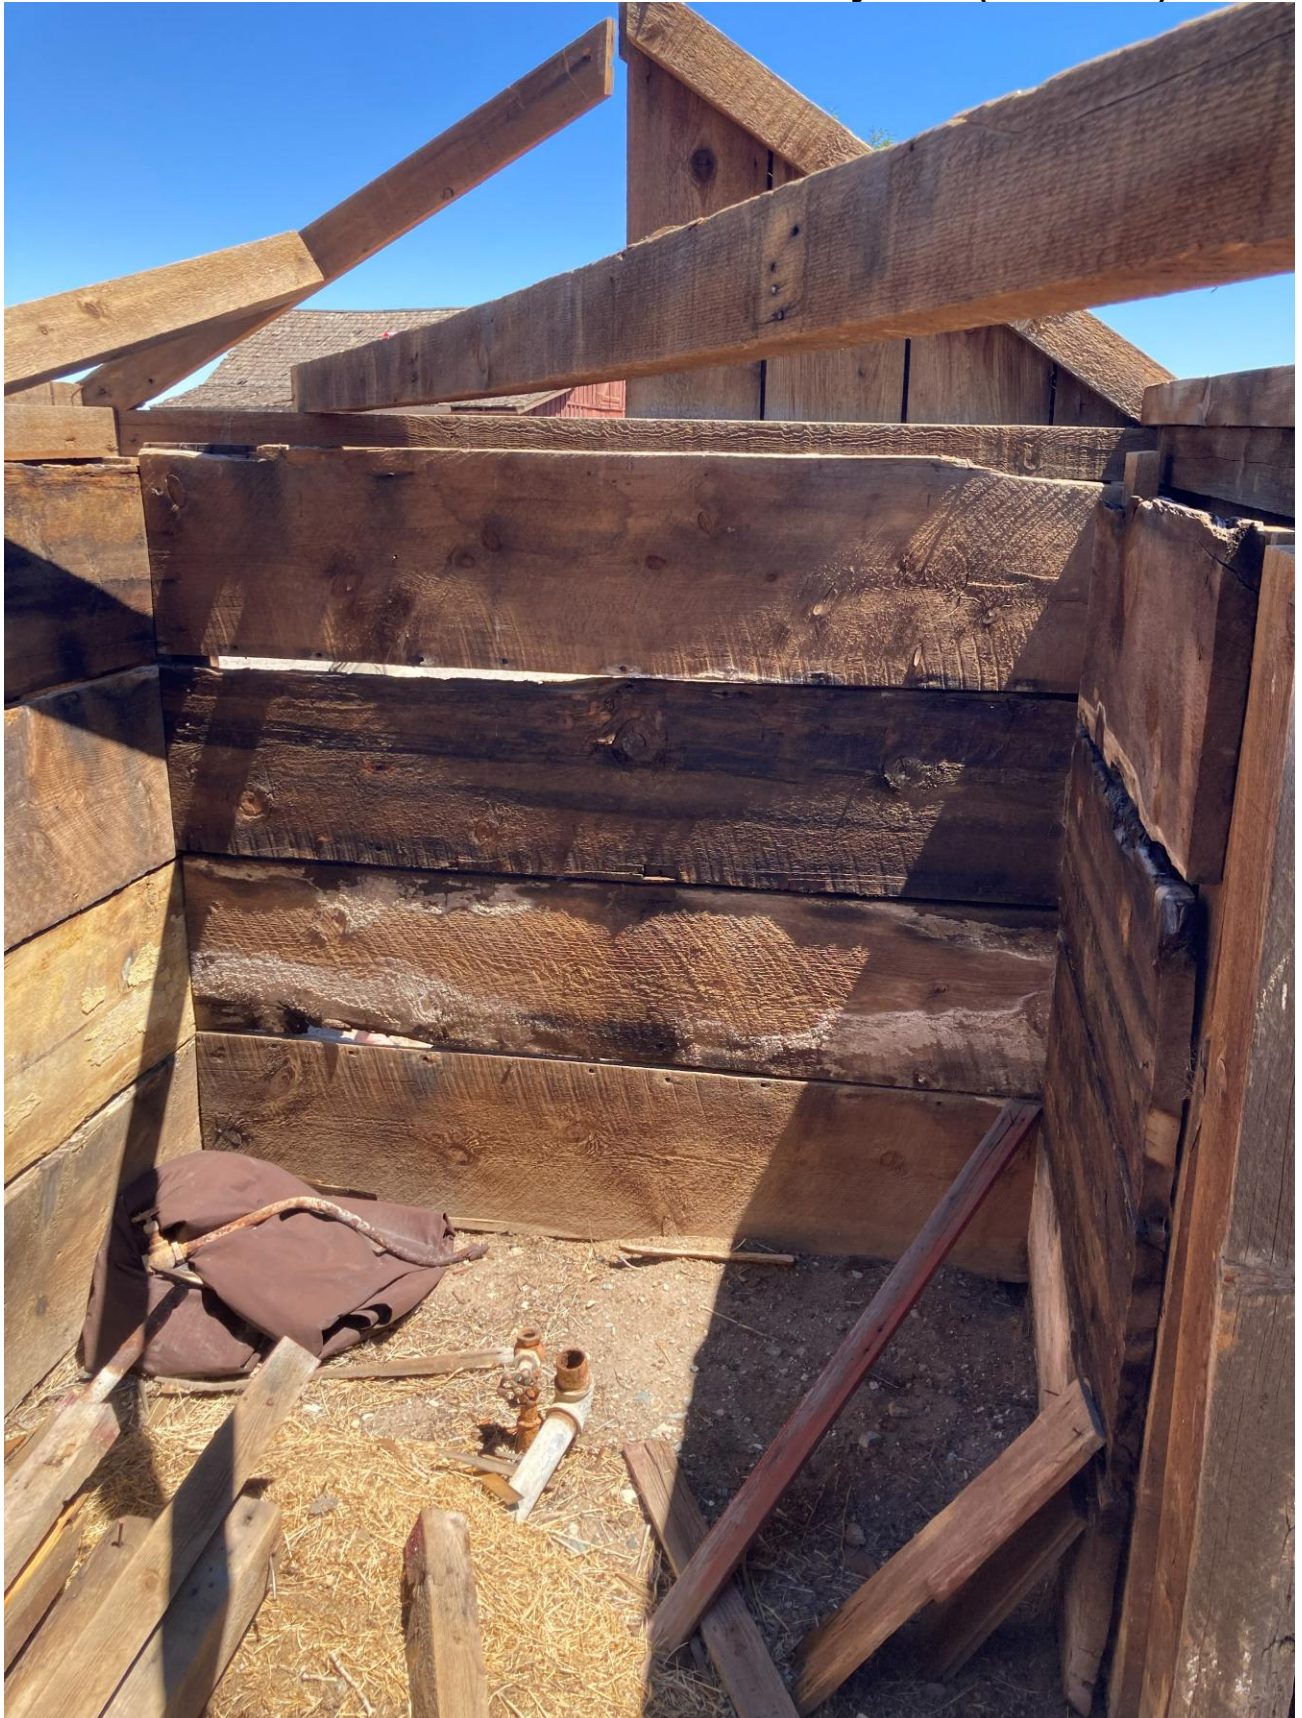
**Interior Photos of Tank House – Taken By Staff (7-28-2026)**

Construction is of heavy planks over covered with board and bat construction. Interestingly the walls are very thick double layer planks (each about 2.25" thick) with the interior gap being filled with a sawdust and manure mixture. The fill material is most likely for insulation against freezing temperatures which would have damaged the plumbing.
