NEVADA  
**STATE HISTORIC  
PRESERVATION OFFICE**

## Architectural Resource Assessment (ARA) Form

| Survey Dates | 10/18/2023 & 4/24/2025 | Recorded By | Michelle Schmitter | Agency Report # 23-P09 | FCA SITE NO.0442 |

| Current/Common Name | Building 20, Stewart Indian School Old Gymnasium | | | |

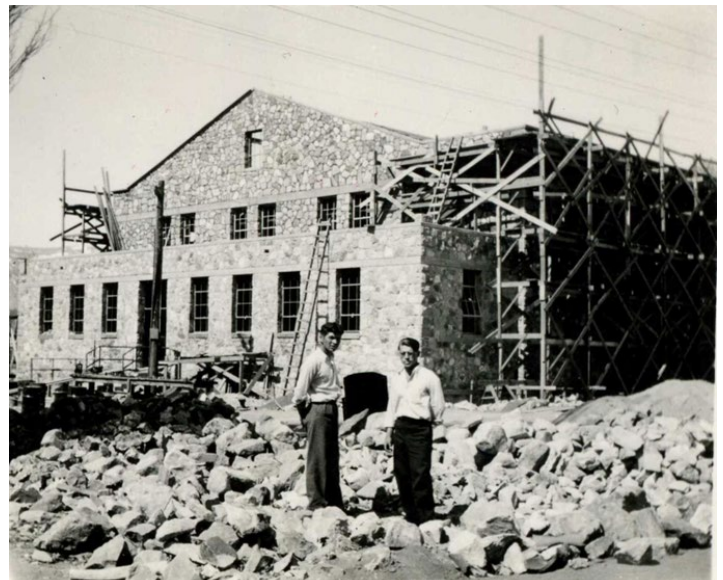
**Construction of the gym is recorded in this historic photo from the Bob Wright collection (SISCC) dating to 1938. Note the piles of sand used to make the mortar and the stones for the walls.**

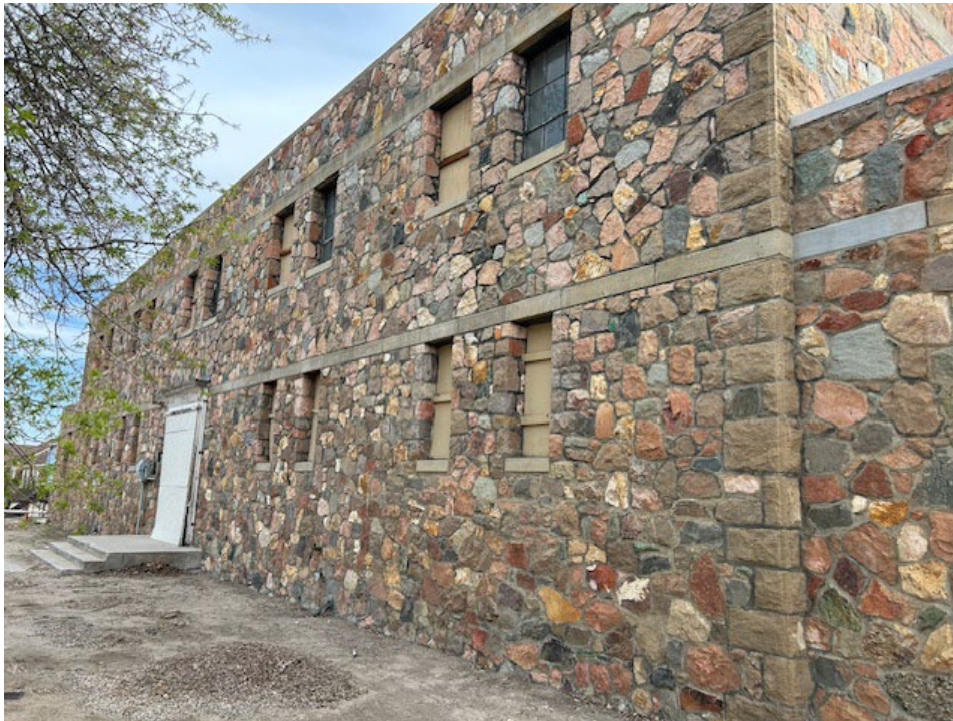
Elevation: North  
Photographer: M. Schmitter

Direction facing: South, close-up of quoins, concrete horizontal band  
Date: 4/24/2025

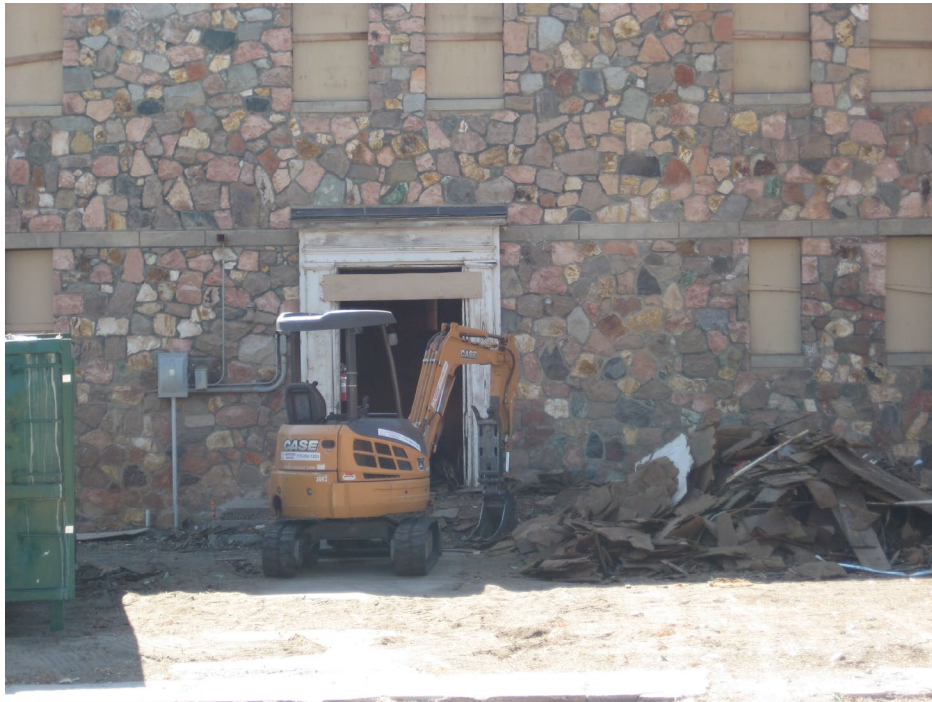
Elevation: North  
cleanup prior to roofing project

Direction facing: South towards entrance door detailing interior water damage  
Photographer: M. Schmitter  
Date: 10/13/2017

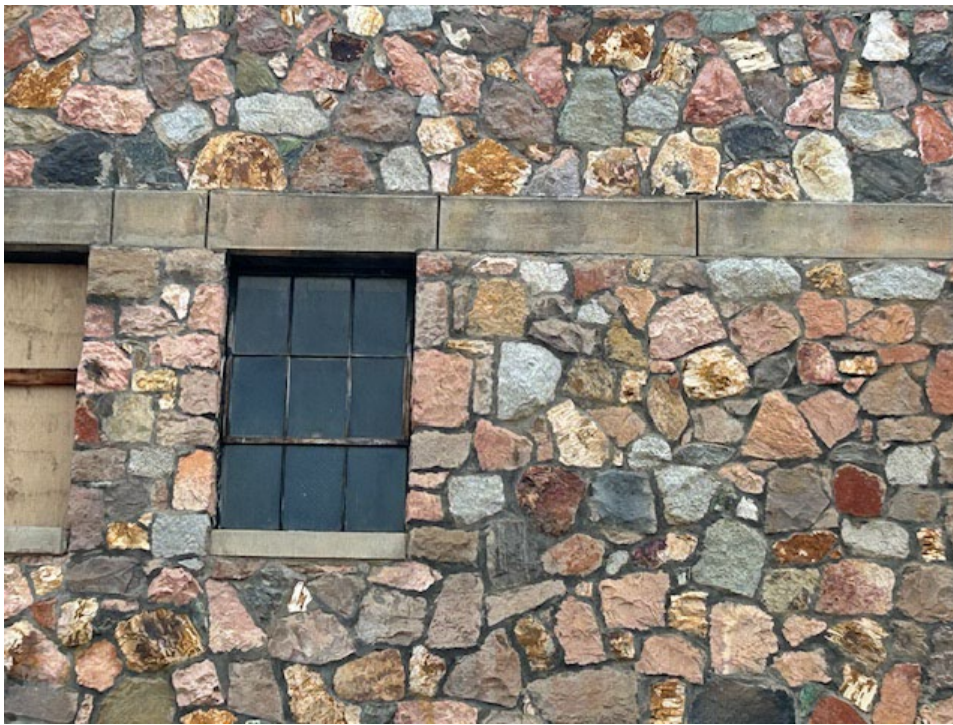
Elevation: North  
and multi-colored stone wall

Direction facing: South, close-up of metal multi-pane windows and concrete sill  
Photographer: M. Schmitter  
Date: 4/24/2025

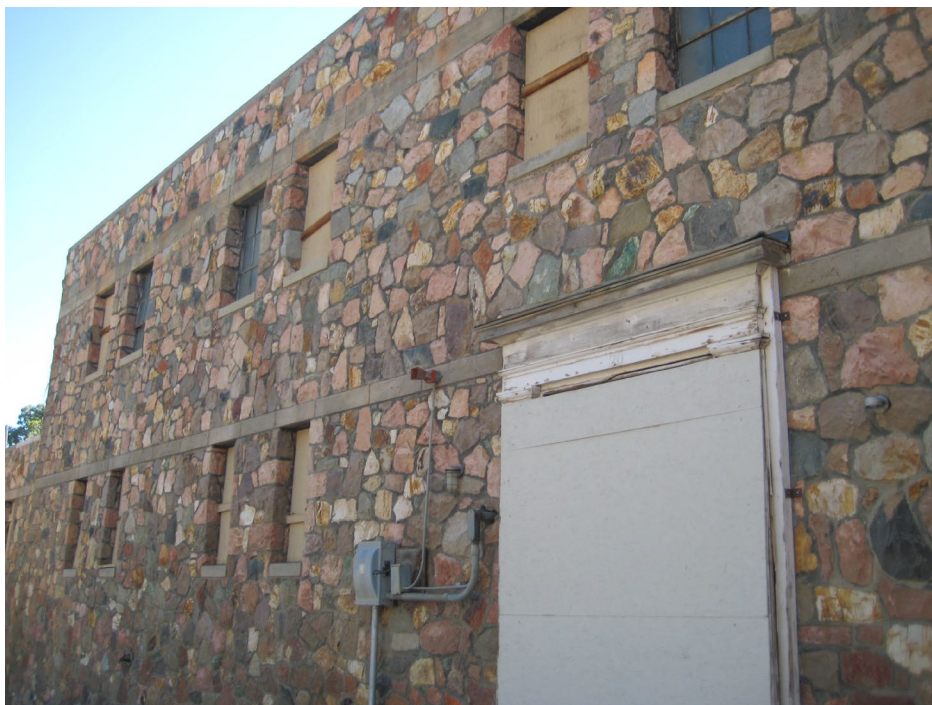
Elevation: North  
Photographer: M. Schmitter

Direction facing: South, view of wood door surround  
Date: 4/24/2025

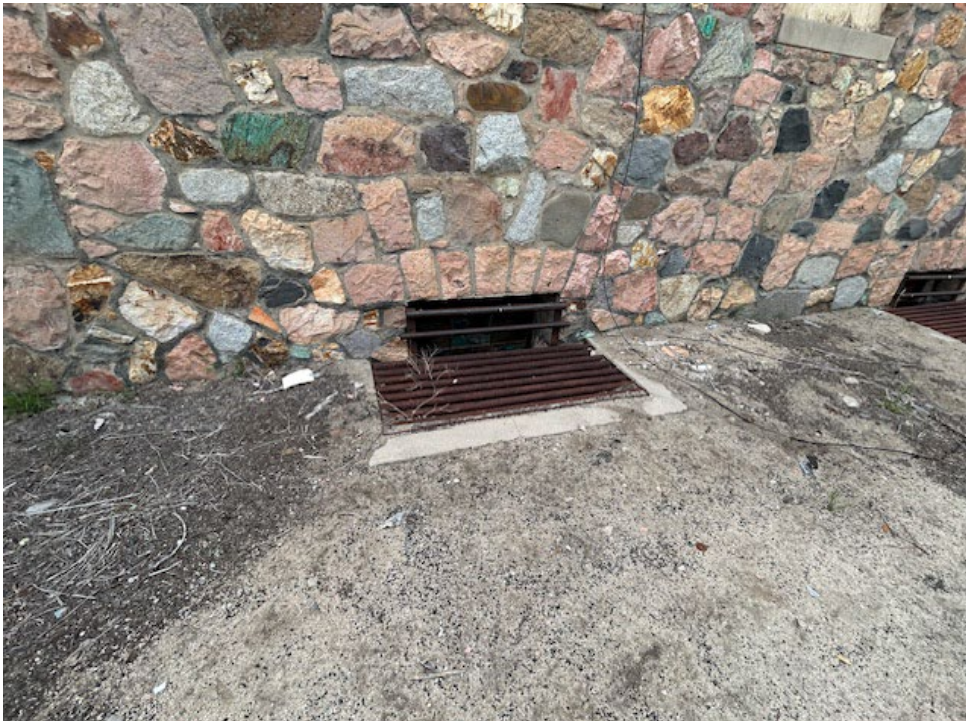
Elevation: East                      Direction facing: West, close-up view of east wall window well with arched stone header, trademark of mason, Jim Christopher  
 Photographer: M. Schmitter                      Date: 4/24/2025

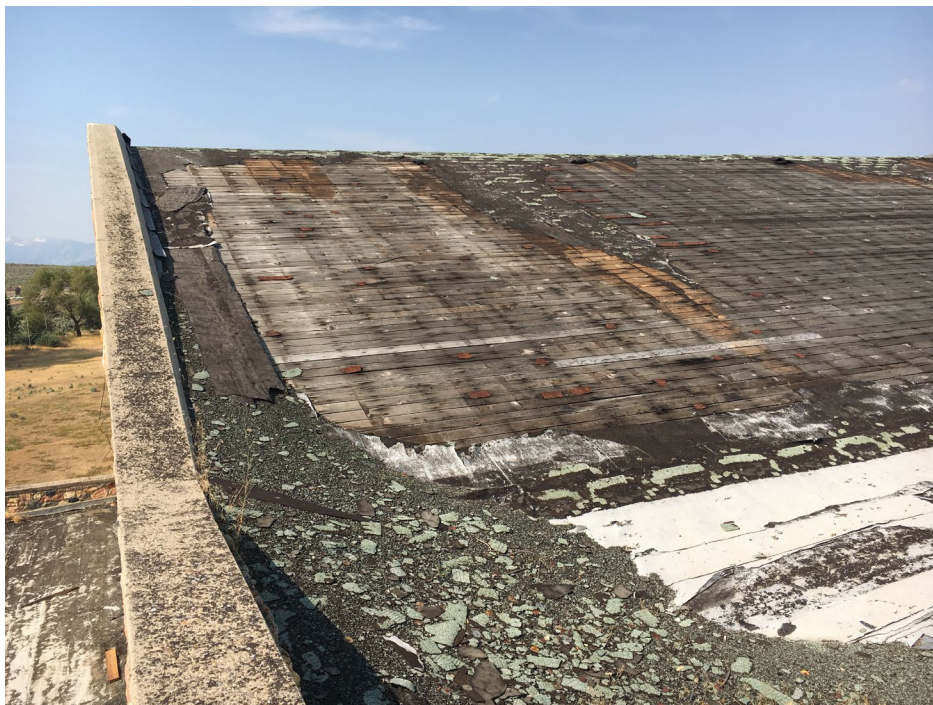
Elevation: Roof and lower parapet                      Detail of Old Gym roof condition prior to roof replacement project  
 Photographer: Kirsten E. Nalley, SPWD                      Date: 8/3/2017

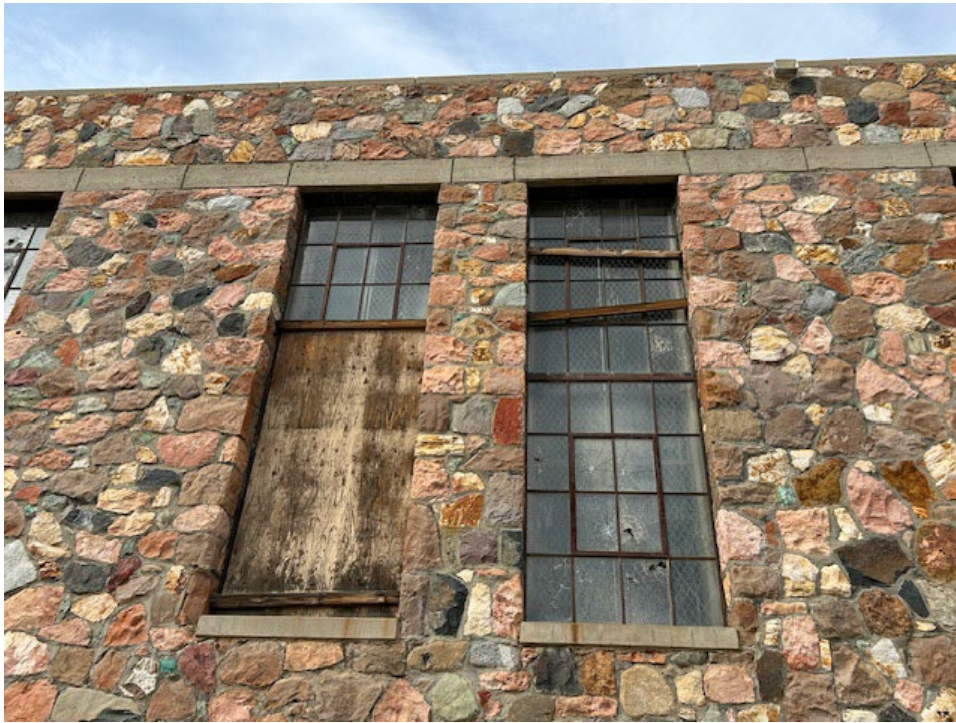
Elevation: South

Close-up of tall metal multiple lite windows with center pivot panel, rust visible

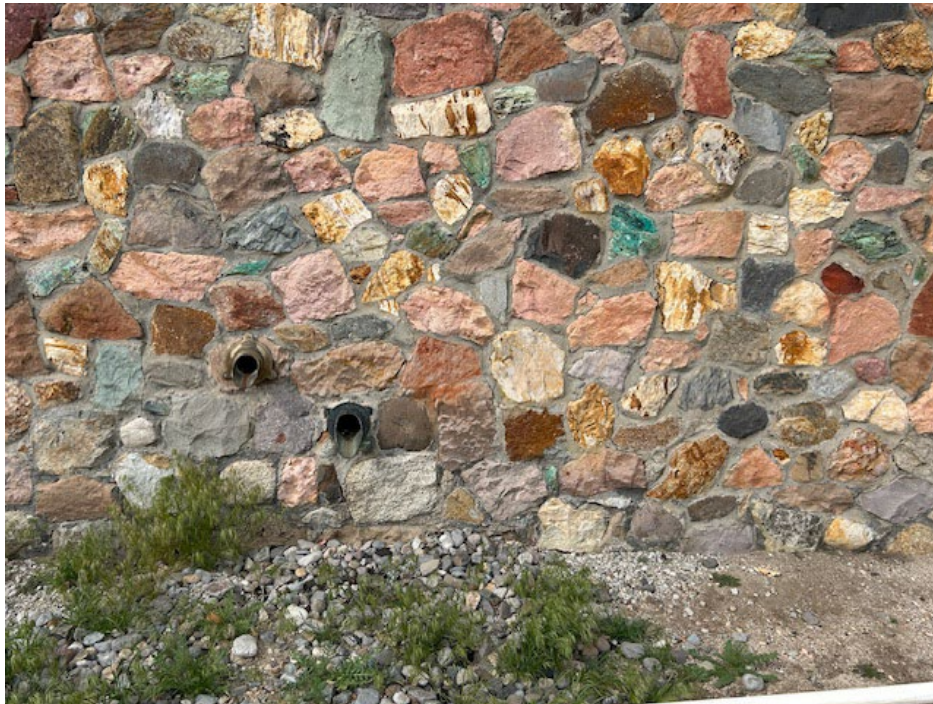
Elevation: South

View of drain spouts (historic and new) and multi-colored stones

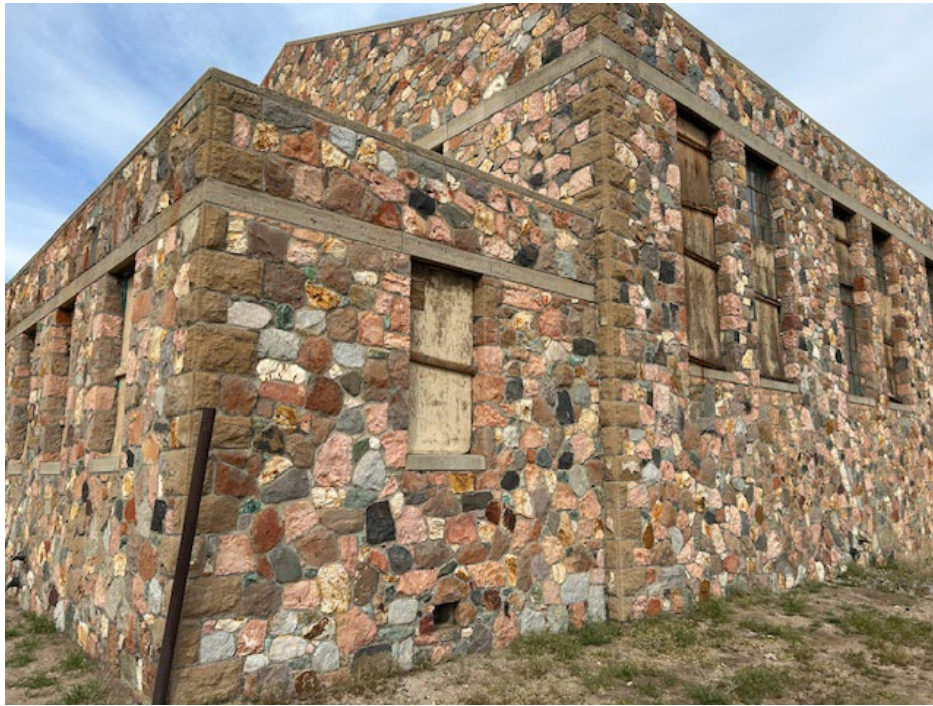
Elevation: South and partial west  
Photographer: M. Schmitter

Direction facing: Southwest corner showing quoins and multi-colored stonework  
Date: 4/24/2025

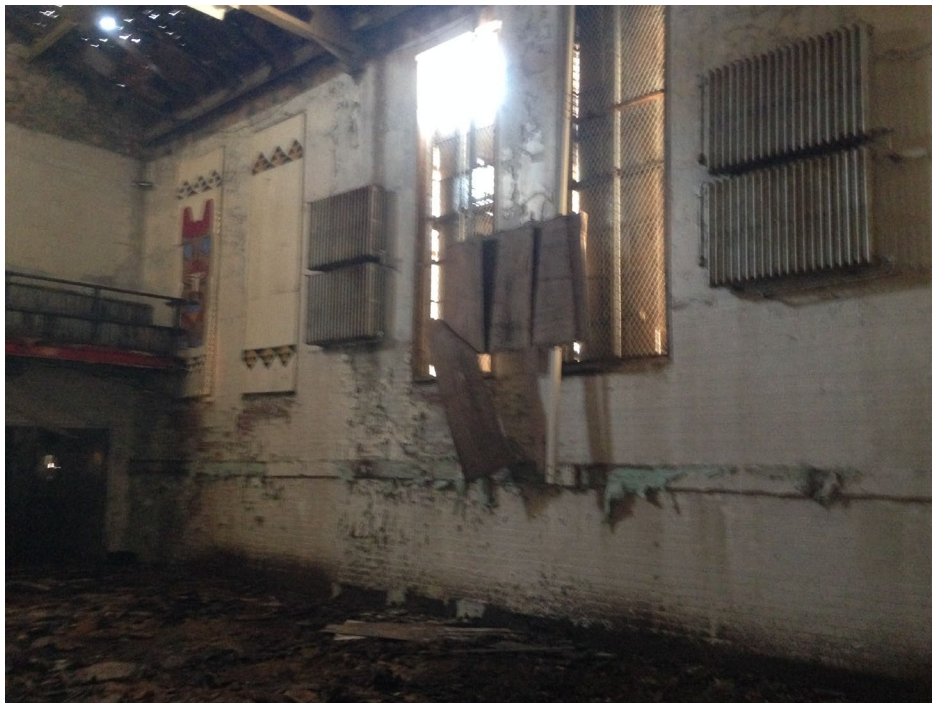
Elevation: Southeast corner, interior primary space  
Photographer: M. Schmitter

Student artwork that served as window shutters visible, floor saturated with water, fiberboard ceiling tiles from above released from ceiling due to moisture infiltration.  
Date: 10/13/2015

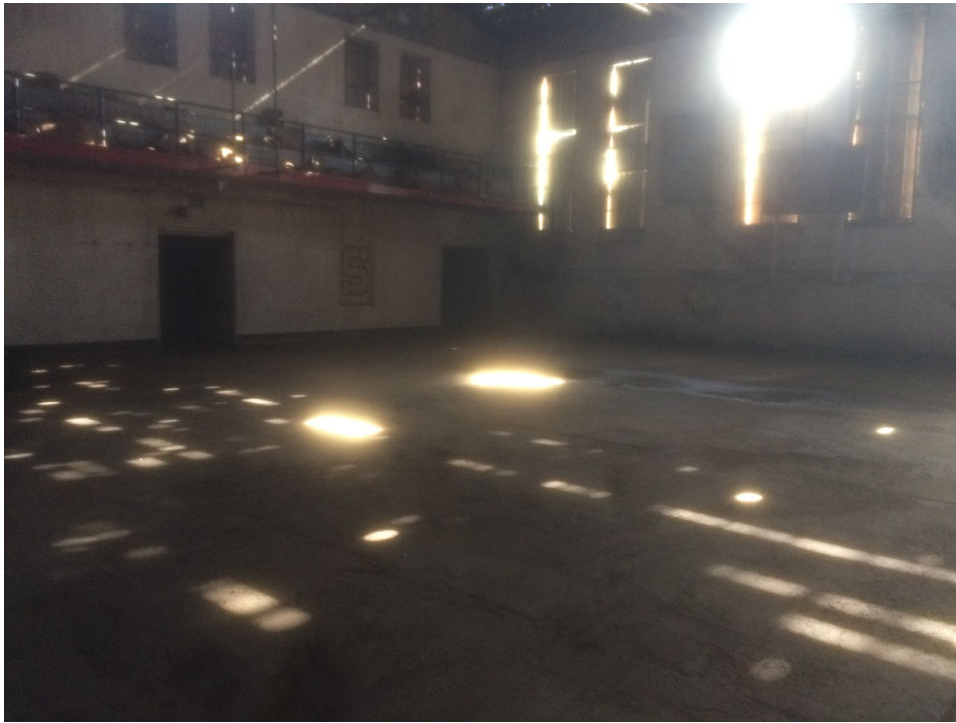
Elevation: Southeast corner, interior primary space

Standing water and deterioration of plaster visible

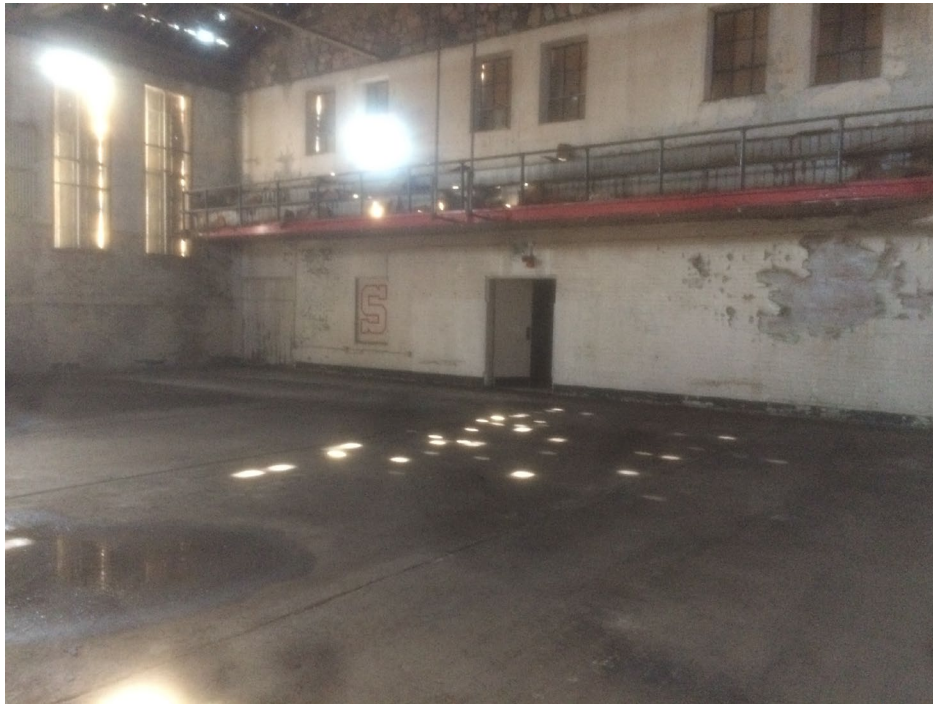
Elevation: Southwest corner, interior primary space

Standing water and deterioration of plaster visible

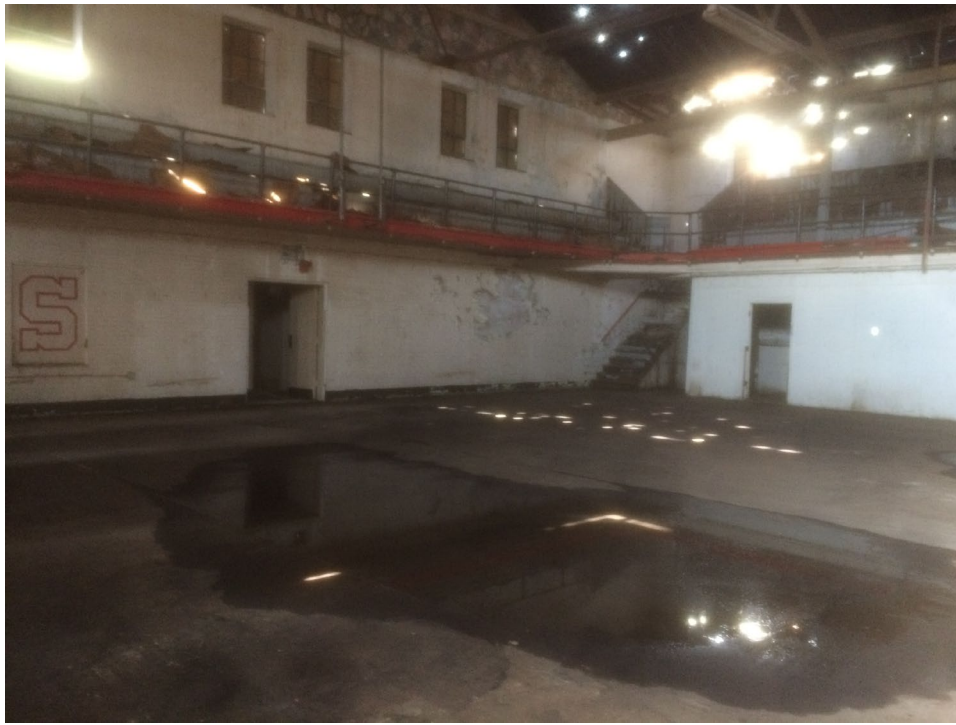
Elevation: Northwest corner, interior primary space

Standing water and deterioration of plaster visible

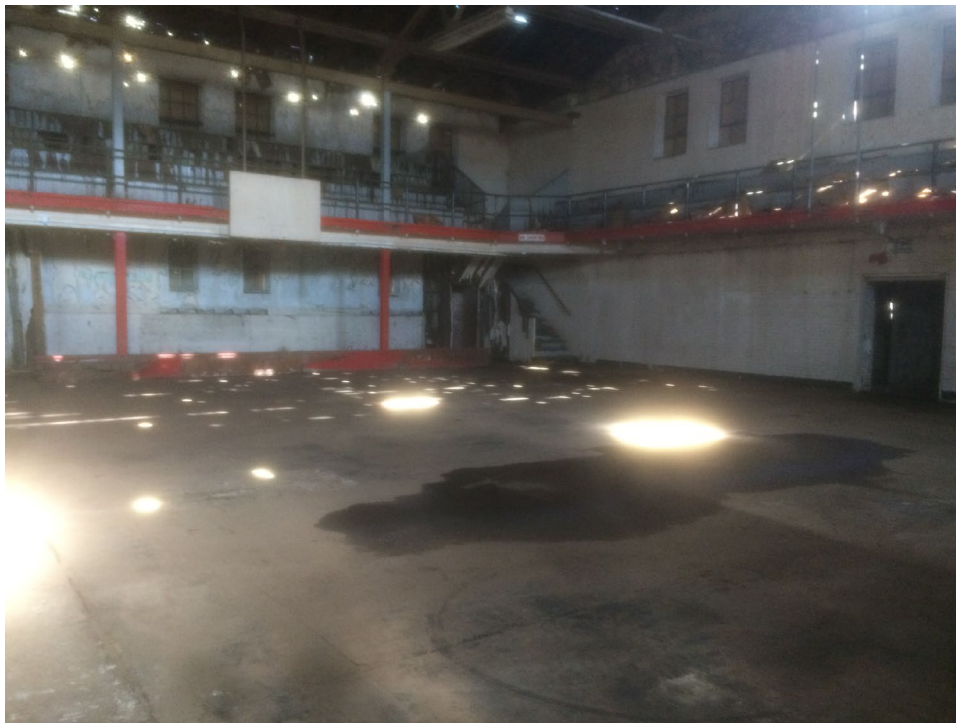
Elevation: Northeast corner, interior primary space

Standing water and deterioration of plaster visible

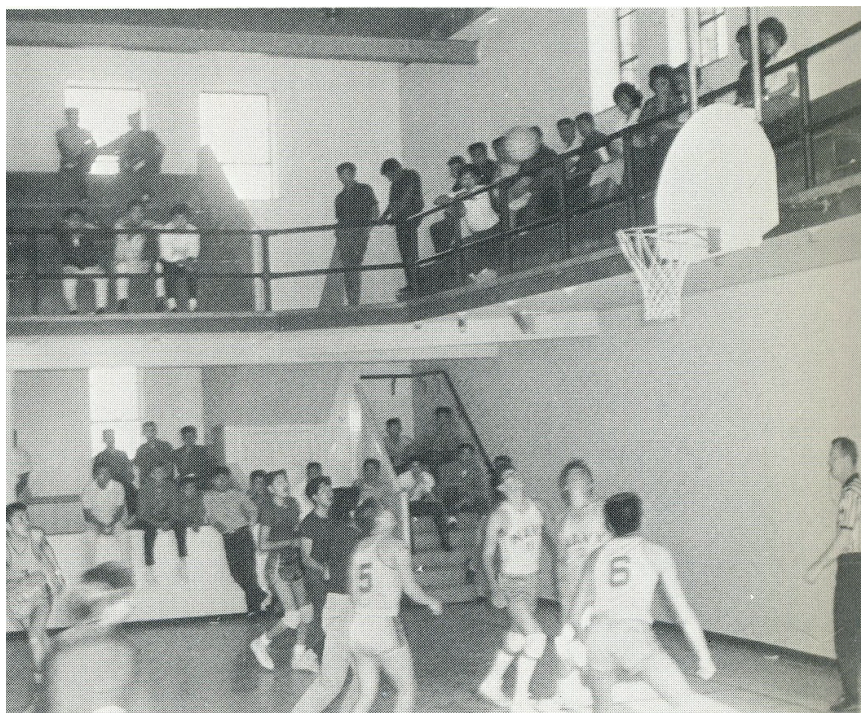
Elevation: Interior, Primary space  
corner to facilitate movement at stairwell

Close-up of stairs at east and balcony treatment above, note cutaway  
Photographer: 1964 SIS Yearbook photo

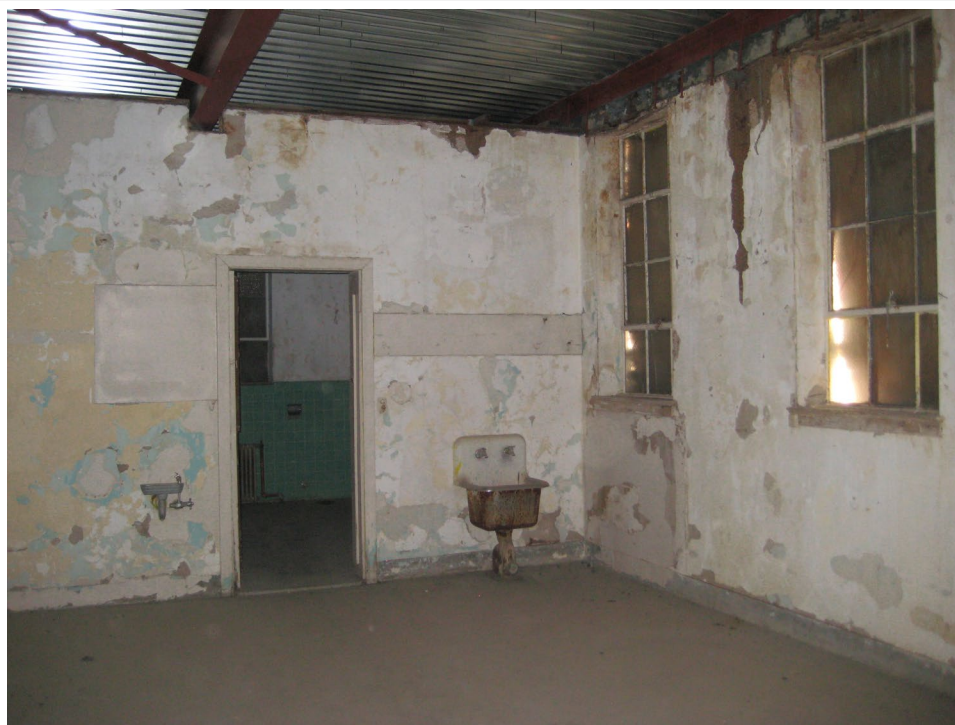
Elevation: Interior of secondary space  
Photographer: M. Schmitter

View towards locker room; note historic utility sink  
Date: 11/21/2023

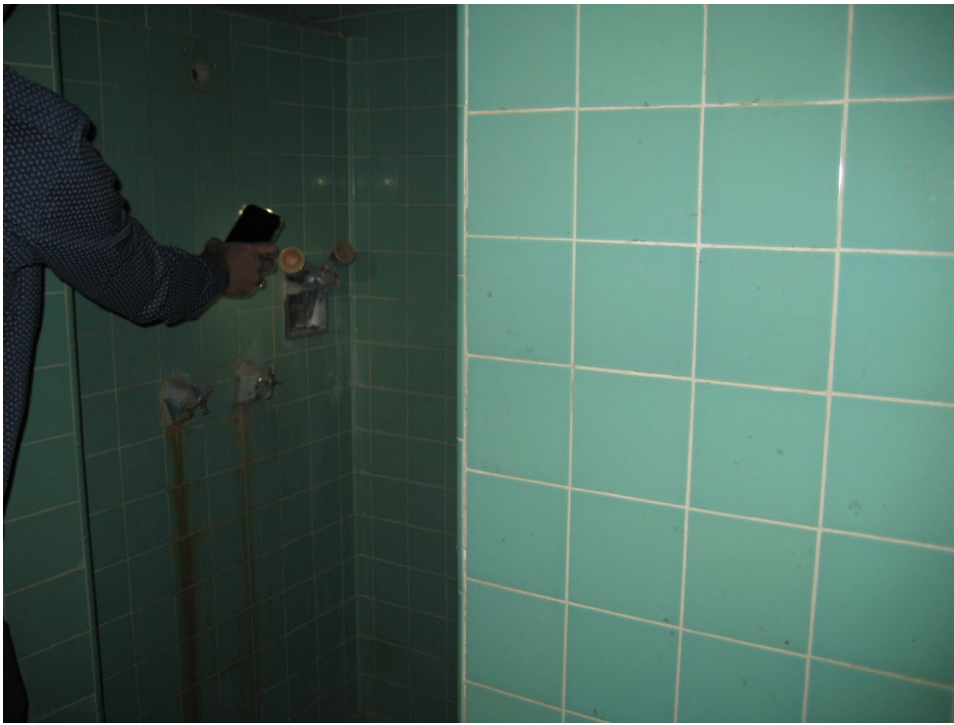
Elevation: Interior of secondary space  
Photographer: M. Schmitter

View of green field tile and shower stall  
Date: 11/21/2023

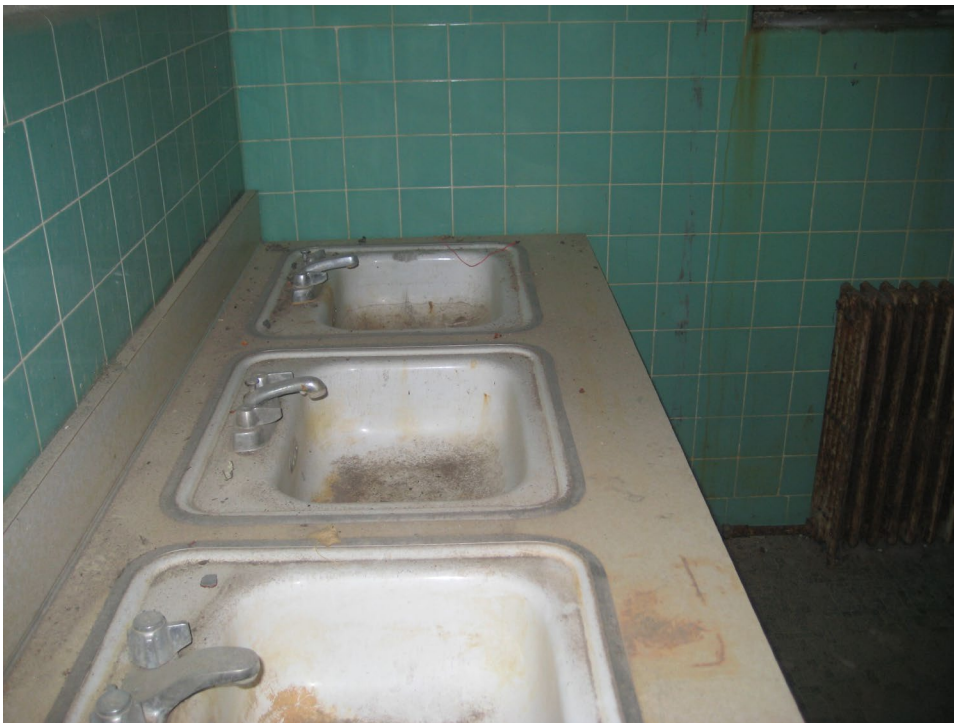
Elevation: Interior of secondary space  
Photographer: M. Schmitter

View of multiple sink basin with Formica counter in restroom  
Date: 11/21/2023
