City of Ely, Nevada Historic City Hall and Fire Station Rehabilitation

An Historic Structures Report

RAFI Architecture and Design

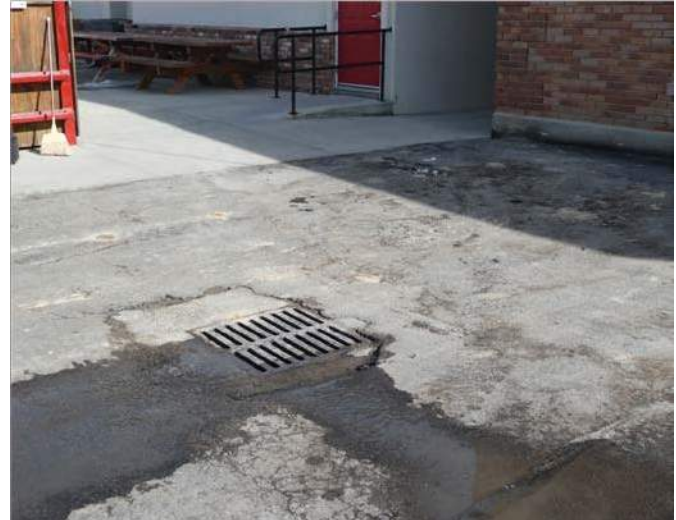
Detail of West Drain in Parking/Drive Area

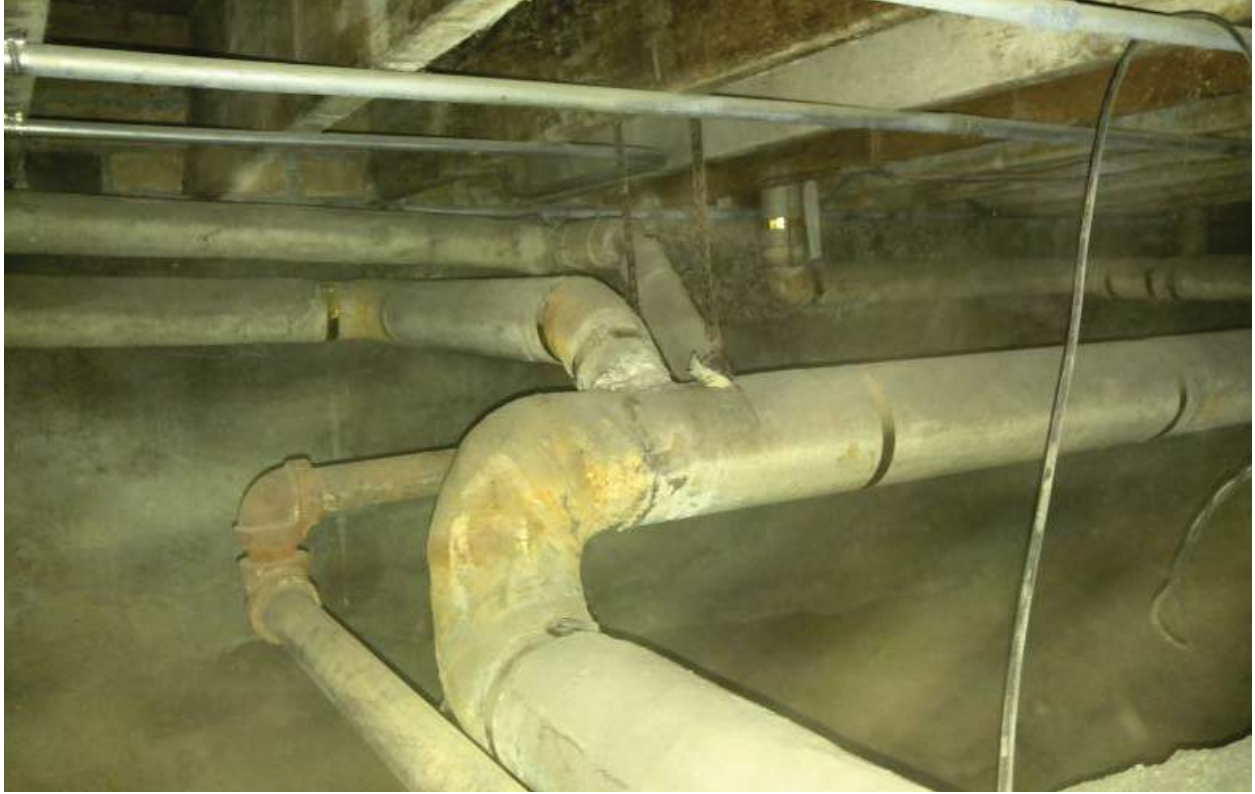
Utilities in the crawlspace.

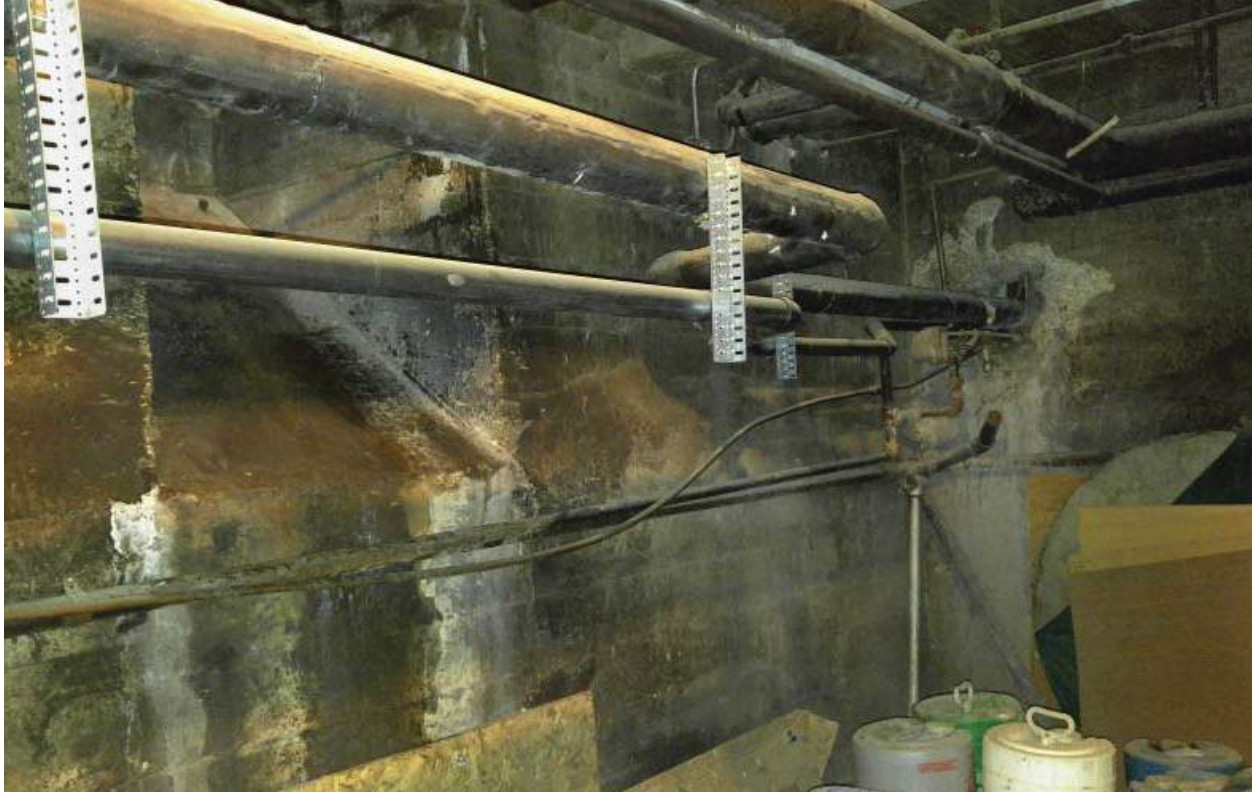
Utilities and storage in basement.

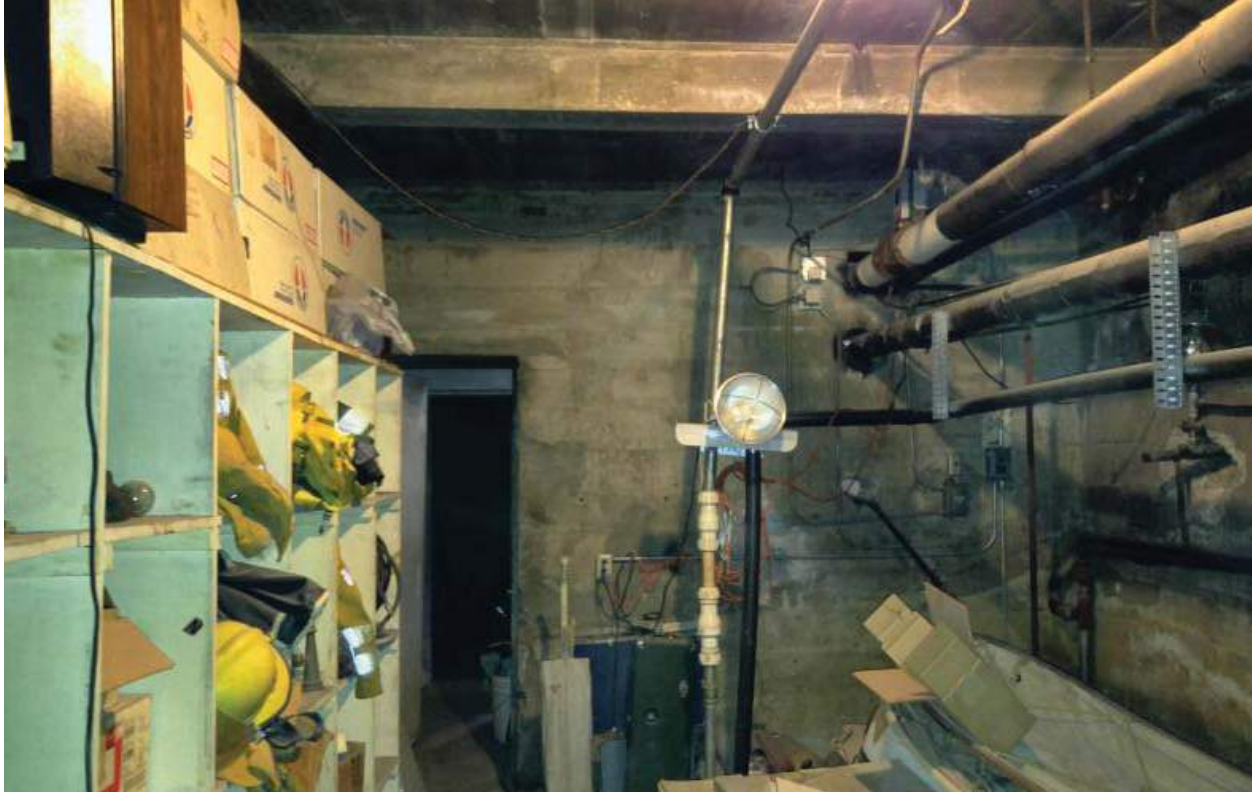
Storage and overflow pump in basement.

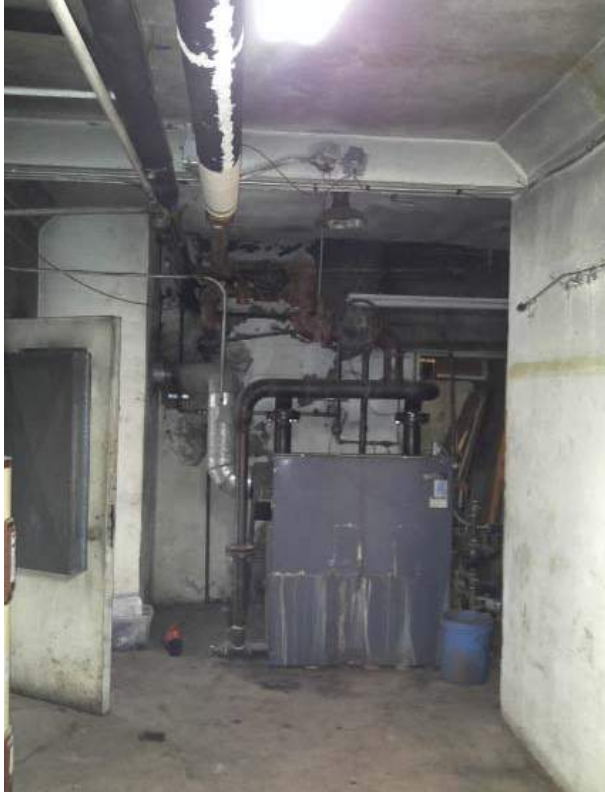
Utilities in the basement.

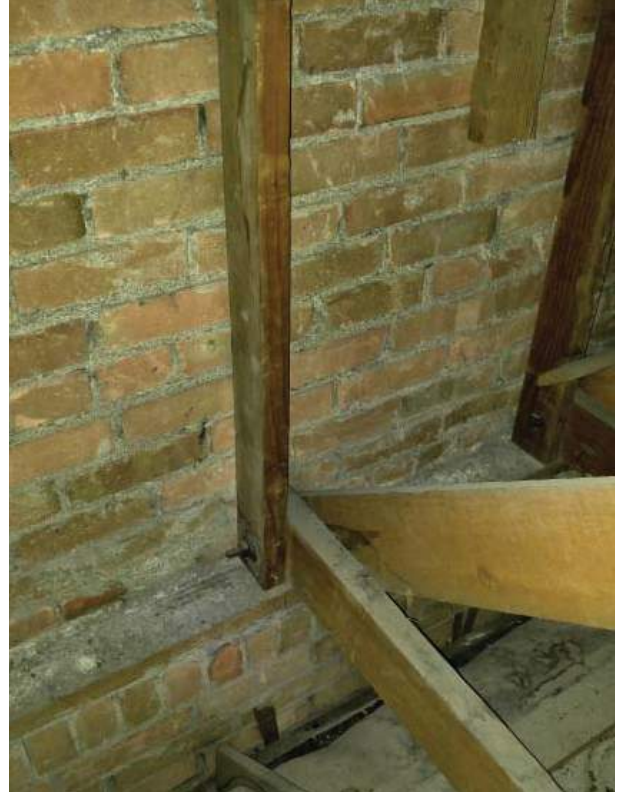
Wall to structure connection in attic space.

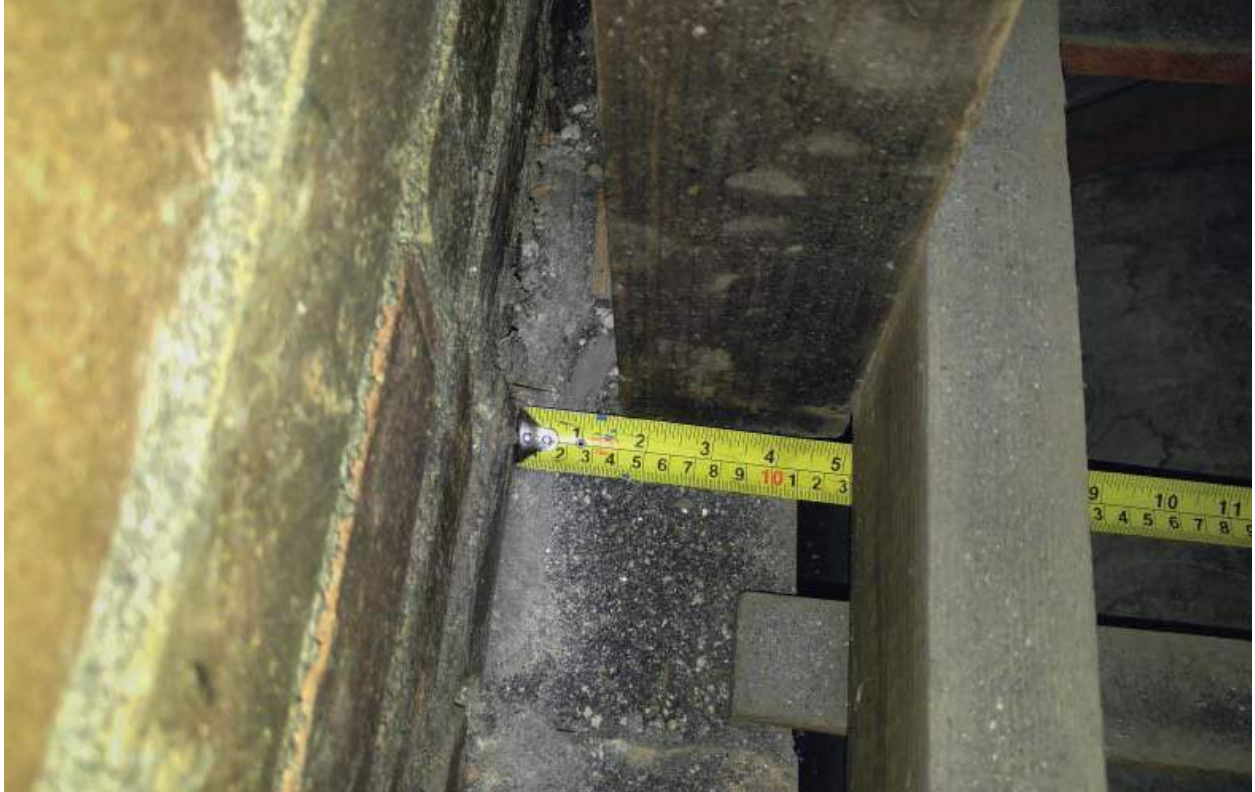
Wall to structure connection in attic space.

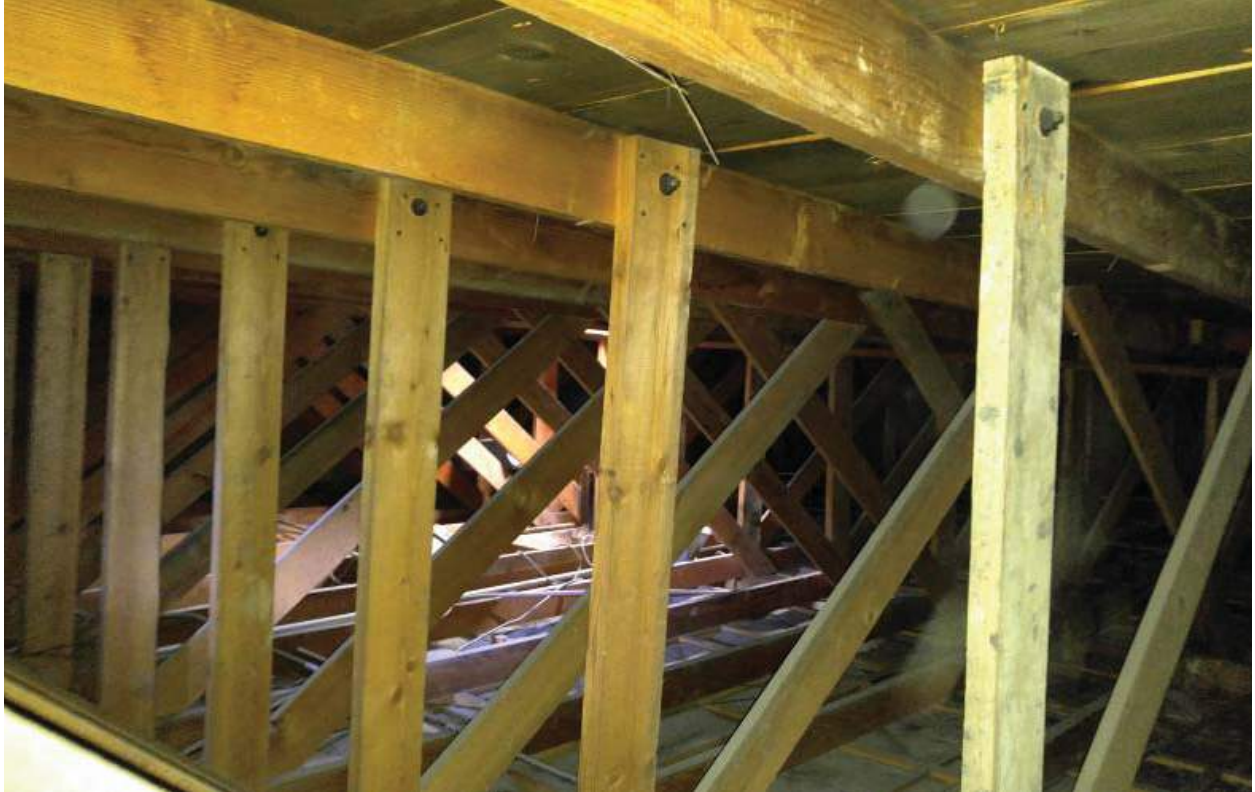
Wooden structure in the attic.

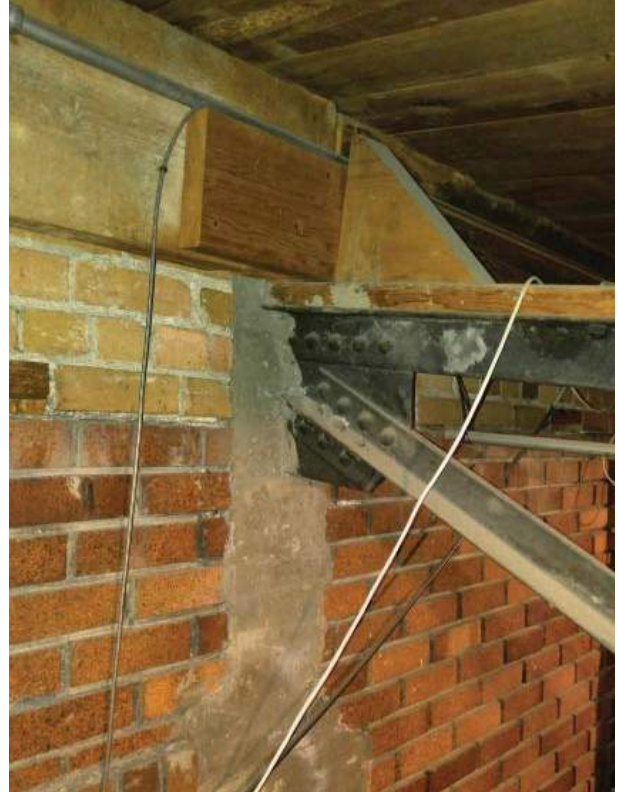
Structure to wall connection above firestation garage.

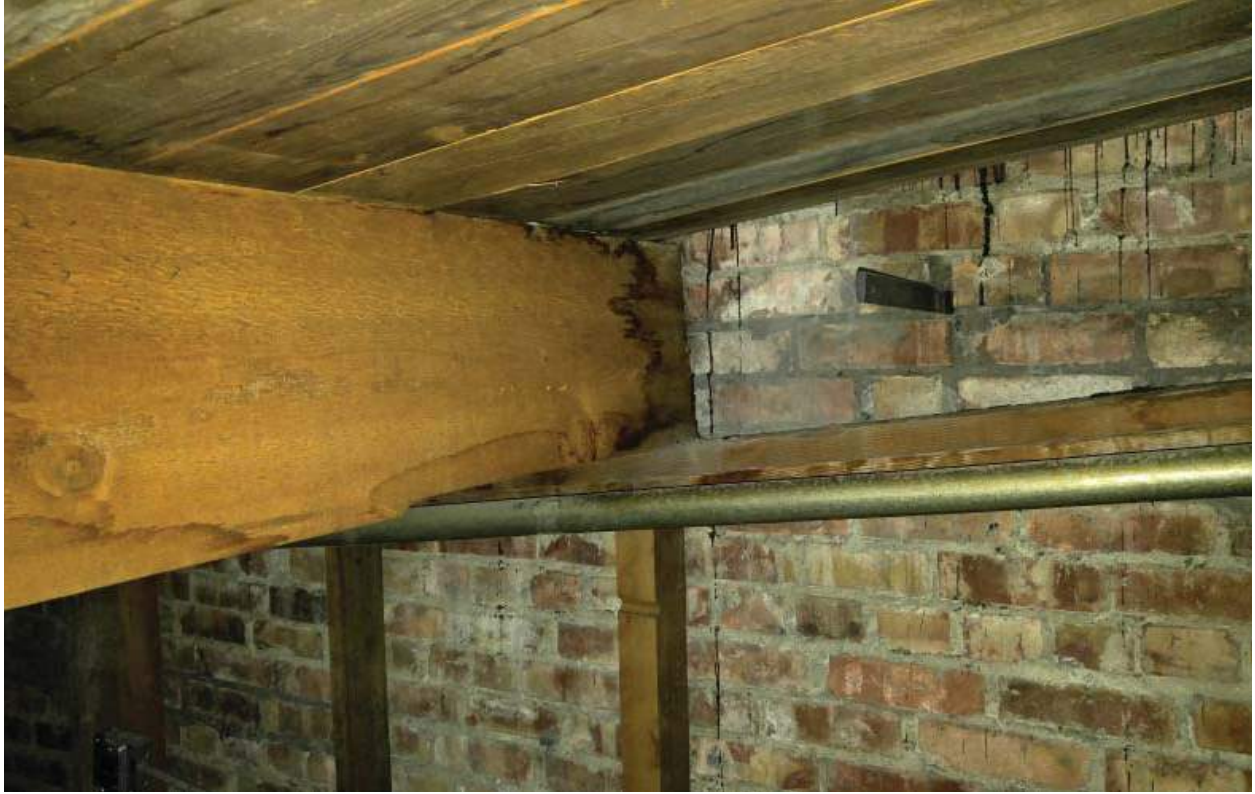
Roof to beam to truss connection.

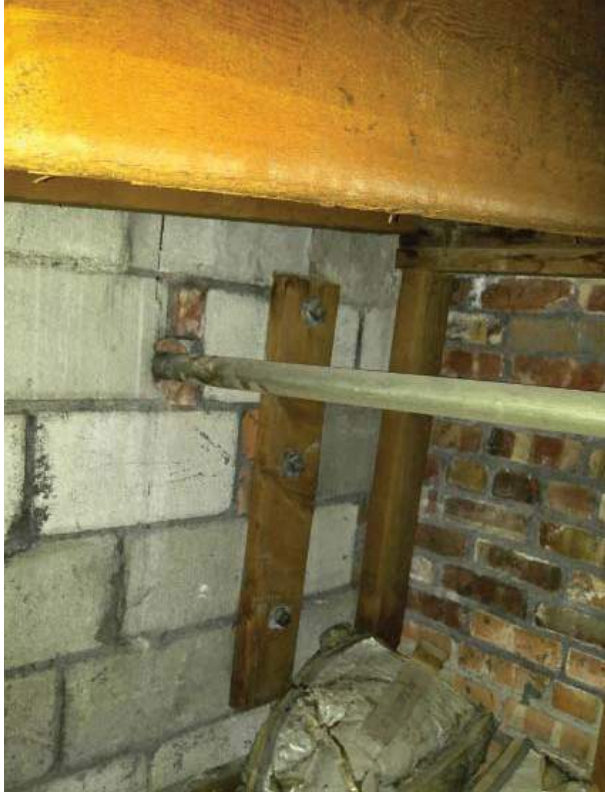
Masonry infill from previous renovation.

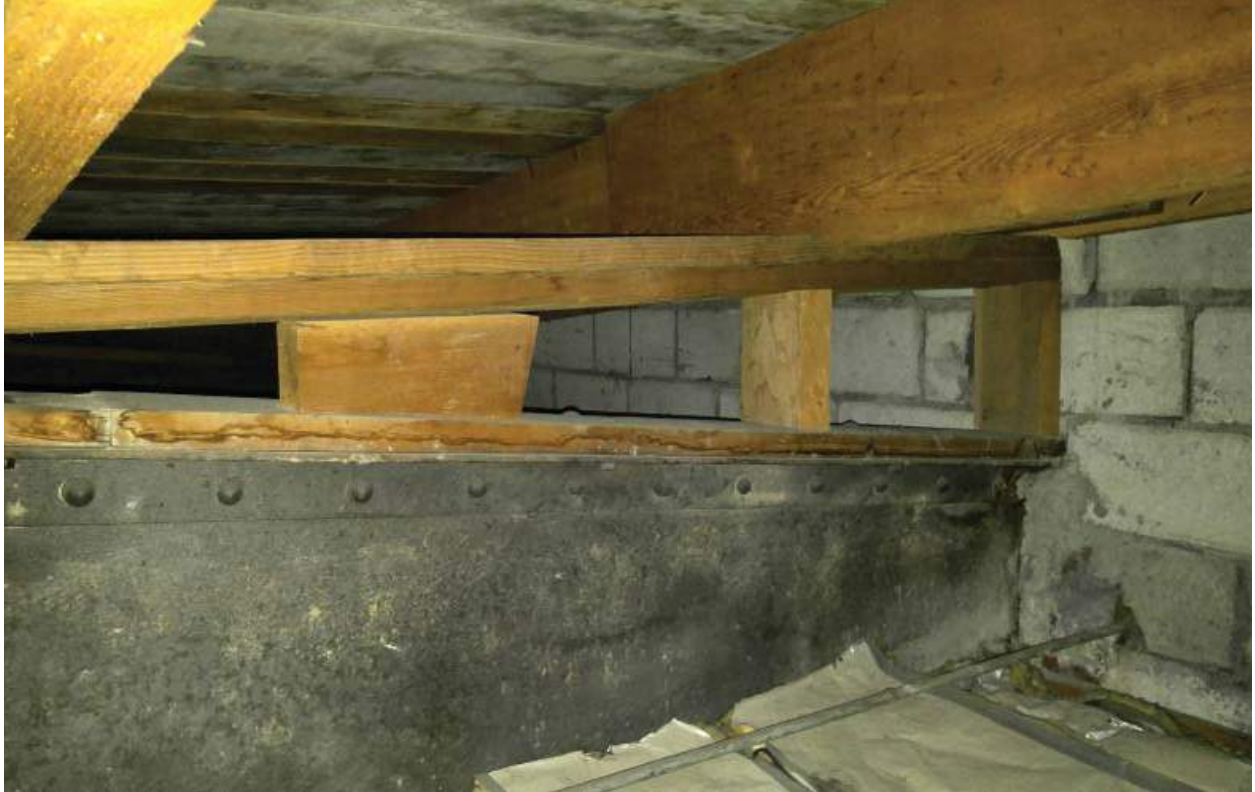
Structural truss above the firestation garage.

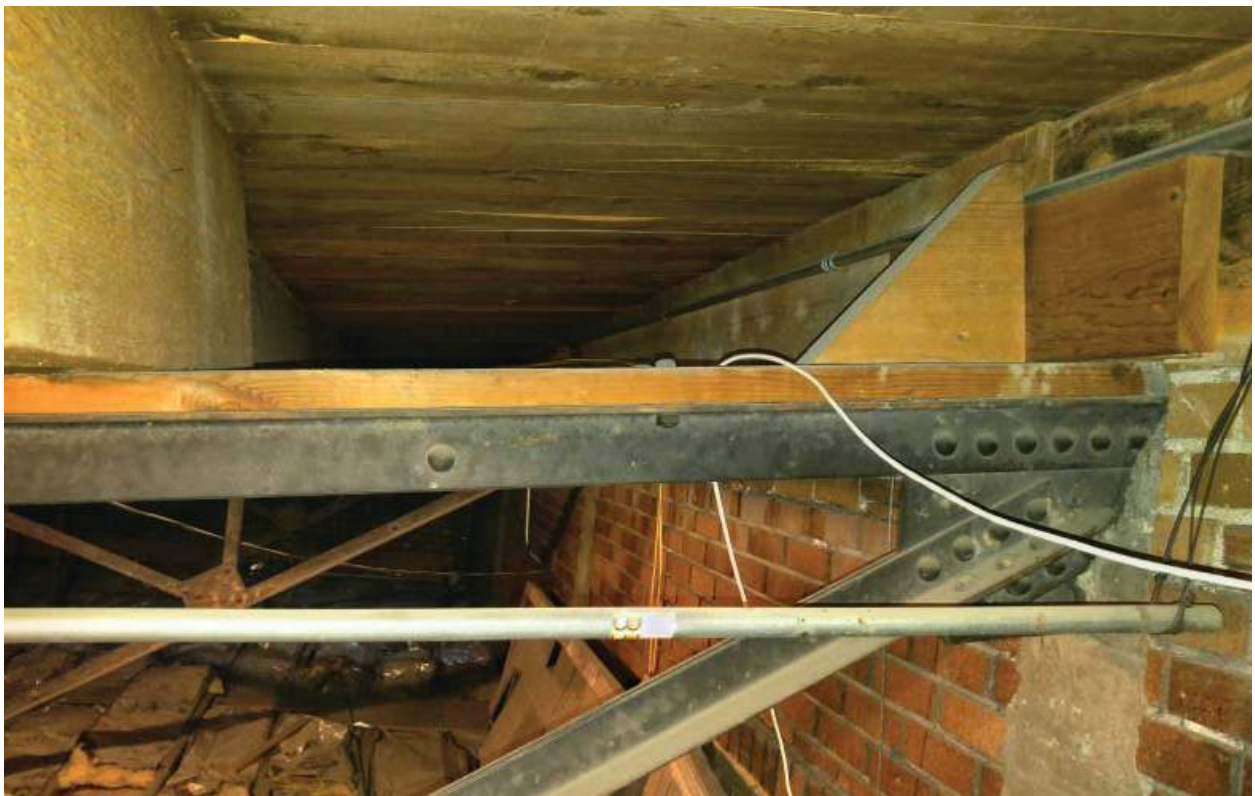
Structural truss above the firestation garage.
