NEVADA COMMISSION FOR
CULTURAL CENTERS AND HISTORIC PRESERVATION (CCCHP)
GRANT APPLICATION FOR FY2021-2022

Historic Property Name: Boulder City Water Filtration Plant Date Built: 1932

LGA Architecture (LGA) is pleased to submit our final Historic Structure and Preservation Assessment Report re: architectural, historical significance, structural engineering, (MEP) mechanical, electrical, & plumbing engineering assessments, life-safety assessments, and hazardous materials assessment for the Boulder City Water Filtration Plant project. This Final Assessment Report also now contains a Section 6; Cost Consultant Report. This cost estimate is for the strategy we are recommending moving forward to protect and preserve this building for a future Community Vision.

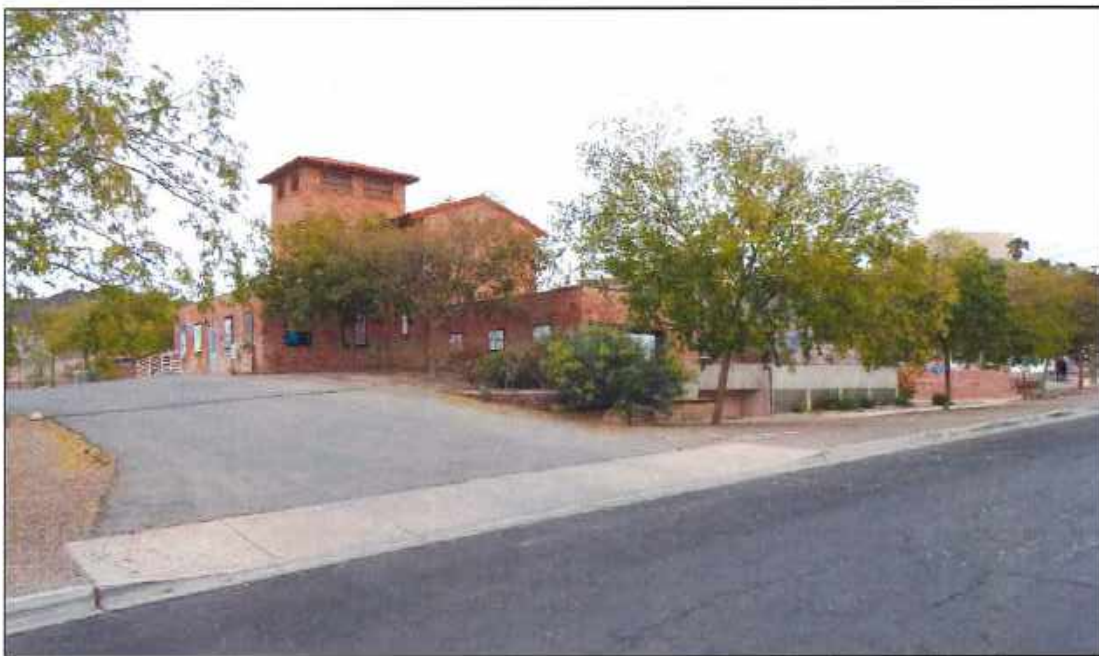
Photograph 1. Overview of the Boulder City Water Filtration Plant from Railroad Avenue, facing north.

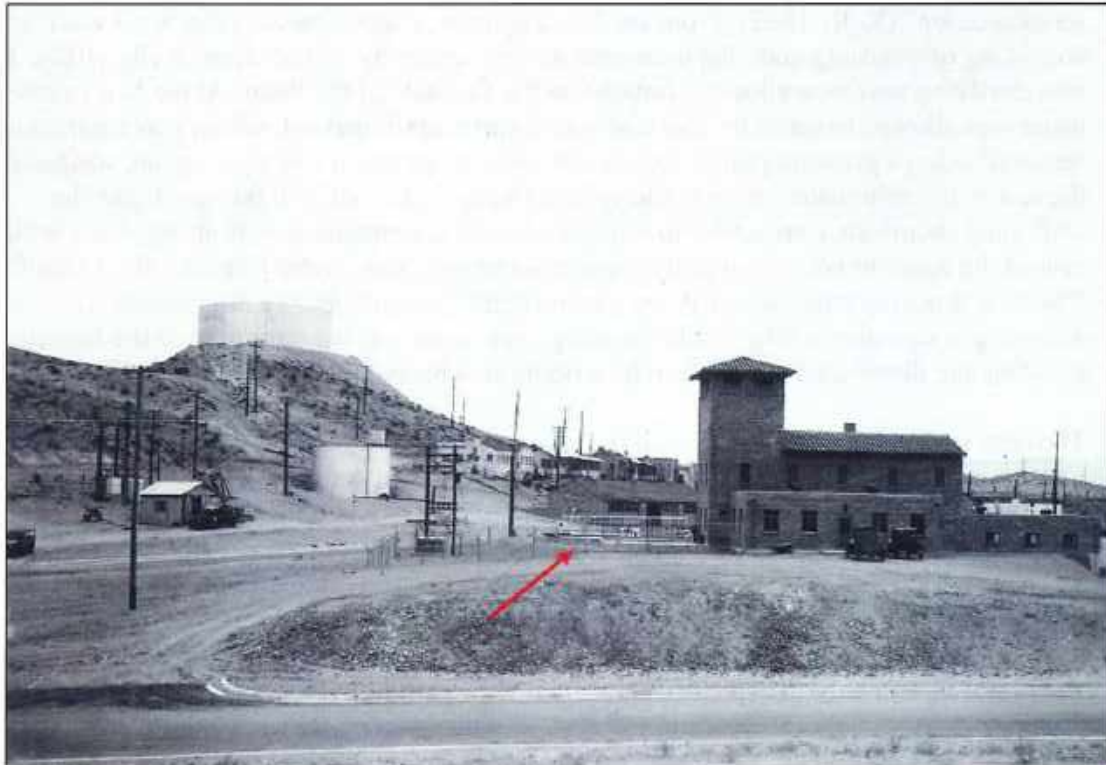
Figure 6. Photograph of the Plant shortly after construction, showing receiving tank and two-million-gallon water storage tank in the background, ca. 1932. Note the infrastructure associated with the clear well at the north end of the building marked with a red arrow. The northwest addition was constructed over the well shortly after this photograph was taken (Photograph courtesy of the National Archives and Records Administration at Denver, Broomfield, Colorado).

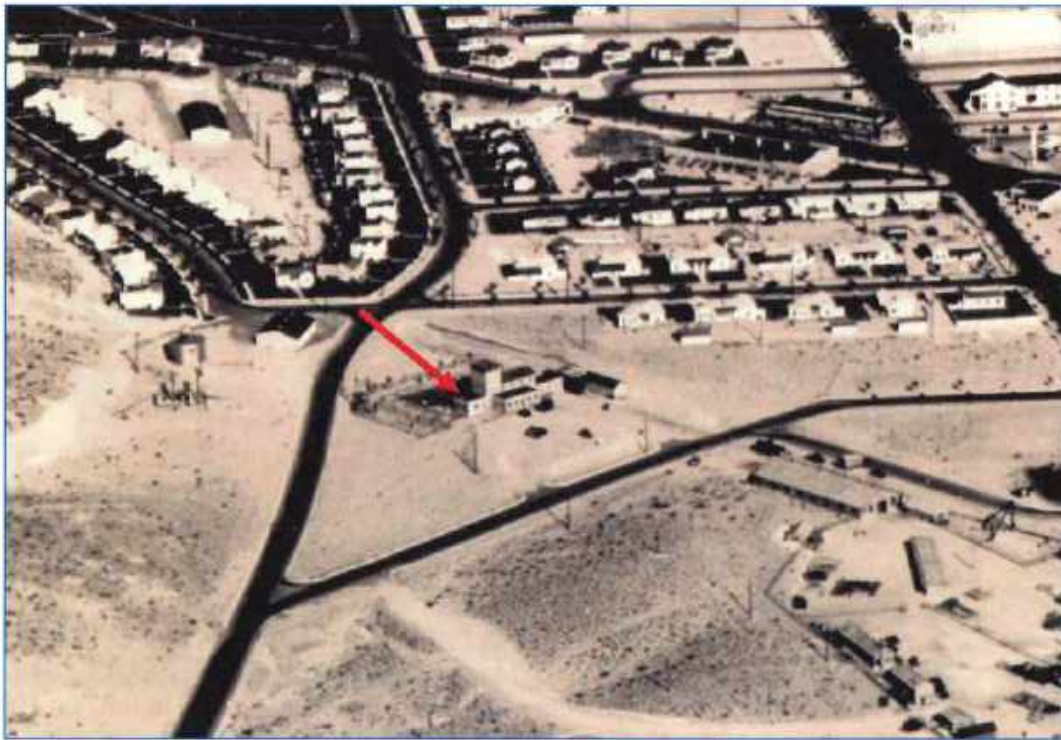
Figure 8. Aerial view of the Plant (center of photo) taken on April 12, 1934, showing the northwest addition (Courtesy Boulder City Museum & Historical Association Archives, photo no. 0007:0238).

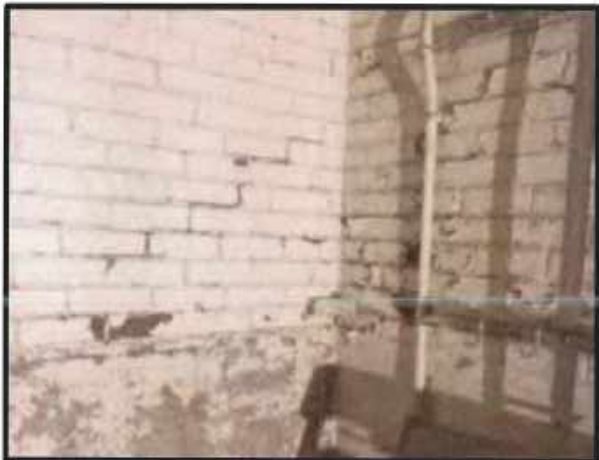
Figure 13 – Step Cracking at South Corner of Unloading Shed

There is limited evidence of differential settlement at the site except for the Unloading Shed. Some vertical and diagonal cracking was noted in both the concrete stem walls and the brick masonry walls above. The foundations for this portion of the building are not on mat and are at a higher elevation than the rest of the structure, which may partially explain some of this observed distress (see Figure 13).

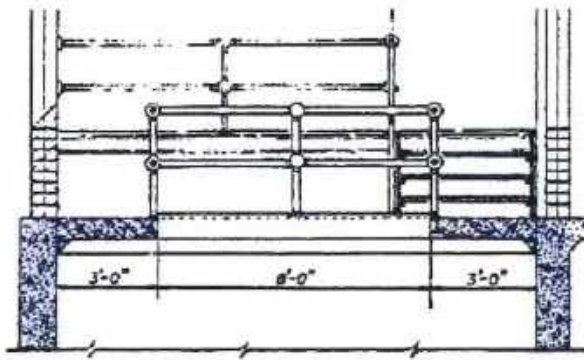
Figure 17 – Section through First Floor of Northeast Addition Above Filter Room (1950 Drawings)

The north end of the Northeast Addition above the Filter Room has a large opening in the floor which consist of 8 inch thick concrete slabs supported by a combination of concrete walls and 5 inch deep steel wide flange beams (see Figure 17). Like the south end these new floor slabs all date to the time of the addition as the chambers below were previously open to the outdoors.

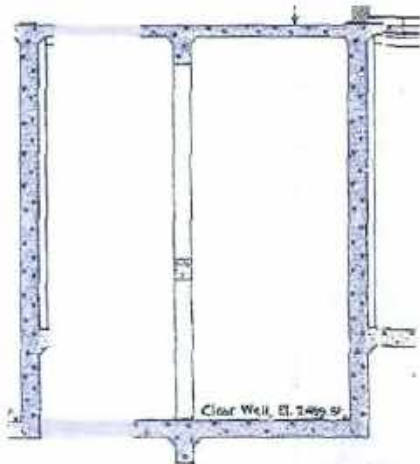
Figure 18 – Section Through Clear Well Showing First Floor of Northwest Addition

At the Northwest Addition the first floor is the old roof over the Clear Well. The structure here appears to be an 8 inch thick concrete slab spanning in the east-west direction to the concrete foundation walls and a north-south running concrete beam in the center of the span (see Figure 18).

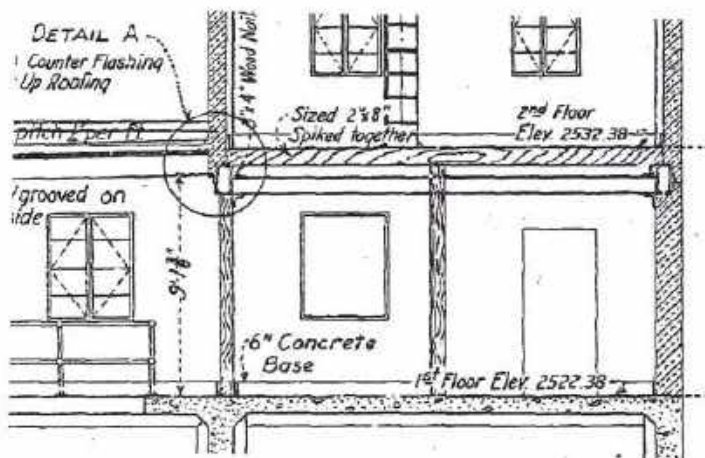
Figure 19 – Section Through Storage Floor Showing 2x8 Second Floor Joists

The Storage Floor is the only second floor level at the building. No observations could be directly made as a ceiling was in place but based on provided documentation it is believed that the framing consists of (2) 2x8 (nominal) wood floor joists spiked together (see Figure 19). The joists span in the north-south direction 19 foot across the space.

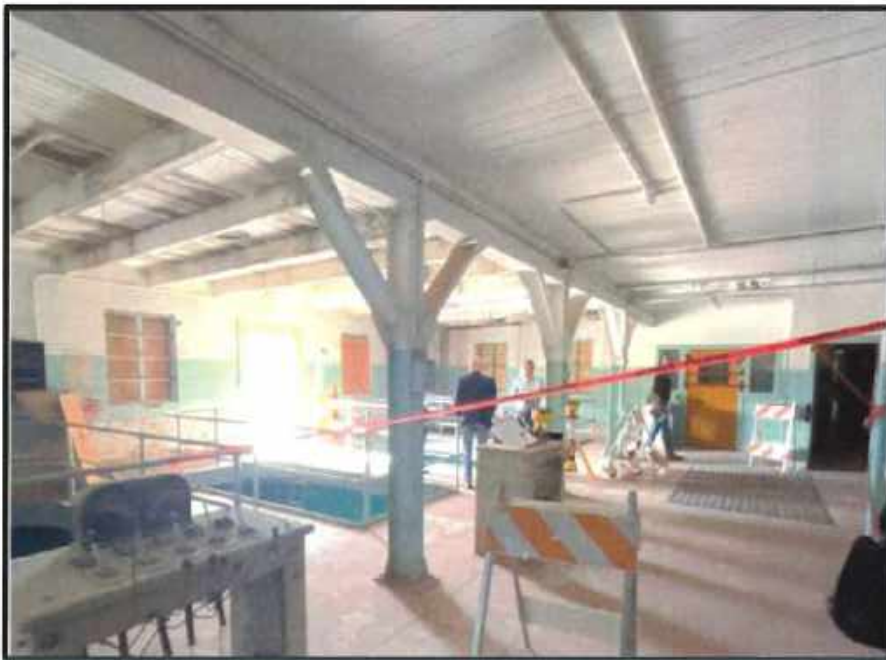
Figure 20 – Underside of Second Floor Framing and Steel Frame Supporting South End of Second Floor

They are supported by a brick masonry wall at the north end and a steel frame at the south end (see Figure 20). Spacing of the joists is not provided but is likely 16 inches on-center. There is straight wood sheathing above the floor joists.

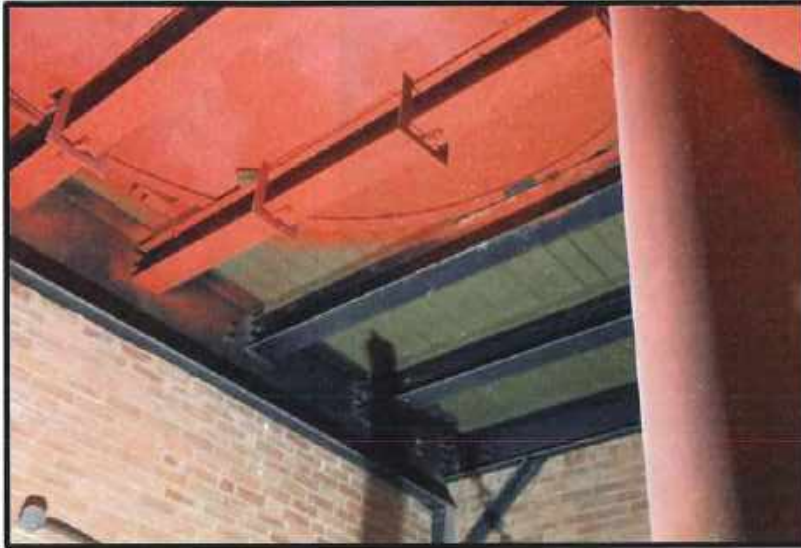
Figure 21 – Tank Floor as Viewed from the Second Floor Below

The Tank Floor is a small third floor area that houses a 10 foot diameter tank. There is a steel frame around the perimeter of the room with columns and beams partially embedded in the exterior brick masonry walls. The floor itself consists of (6) east-west running steel beams spanning the 15 foot

distance across the tower and spaced at around 2 to 3 feet on-center. Above the steel beams there is 1 inch thick wood sheathing that forms the floor.

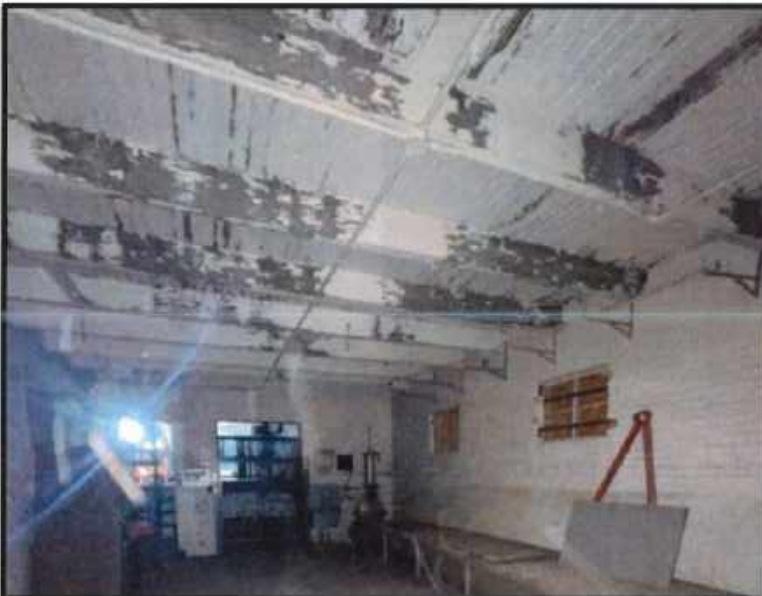
Figure 24 – Roof Framing at Unloading Shed

At the one-story portions of the building the roofs are flat and the framing consists of 4x10 (nominal) wood rafters spanning in the north-south direction and bearing on brick masonry walls. The rafters have straight wood sheathing (2x laid flat at original construction) and a built-up roof above. Over the Unloading Shed and Filter Beds the rafters are spaced at 36 inches on-center, whereas the spacing increases to 48 inches on-center at the new additions (see Figure 24).

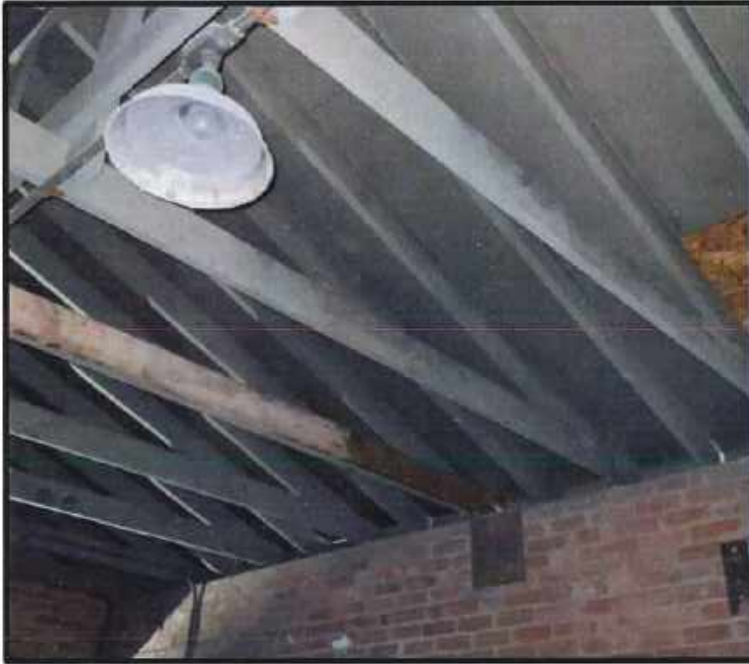
Figure 25 – Roof Framing above Storage Floor

The Storage Floor has a gable roof which consists of 2x6 (nominal) wood rafters at 16 inches on-center. At every other rafter there is a 2x6 horizontal tie and vertical at the peak to essentially create a truss. Above the rafters there is 7/8 inch thick straight sheathing, 3-ply built-up roofing and a tile roof. The roof framing spans 19 feet, has a 4:12 roof pitch, and bears on a 2x sill above the north/south brick masonry walls (see Figure 25).

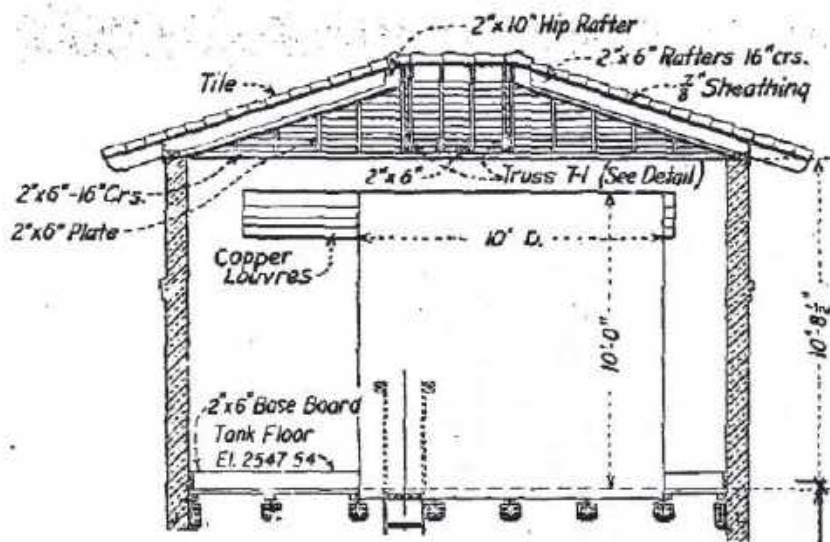
Figure 26 – Section Showing Roof Framing Above Tank Floor Tower

Above the Tank Floor the tower has a hipped roof. The framing consists of 2x10 (nominal) hip rafters and 2x6 (nominal) rafters at 16 inches on center. Like the second floor roof there is 7/8 inch thick straight sheathing, 3-ply built-up roofing and a tile roof (see Figure 26).

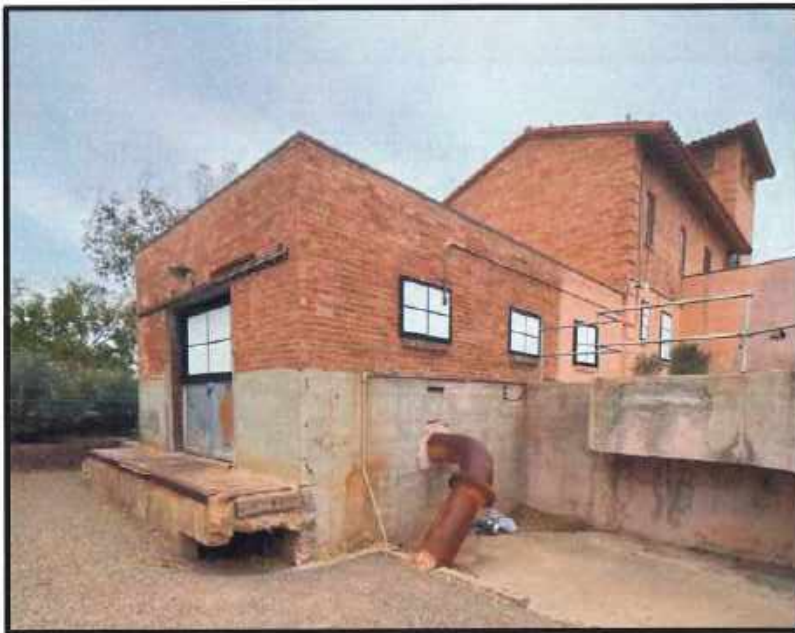
Figure 28 – Photo at South End of Site Showing Loading Dock (left) and Clarifier Tanks (right)

At the south end of the Unloading Shed there is an exterior concrete framed stair/loading dock that has been partially demolished. At the east end of the site several feet of the concrete walls around the Clarifier Tanks are still visible (see Figure 28).

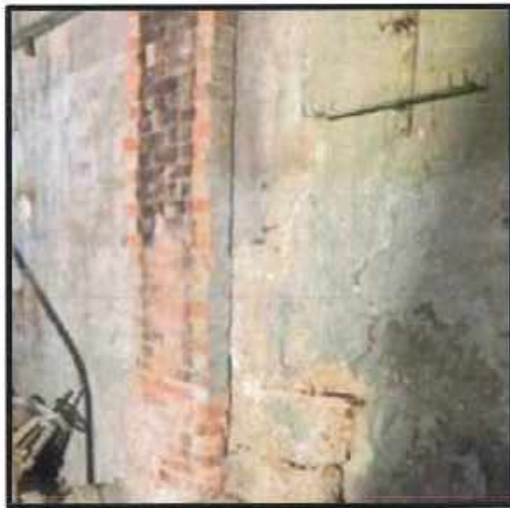
There is a chimney that was within the two story portion of the Operating Floor, which was demolished at some point in the past. Portions of this chimney remain at the basement level and pose a falling hazard with questionable stability (see Figure 32).

Figure 32 – One Wythe of Old Chimney Still Remains

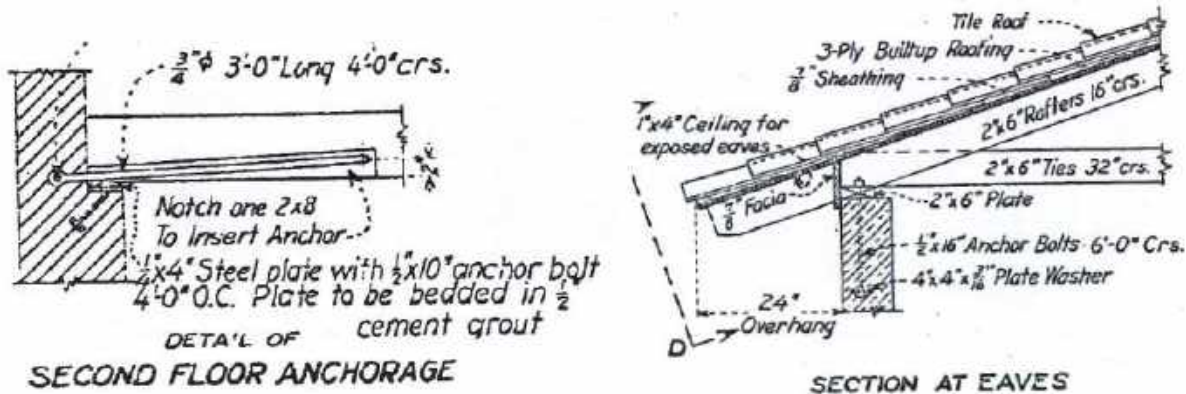
Figure 33 – Detail of Second Floor (left) and Roof (right) Anchorage to Masonry Walls

While the building was not explicitly designed for seismic it does appear there were some detailing considerations given to anchoring the diaphragms to the walls. Tie rods and anchor bolts are typically used to provide some positive attachment between the wood framed floors/roofs and the masonry walls. Spacing of the anchorage varies, but in some cases is up to 6 feet on-center (see Figure 33).

- **Seismic Repairs** – Based on the preliminary assessment additional anchorage of floor and roof diaphragms to masonry walls will be required. In addition, it is recommended that a plywood overlay be installed over existing wood sheathed floors/roofs to strengthen the diaphragms for seismic. Finally, some localized reinforcement should be anticipated at one or two wall lines to address shear issues. The reinforcement could take several forms – FRP added to the inside face, shotcrete, or at the tower potentially adding in new bracing to the existing steel frame that is already integral with the wall.

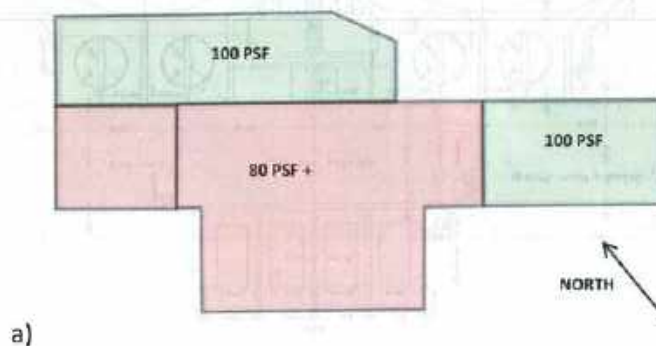
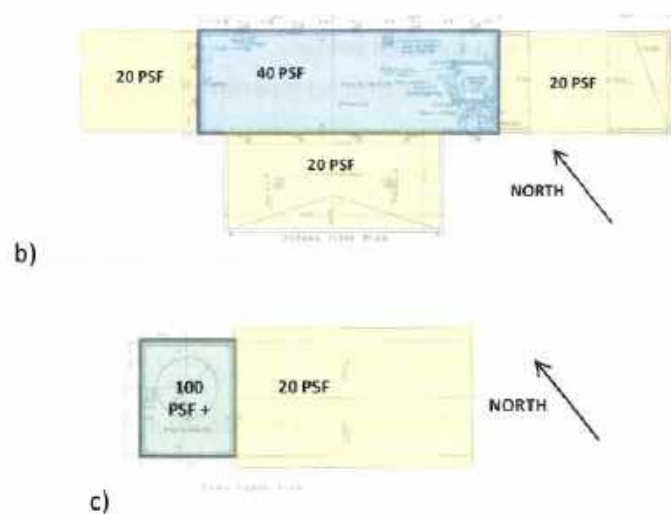
Figure 34 – Schematic plan showing preliminary capacities of a) ground floor, b) second floor, and c) tank floor level

Based on the limited information found in existing drawings, the first-floor member capacity may be between 80 and 100 pounds per square foot (see Figure 34). Additional probes are required to confirm the design assumptions used in the strength calculations as this capacity is based on select members where information could be gathered in the field or from provided documentation – many structural elements withing the floor assembly have not yet been evaluated due to lack of information.

The spacing of the second-floor wood joists is currently unknown. Preliminary assumptions are that the joist spacing may be between 12 to 24 inches. At a 12-inch spacing the member exhibited a deflection deficiency at 40 psf. Additional probes to identify wood species and joist spacing will help confirm the capacity.

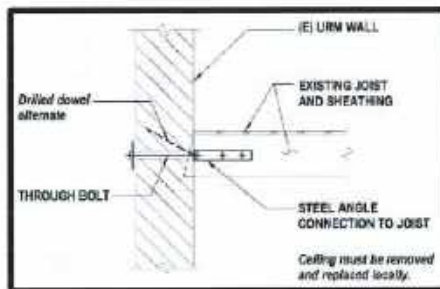
Figure 37 – Conceptual retrofit detail to supplement out of plane anchorage capacity

The current out of plane detailing is not adequate for an improved seismic performance. Improved seismic detailing of the out of plane masonry attachments can supplement the capacity of the existing anchors. New tension anchors can be added to the floor level as shown conceptually in Figure 37.

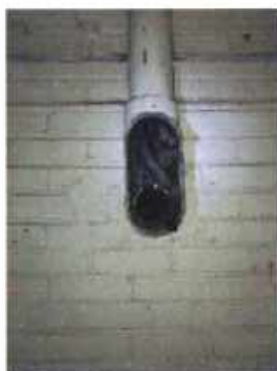
The original electrical service entrance was located on the Northeast side of the property stubbed to a weather head approximately 20' high on the water tank tower. The service has been disconnected and removed to the weather head with cables inside the building being cut at the nearest accessible point in the building. Refer to Photo 1 & 2 for disconnected service locations.

Photo 1 - Interior Service Entrance Conduit and Cut Conductors

A new electrical service will be required, size to be determined based on new building use. The existing service location can be reused however new conduit, conductors, weather proofing, and weather heads will need to be installed.

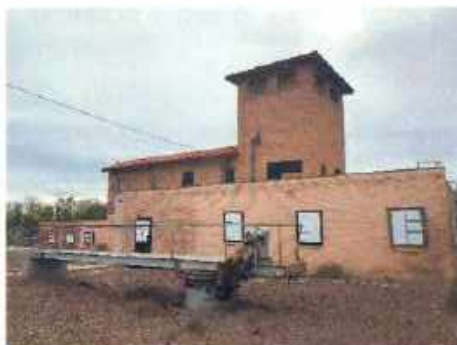
Photo 2 - Exterior Service Entrance Weather Head, looking South

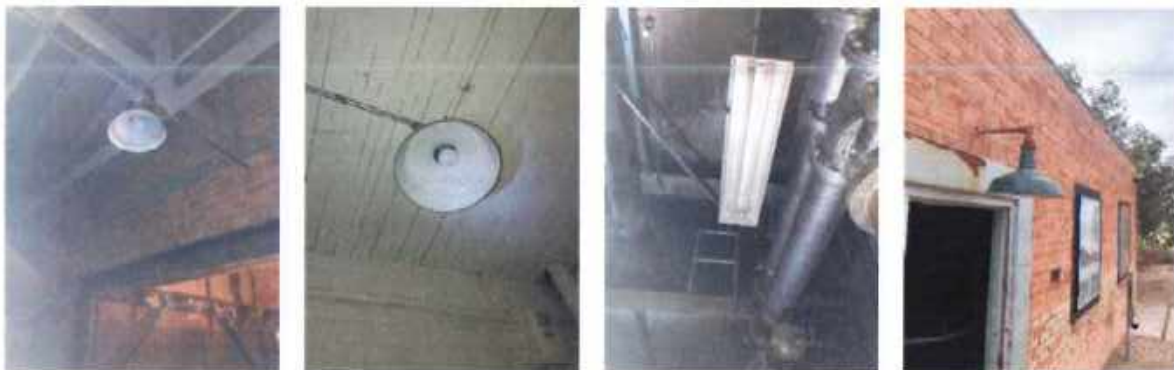
Existing lighting is a combination of fluorescent T12 tubing, and incandescent light bulbs in pendant fixtures. Exterior façade light fixtures are similar in appearance to the interior pendant mounted fixtures, except wall mounted. Refer to Photo 3 for typical fixtures. The fixture housing can remain or be replaced with a new fixture matching the original form-factor. No additional exterior lighting was found on the property for the adjacent community gardens or the parking area. Additional fixtures are recommended to comply with IES recommended light levels. New LED light sources will need to be installed throughout to comply with IEC recommended lighting levels, egress lighting, and energy consumption compliance.

Photo 3 - Typical Existing Light Fixtures

Egress lighting and exit signage will need to be installed throughout. Recommend providing battery back-up on board new fixtures and exit signs in case of normal power loss.

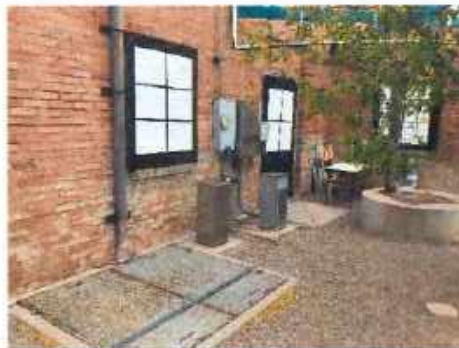
Existing telephone and data systems service entrance is at grade on the Northwest corner of the property, refer to Photo 4. There are exterior rated enclosures and a metering pedestal however it appears that the service is disconnected at this time. Inside of the building the existing telephone backboard board and all equipment will need to be replaced to be compatible with modern tele-data infrastructure. This is not recommended to be in view of the public as it will not be able to match the historic aesthetic of the space.

Photo 4 - Telephone Service Entrance

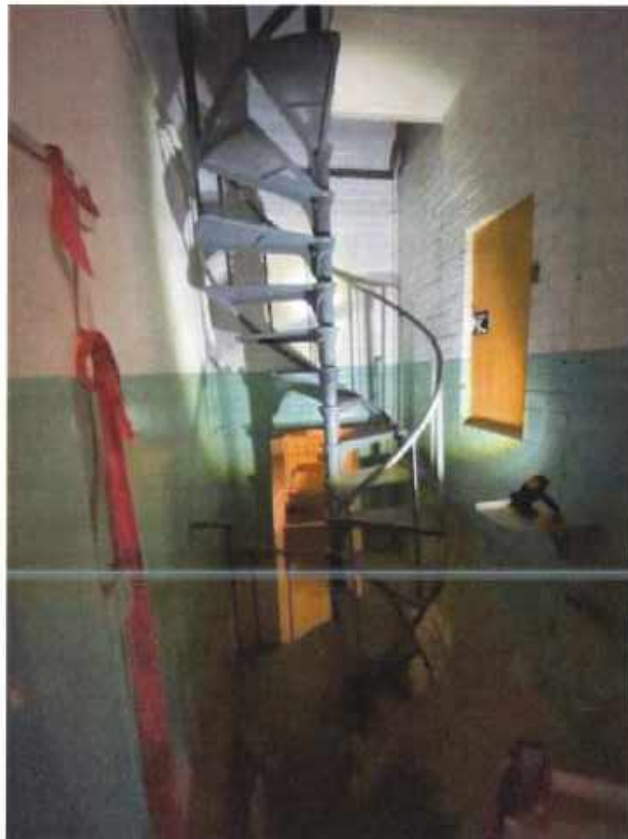
- Single spiral stairway serves Basement through Second Level
- Third Level accessible by ladder only
- Multiple elevation changes without accessible ingress/egress
- Grated floors
- Stairs without solid risers
- No exit signage
- No emergency lighting
- Elevator not functional.

Figure 1: Spiral Stairway

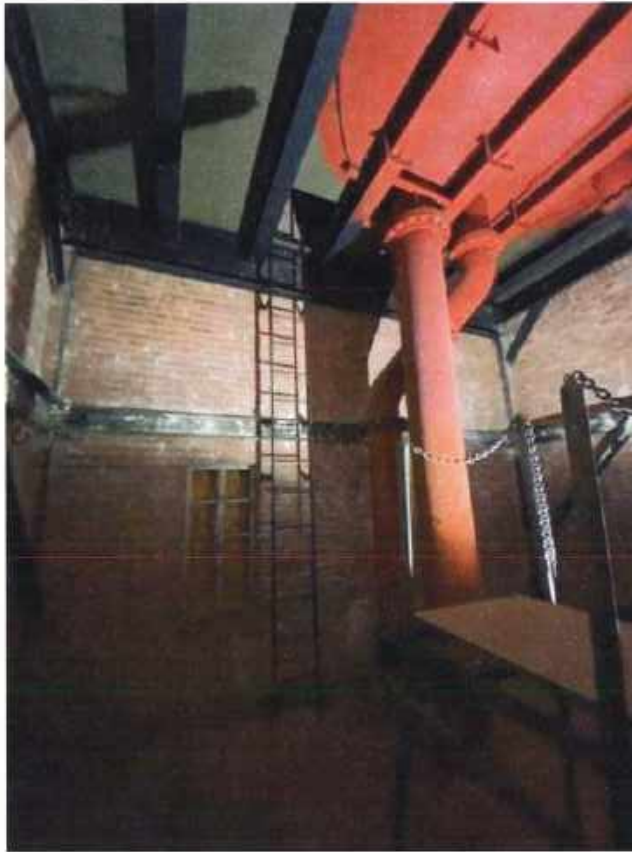
Figure 2: *Ladder access to Level 3 tank*

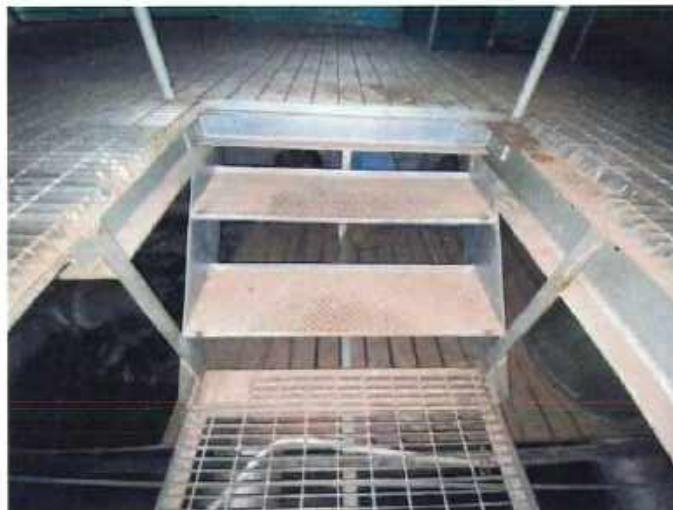
Figure 3: *Open grate floor and stairs*
