Stewart Old Gym Building

Seismic Stabilization and  
Rehabilitation

SPWD Project 23-P09

Programming and  
Conceptual Design Document

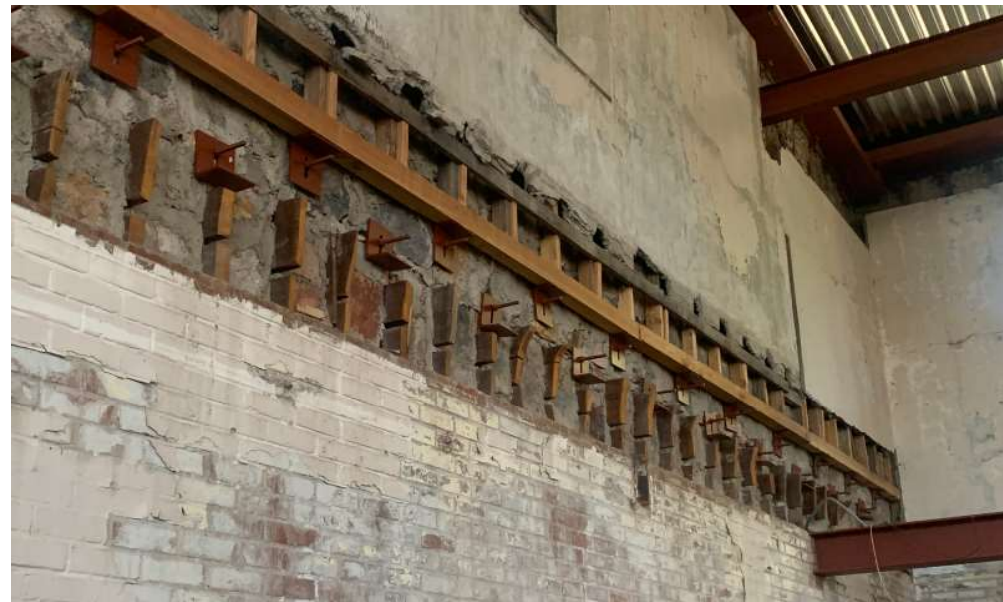
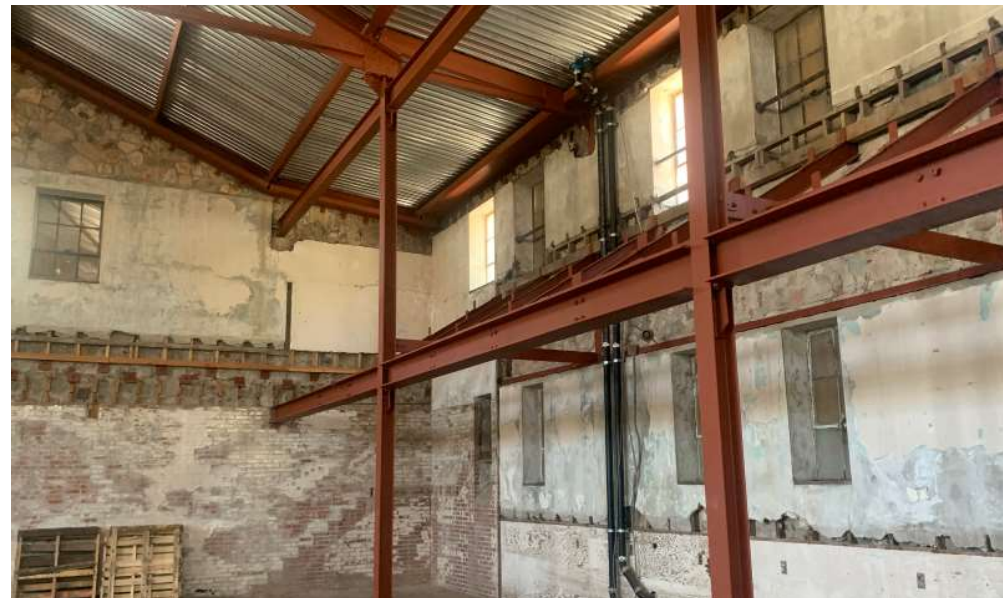
The original balconies at the east and west ends of the gym were of wood construction. The balcony at the north side of the gym was of wood and steel construction. The wood portions of these balconies were deteriorating and were removed as part of the 2019 project. The steel framing is in good condition but portions are anticipated to need to be removed to accommodate the updated balcony construction.

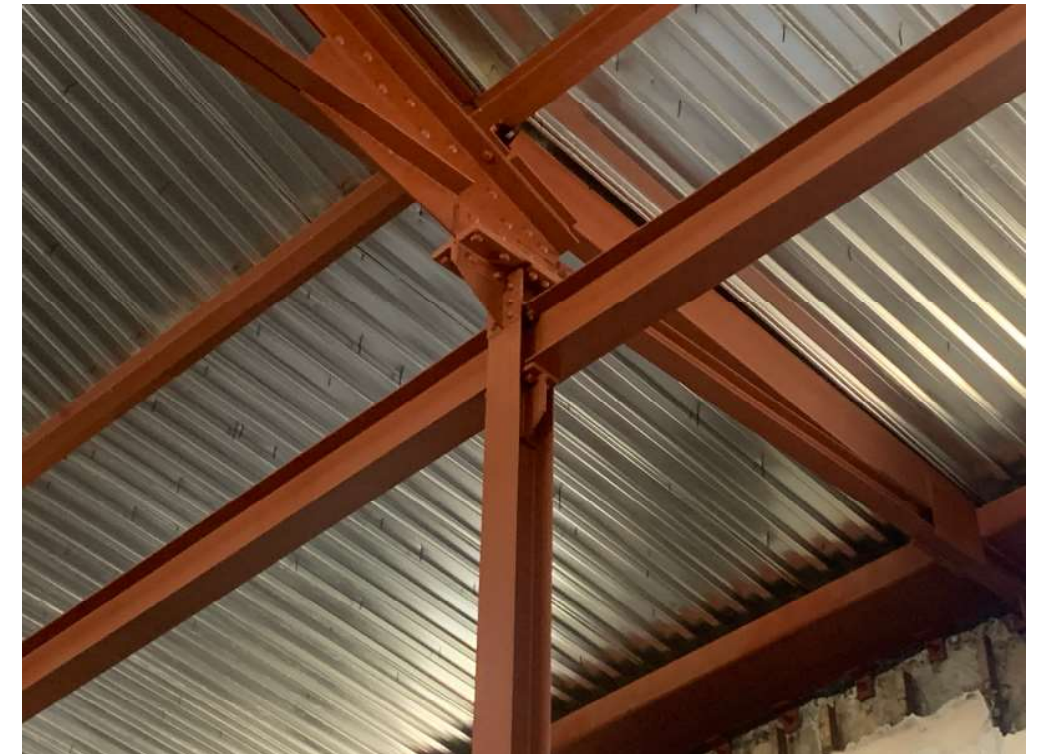
At the gymnasium, the existing roof structure consists of the original steel trusses and purlins, as strengthened in 2019, supporting the new metal deck also added at that time. The steel trusses are supported by original steel columns.

At the east and west wings of the building, the original roof was of wood-framed construction. This roof was deteriorating and was removed during the 2019 project. The roof in these areas was then replaced using metal deck supported from the existing masonry walls and new steel beams and columns.
