Stewart Facility
5500 Snyder Avenue, Carson City, NV 89701

Request for Permission to Undertake Structural or Visual Alterations

Building Number and Name: #20 Old Gym

CIP Project Number 23-P09. Advance Planning Old Gym Building Seismic Stabilization and Rehabilitation (Stewart Facility)

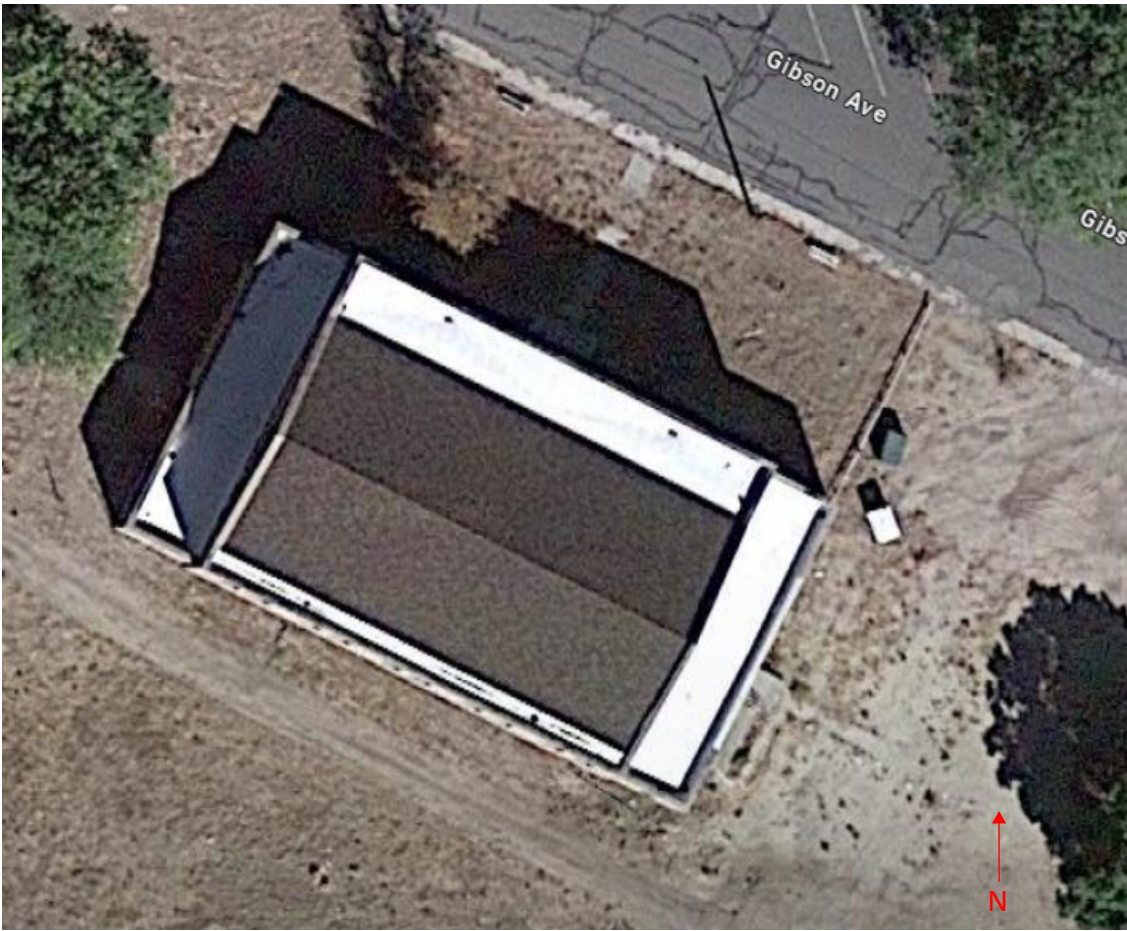
Plan View

Existing conditions include non-maintained landscape with exposed soil, weeds, and 2 trees.

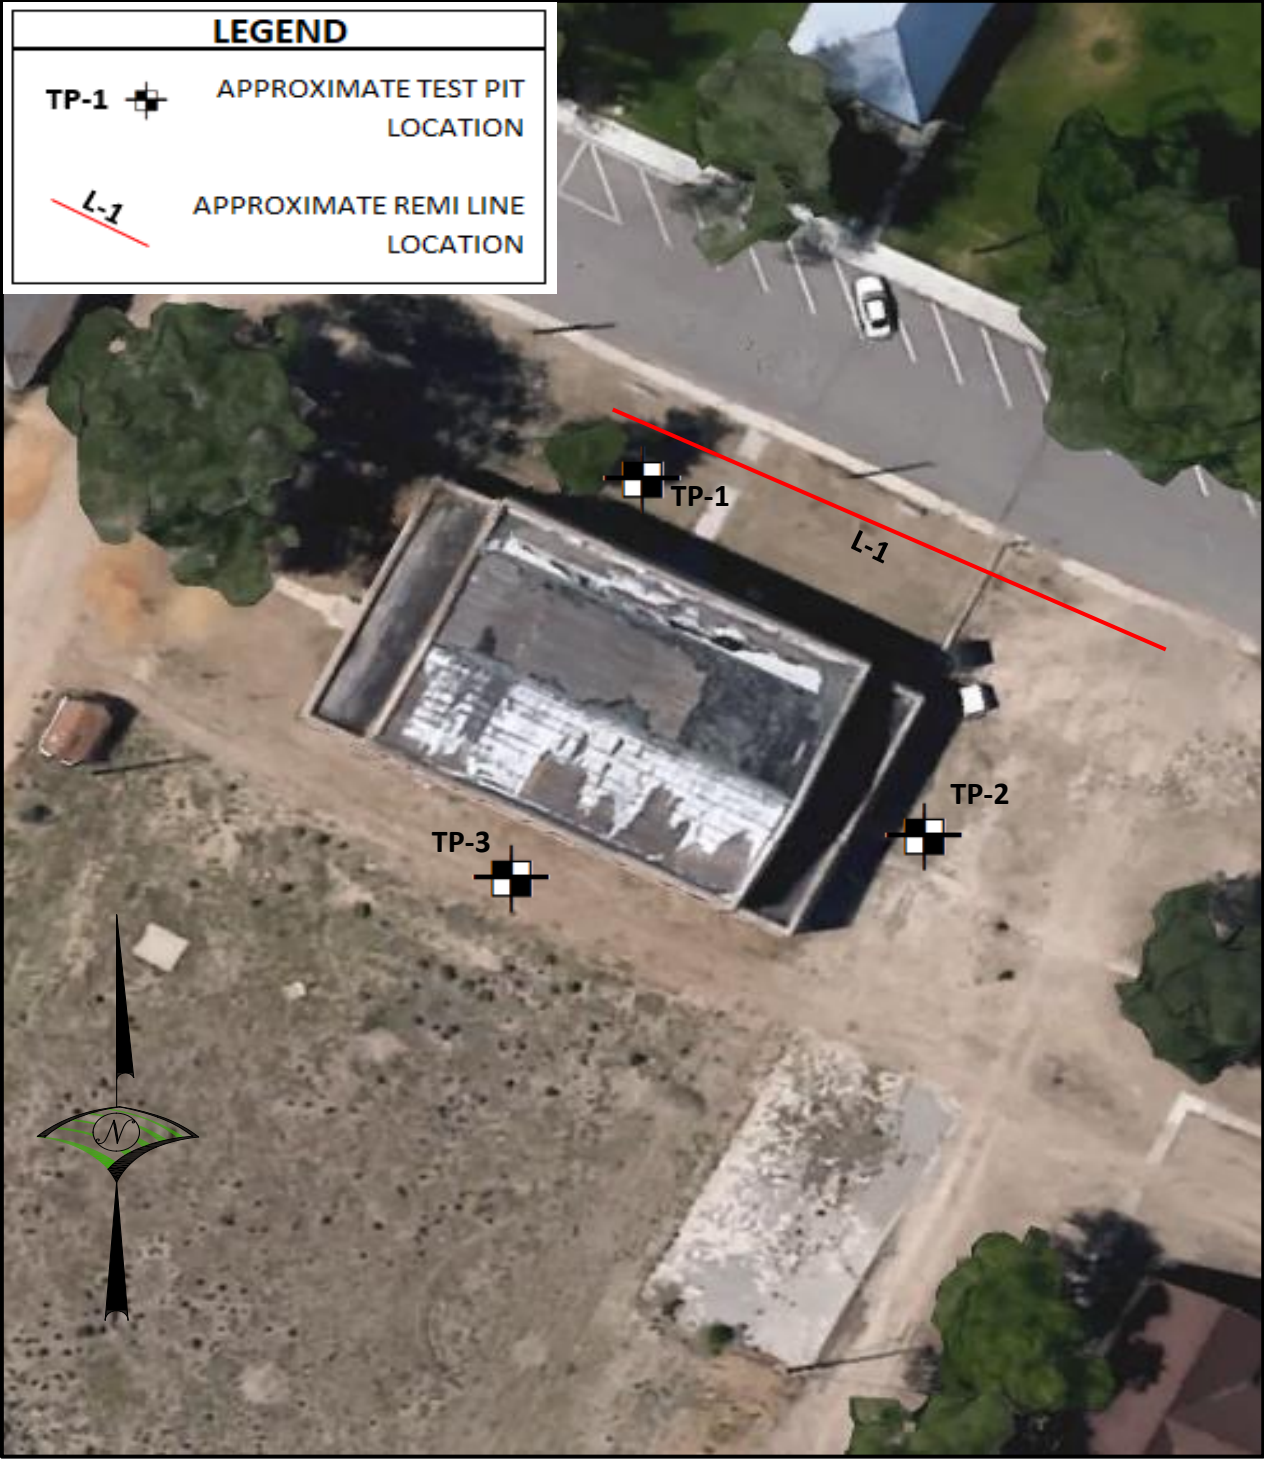
OLD GYM BUILDING AT STEWART FACILITY	SITE MAP AND APPROXIMATE EXPLORATION LOCATIONS	FIGURE 2
--------------------------------------	------------------------------------------------	----------

As part of the first phase, a geotechnical report has been requested to understand the soil conditions of the site. The report requires three test pits to be dug at the attached plan locations. The test pits will be dug by a backhoe to 15' deep and filled back in on the same day. The purpose of the excavations is to collect soil data to be used for the future rehabilitation of the Old Gym.

See attached site plan for the three test pit locations (TP1, 2,3) and the ReMi (Refraction microtremor) line. The ReMi test is non-destructive and performed to measure sound waves in the soil (it does not penetrate the soil).
