City of Ely, Nevada Historic City Hall and Fire Station Rehabilitation

An Historic Structures Report

RAFI Architecture and Design

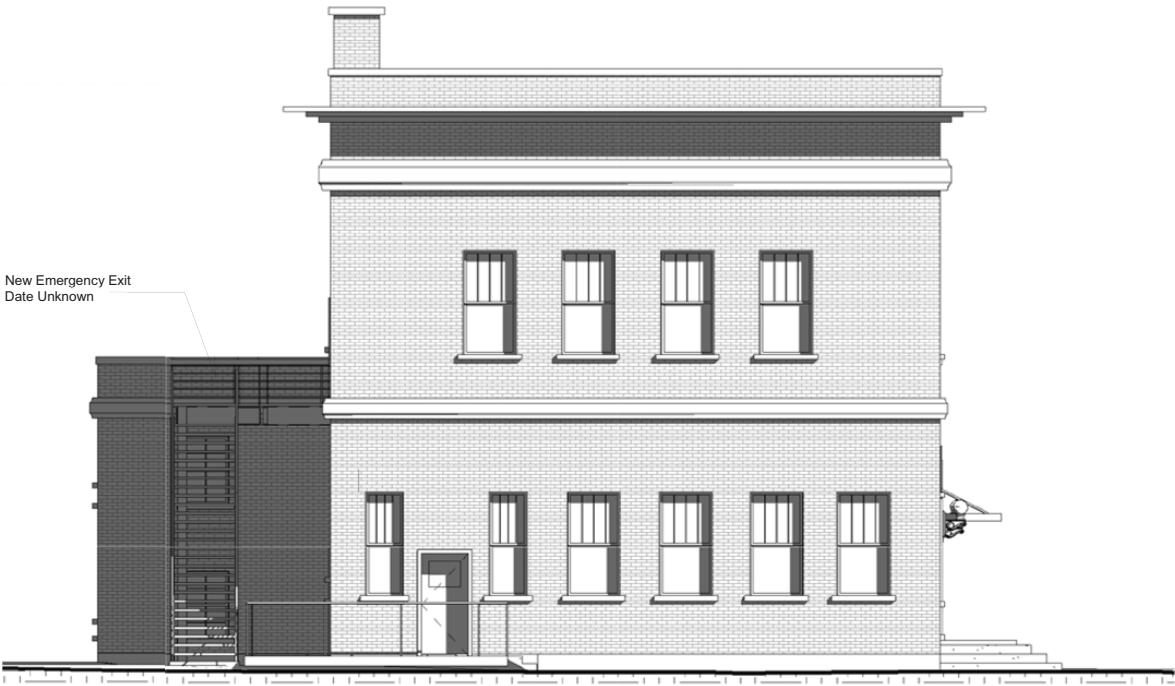
New Emergency Exit
Date Unknown

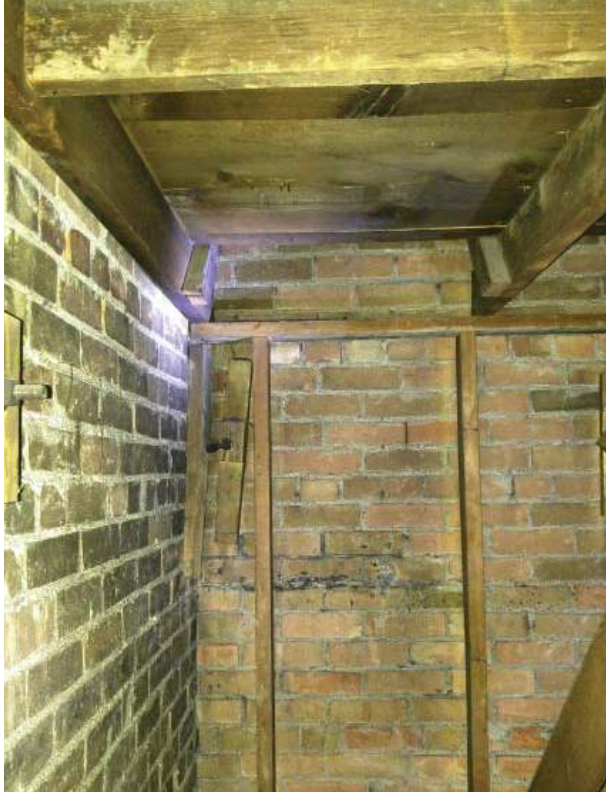
Wall to structure connection in attic space.

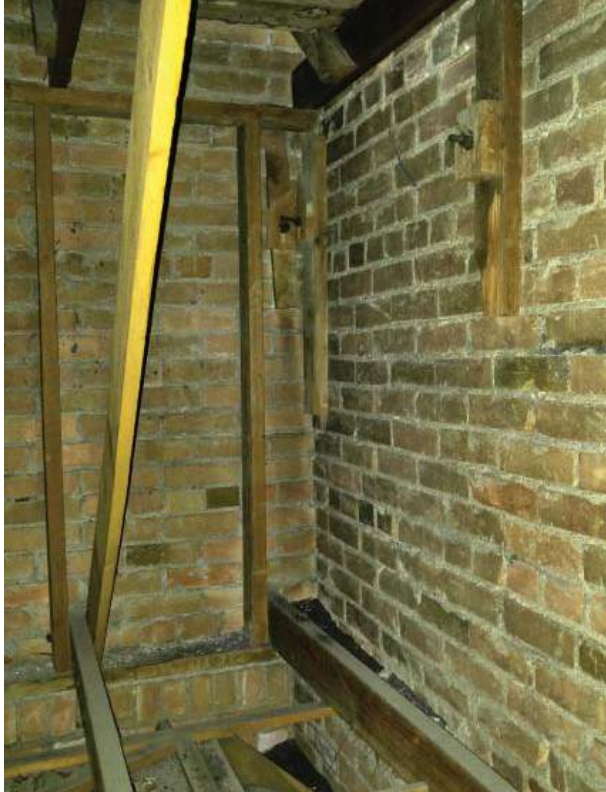
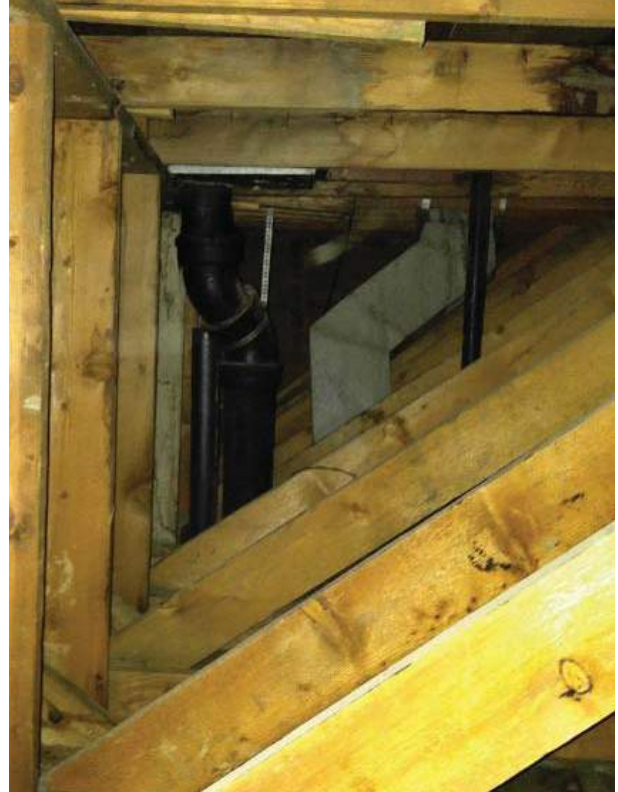
Attic space.

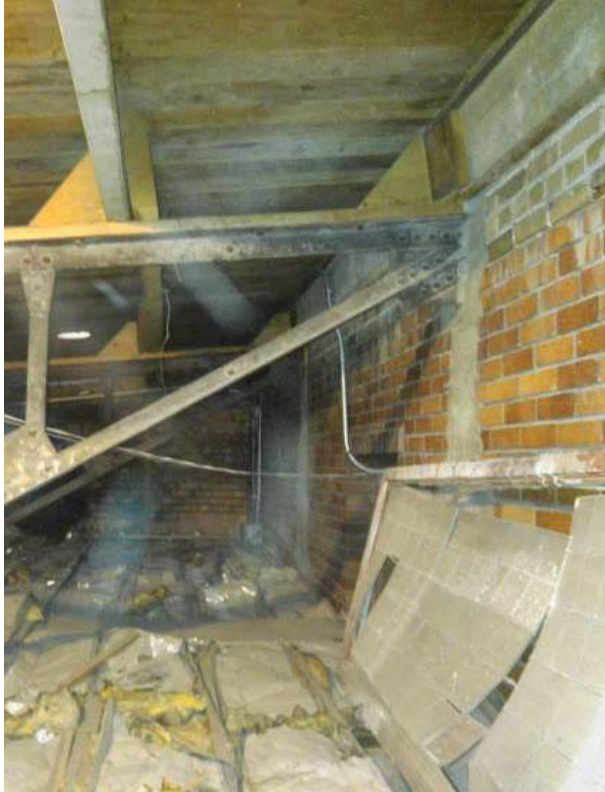
Structure to wall connection above firestation garage.
