# **Huntridge Theater**

**Las Vegas, Nevada**

Site Visit conducted by

*October 11, 2016*

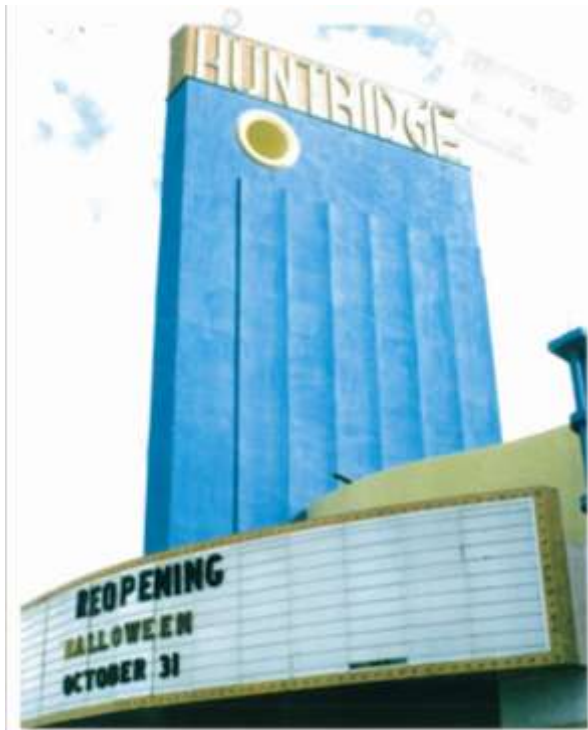
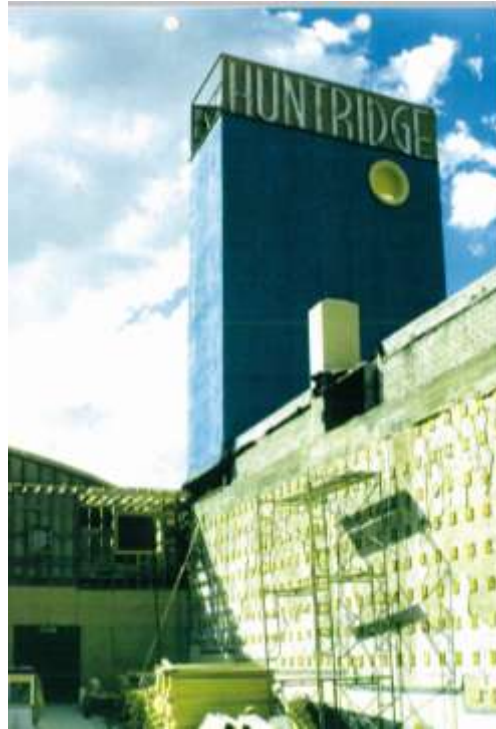
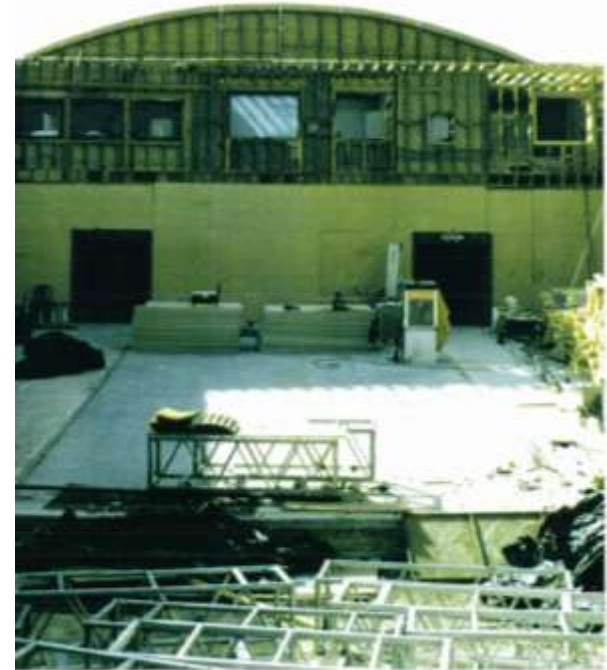
Installation of the new roof (1997)

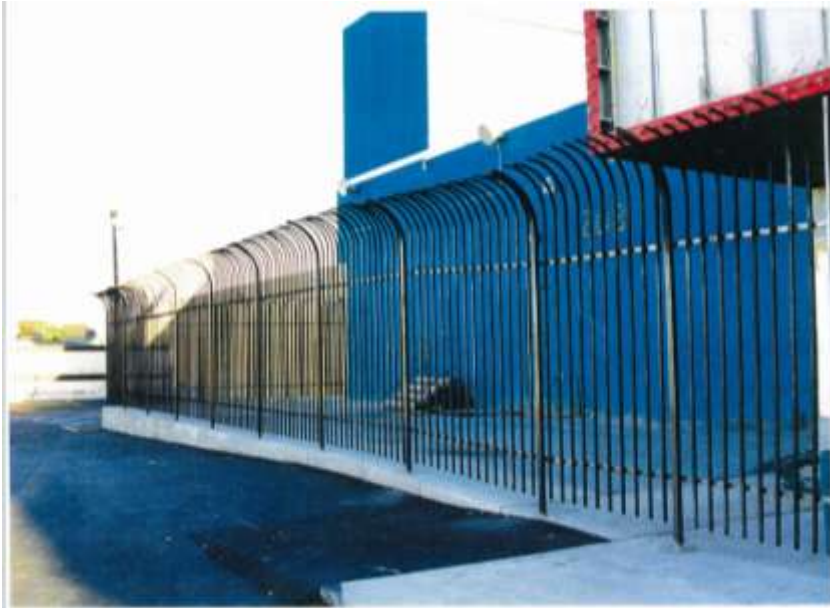
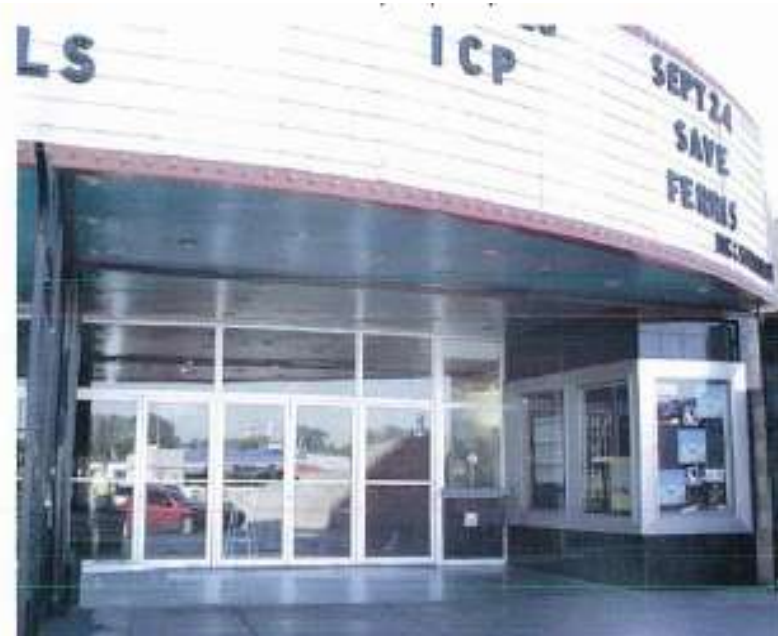
Installation of new security fencing; restoration of marquee (late 1990s)

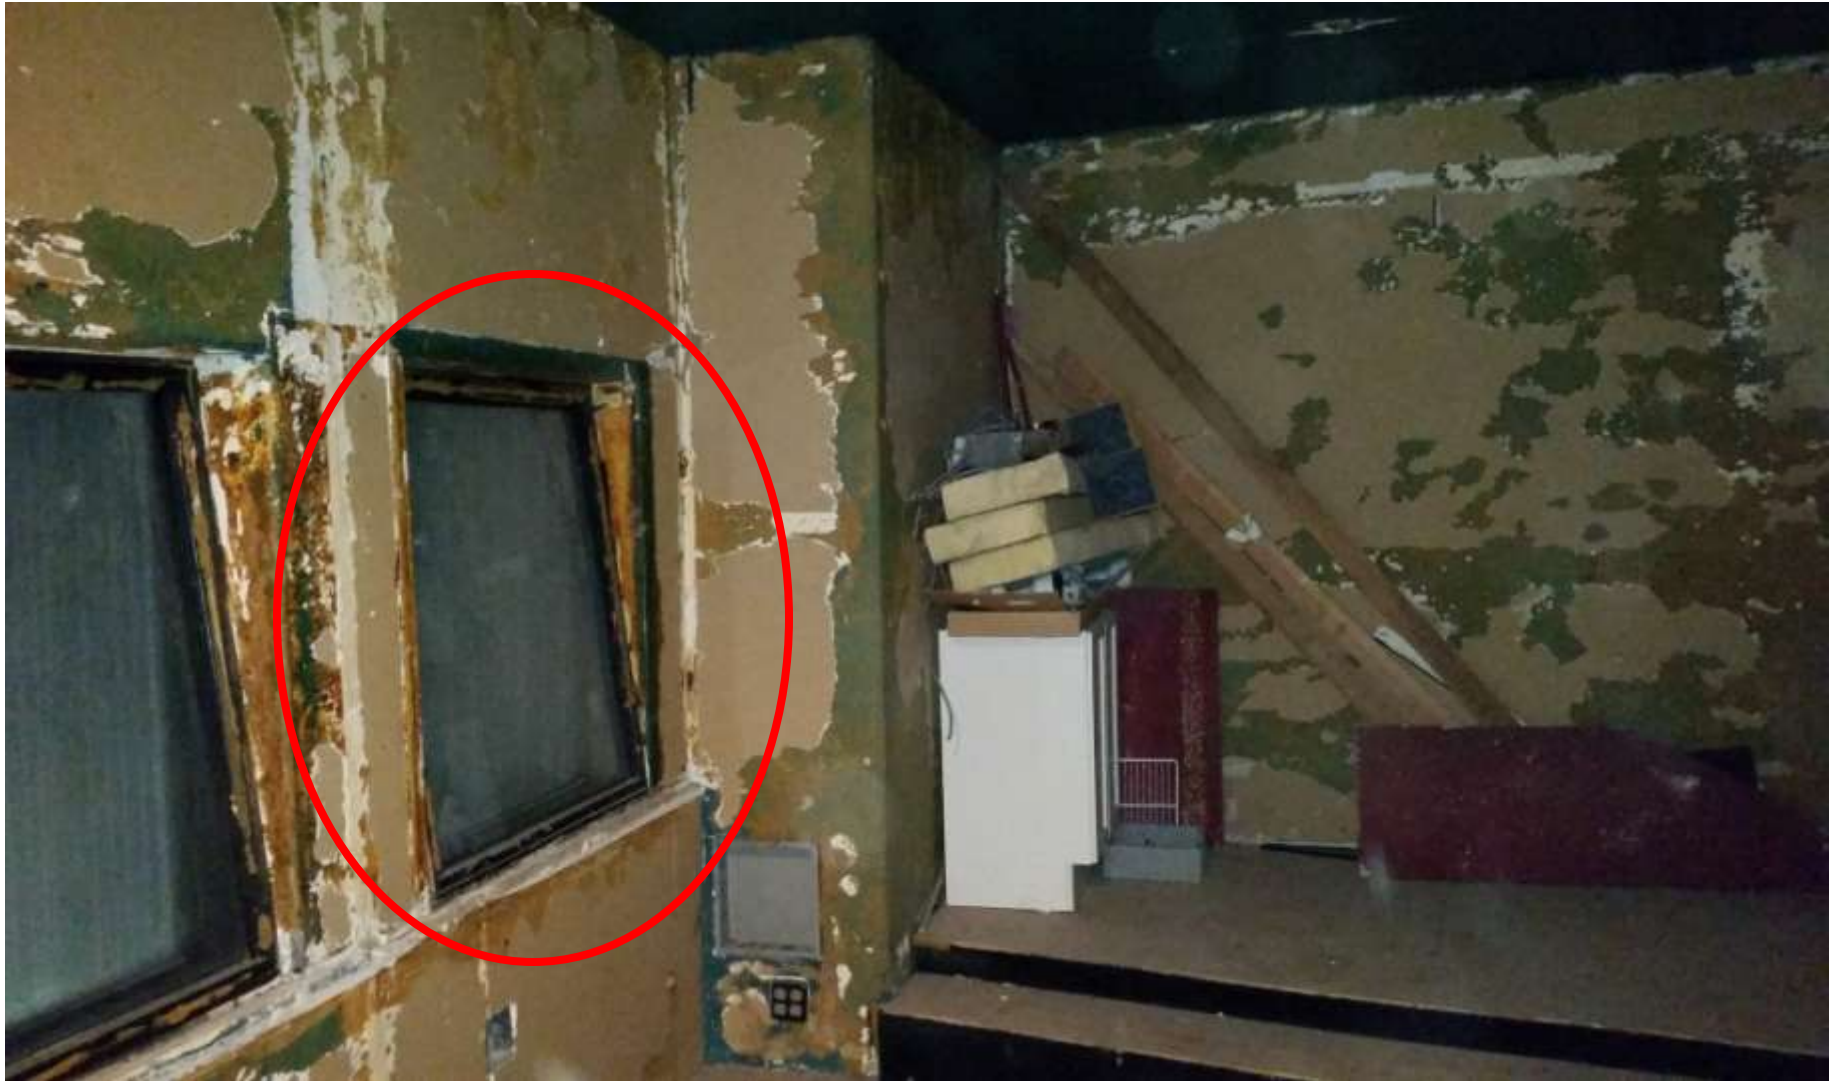
Backstage Area

Note, damage to wall (see enlarged image)

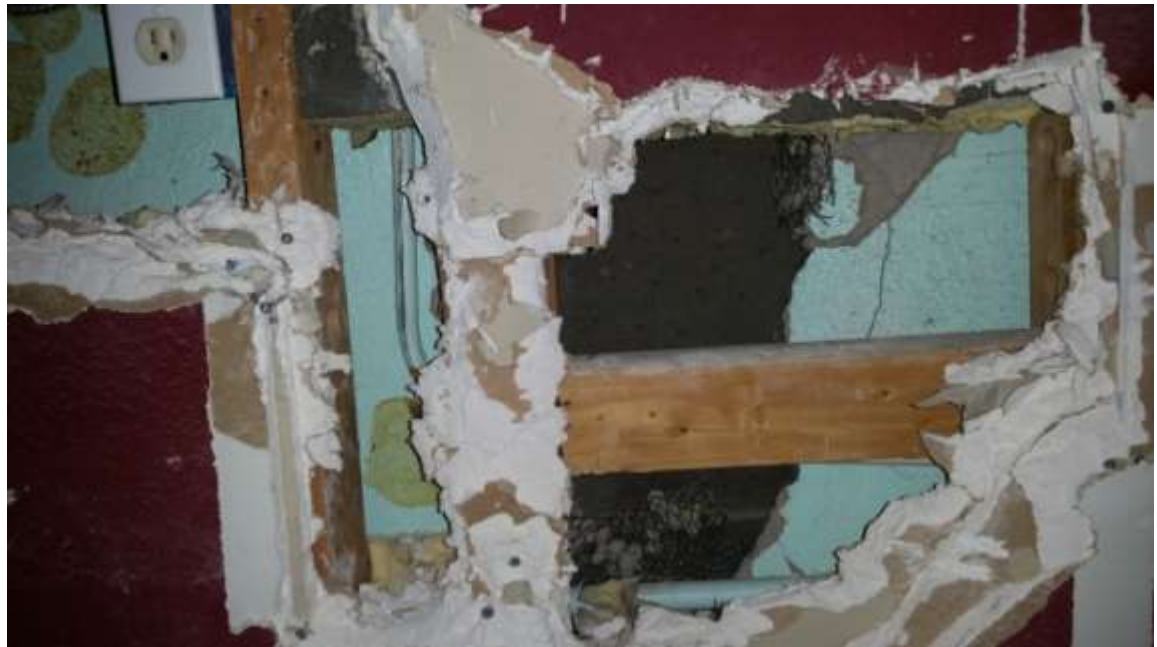
## Second Floor Sound Studio Area

Note: cuts in wall, possibly to  
access interior sound equipment
